# REPAIR GUIDELINE

Line trimmer \_STX3800

*Version: 1*

*Issue Date: 01/11/2019*

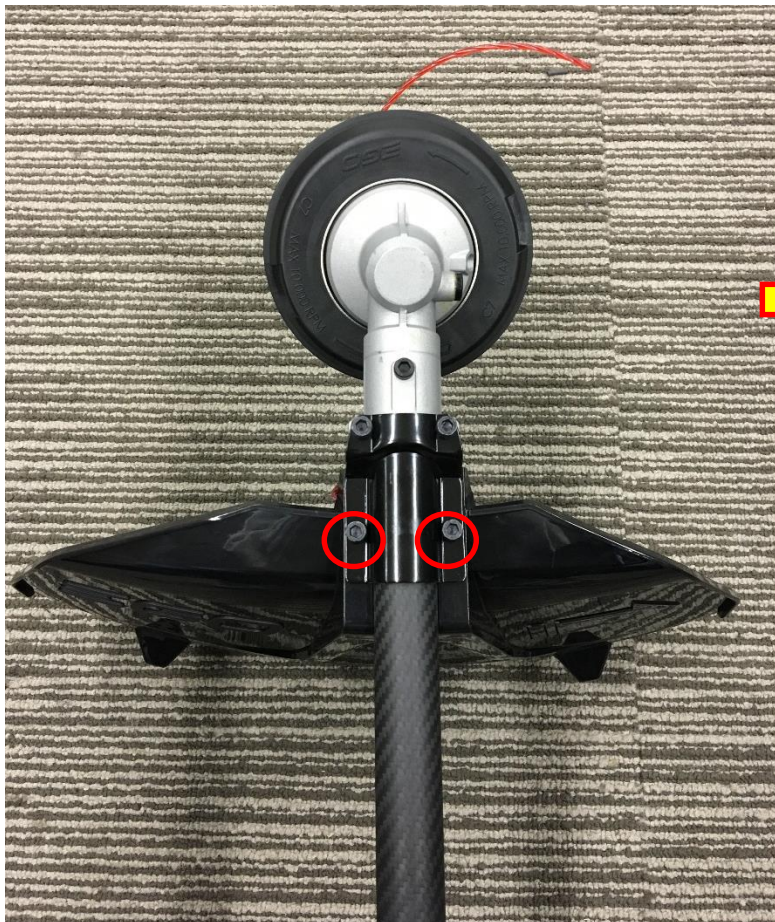
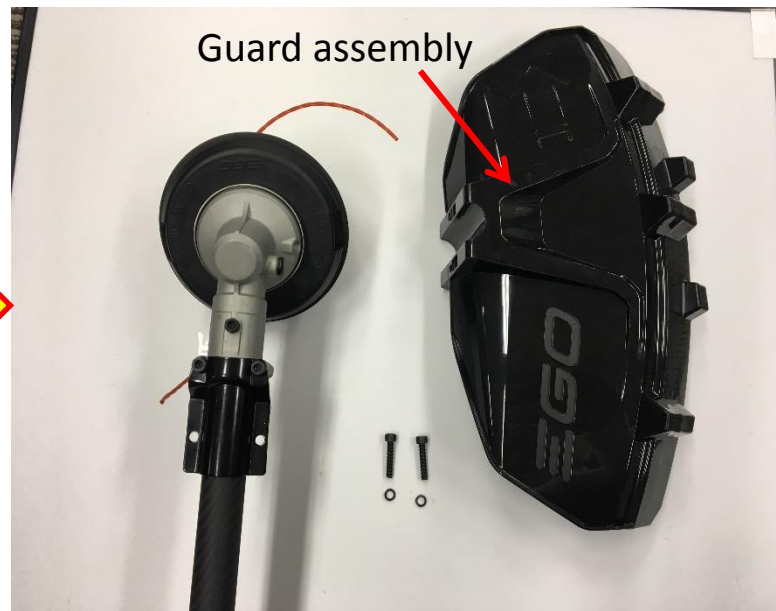
1. Loosen 2 screws to disassemble the guard assembly, if the guard assembly is broken, replace it with a new one.

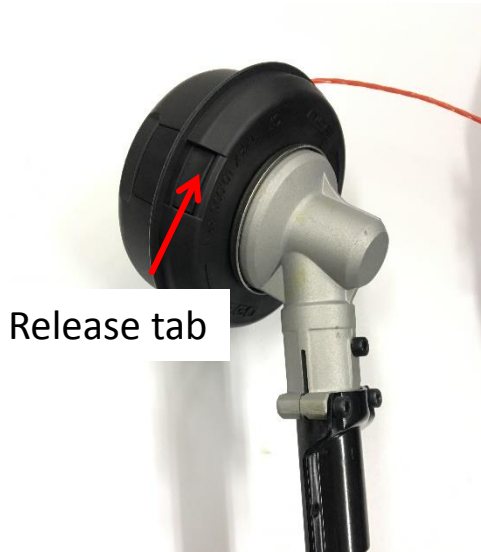
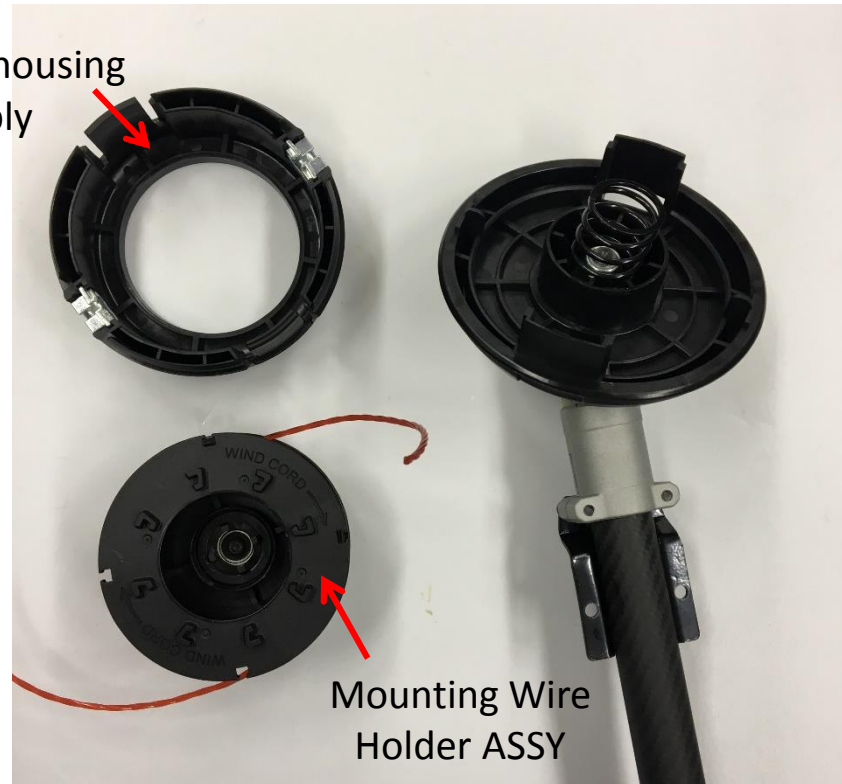
Lower housing assembly

2. Press the release tabs to remove the lower housing assembly & mounting wire holder ASSY.

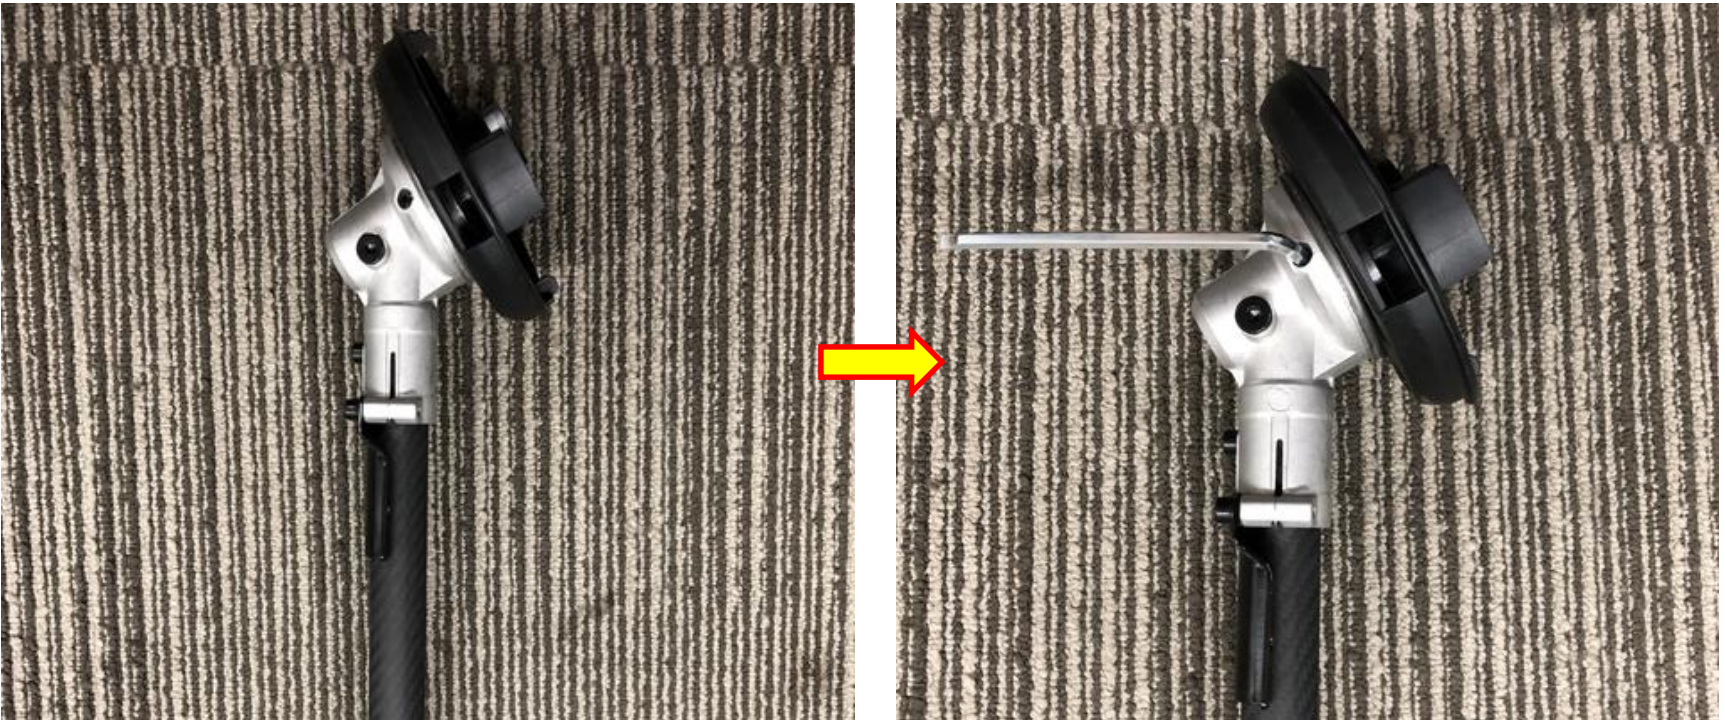
4. Rotate the upper housing assembly to align the slot in the flange with the hole in the gear case.
5. Insert the hex wrench into the aligned holes to act as a stabilizer.

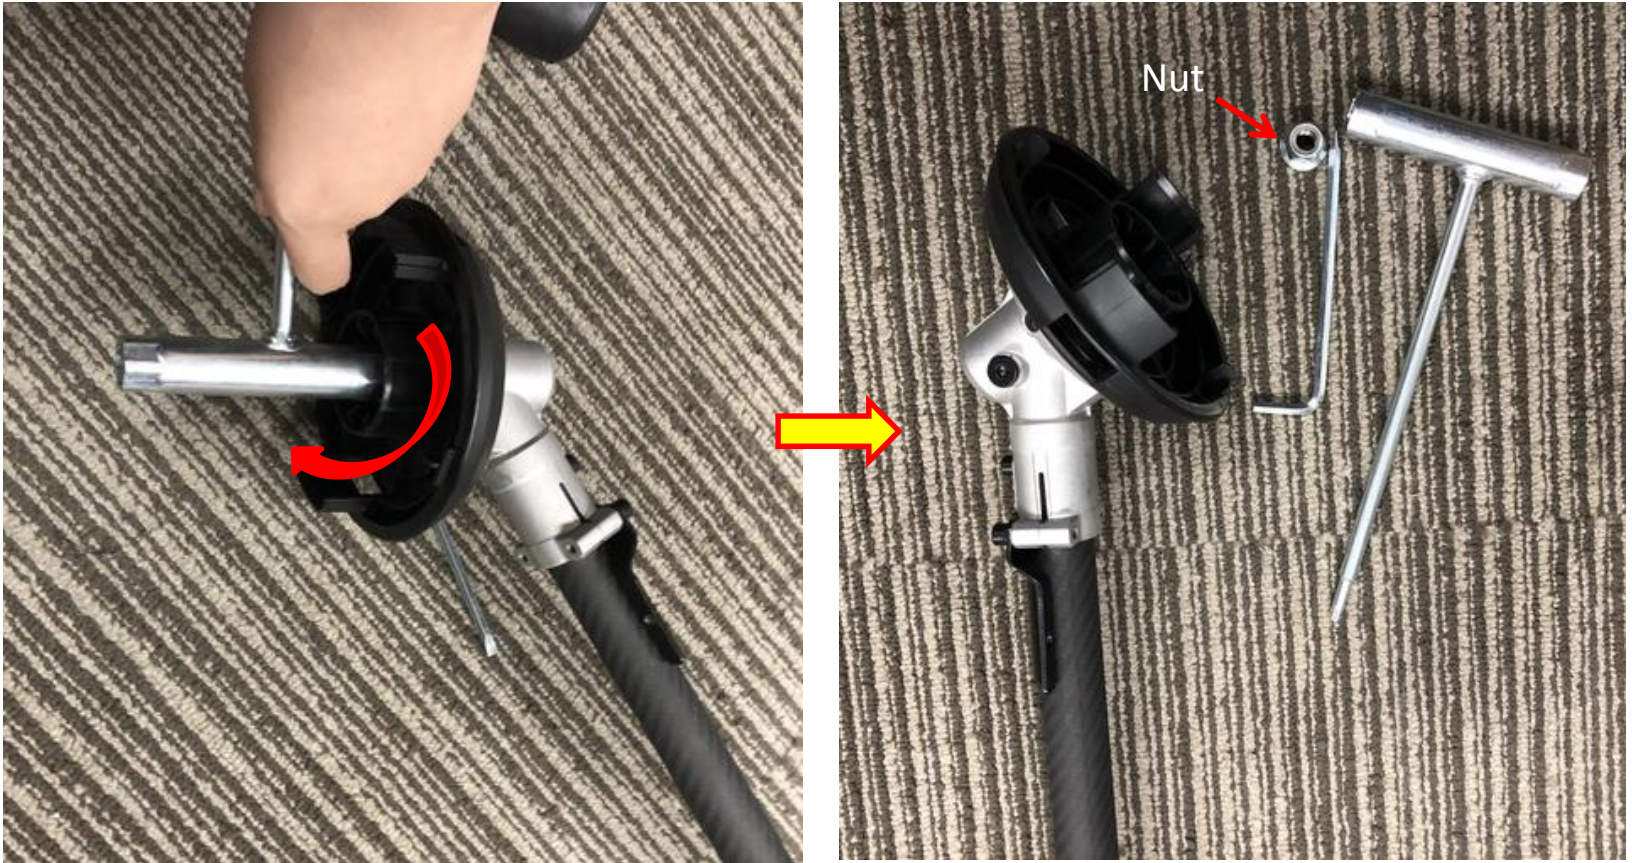
6. Loosen the nut with socket wrench clockwise to remove it from the shaft.

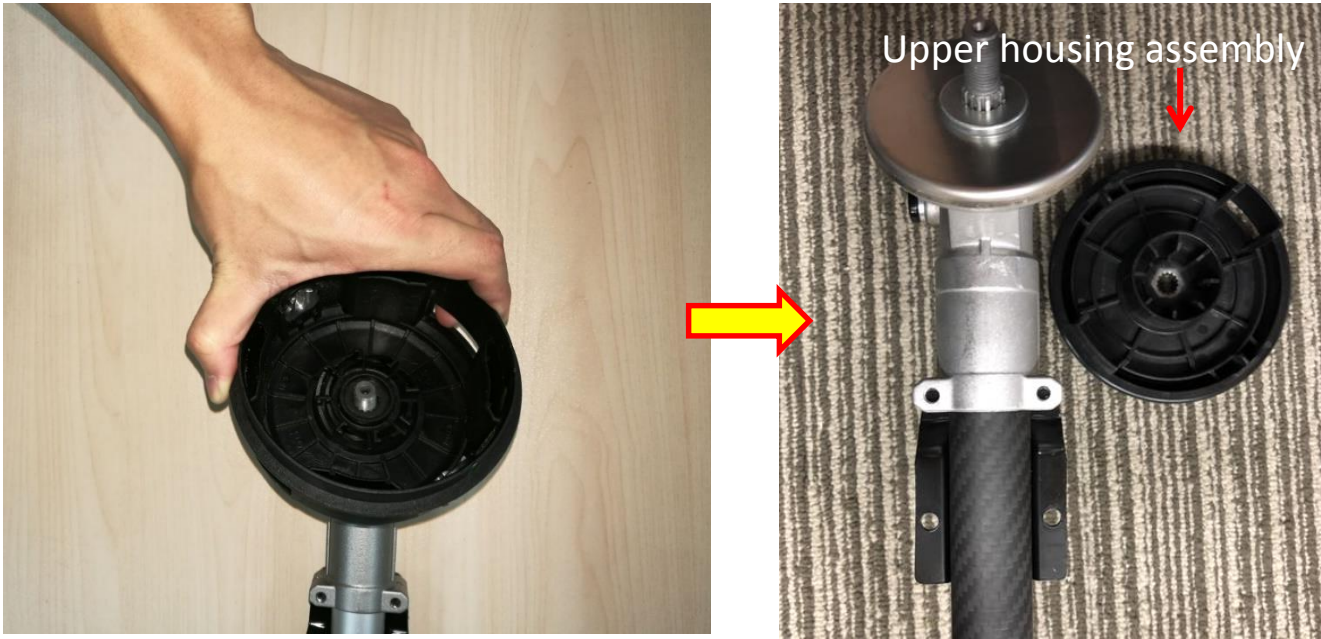
7. Take the upper housing assembly out of the shaft.

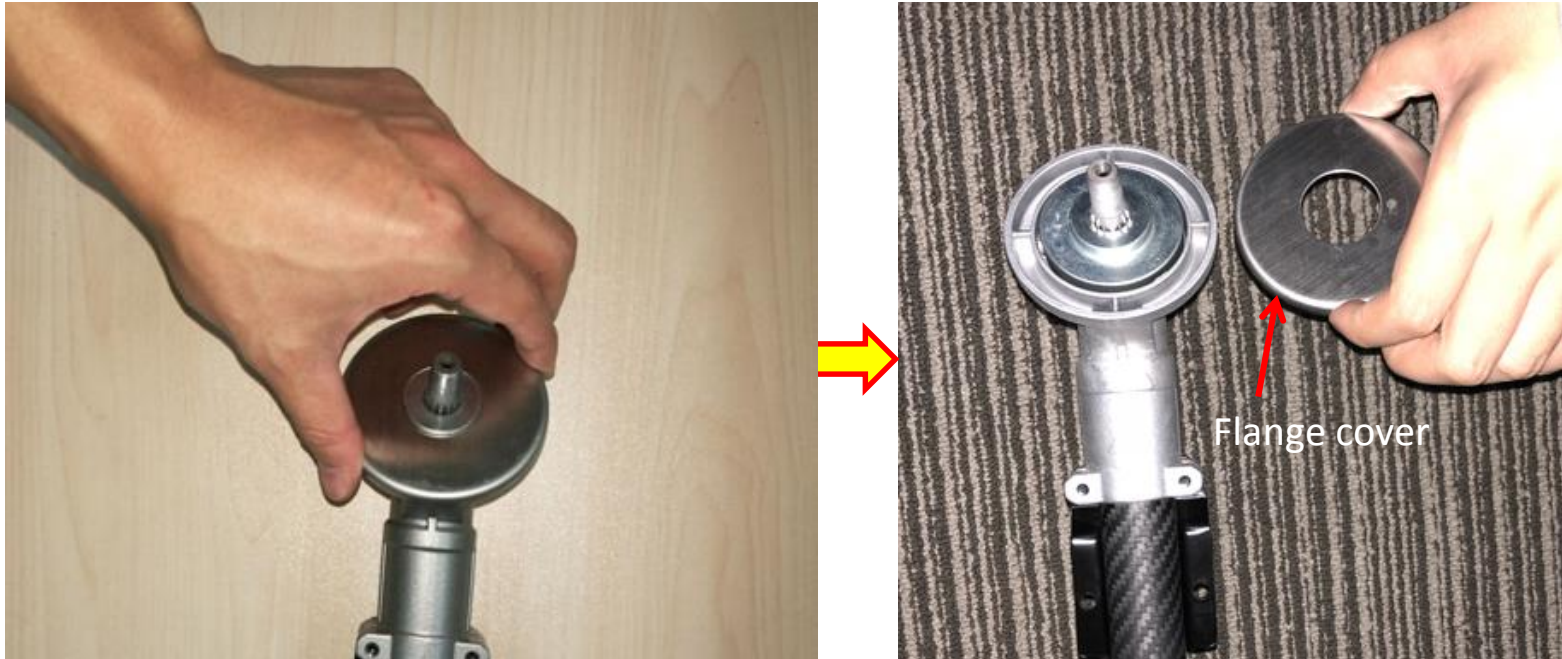
8. Take the flange cover out of the shaft.

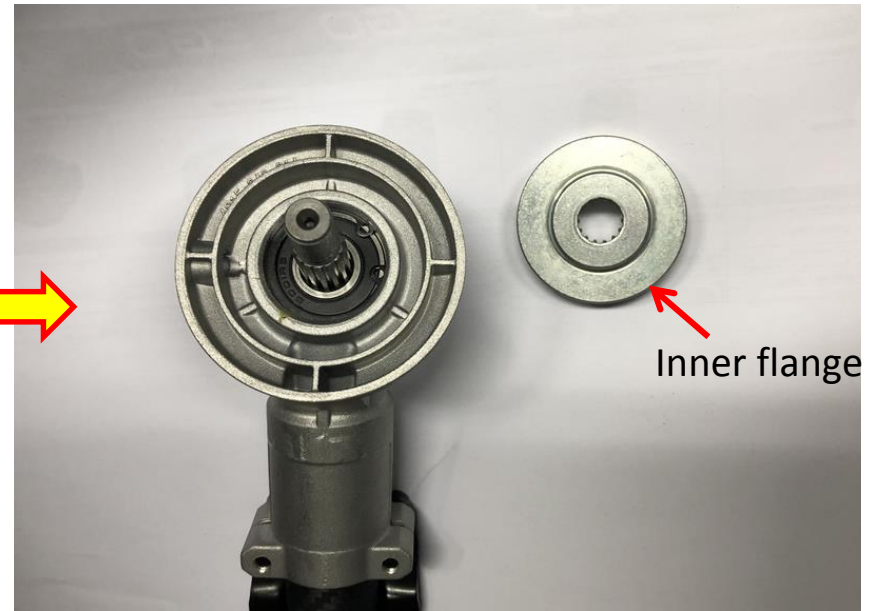
9. Take the flange out of the shaft.

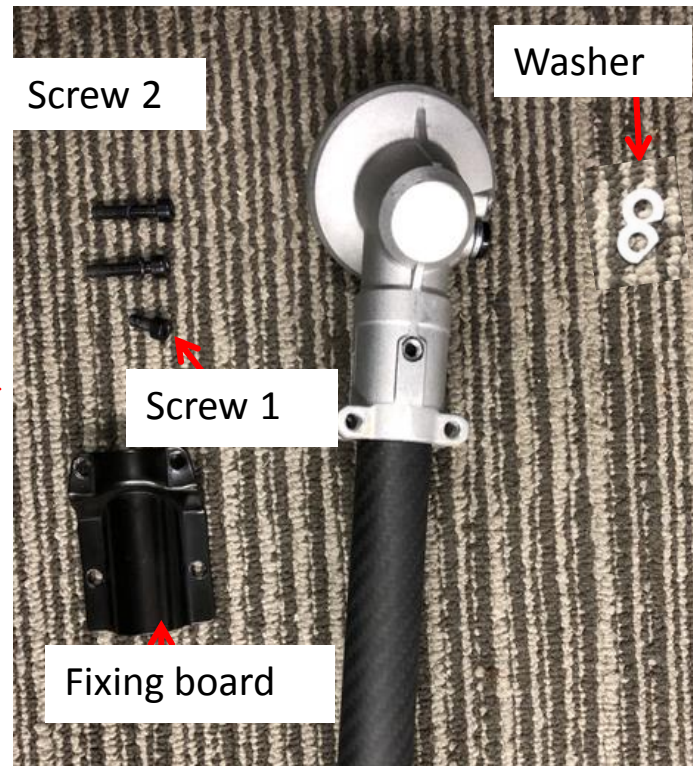
10. Loosen 3 screws to remove the fixing board.

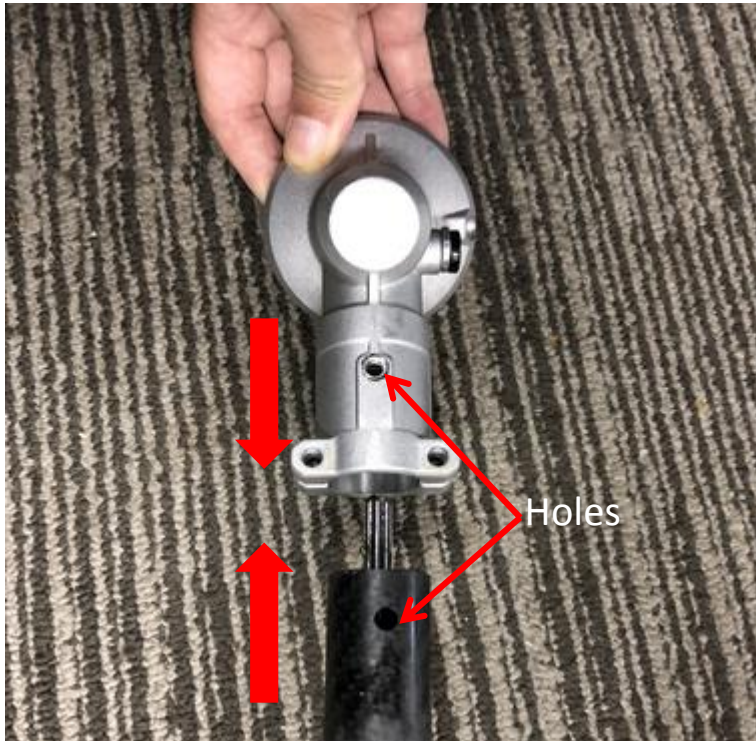
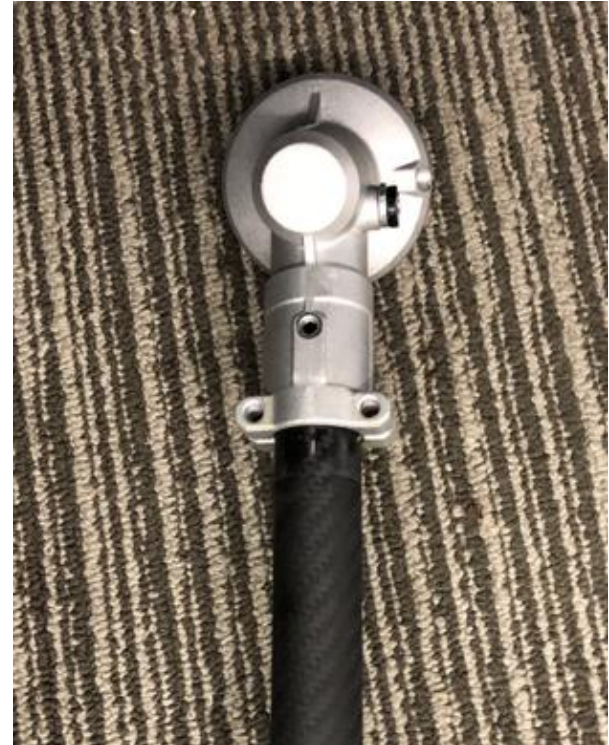
12. With the hole in the gear case aligned with the hole in the tube, reassemble them into place.

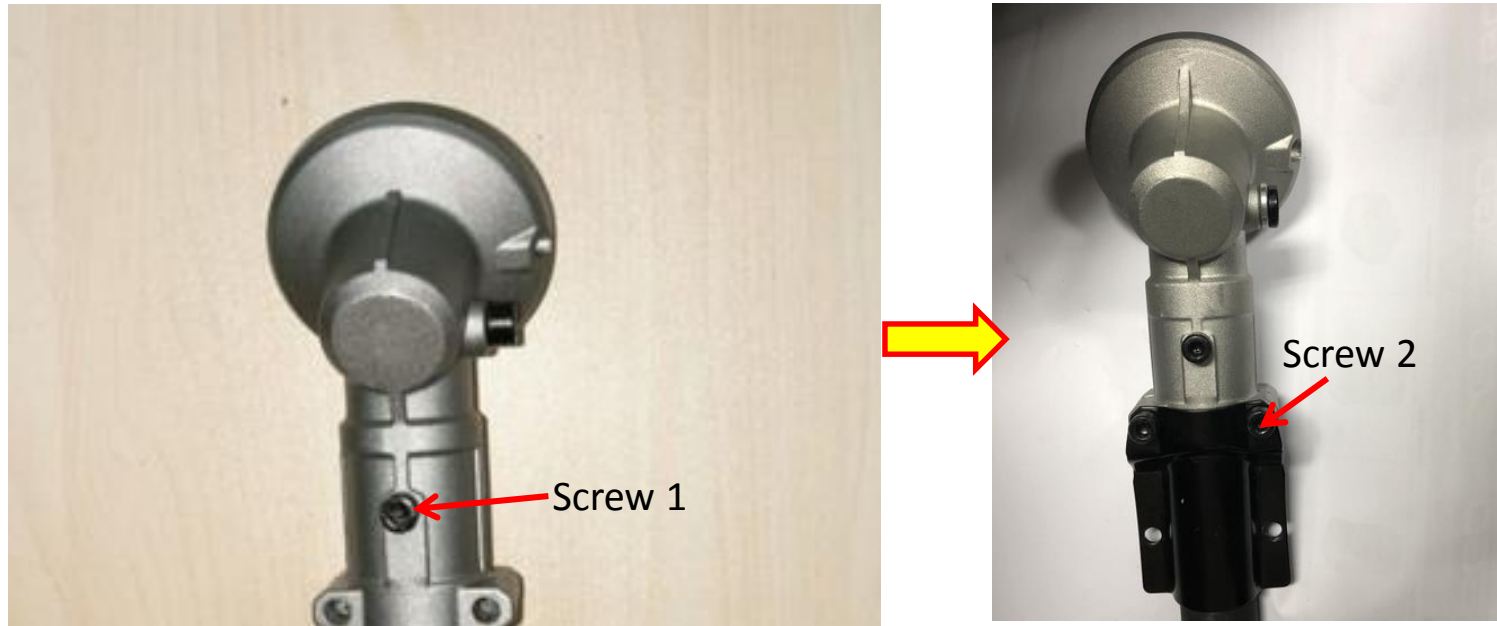
13. Tighten the gear case with the connecting tube with screw.
14. Tighten the fixing board with the gear case with screws.

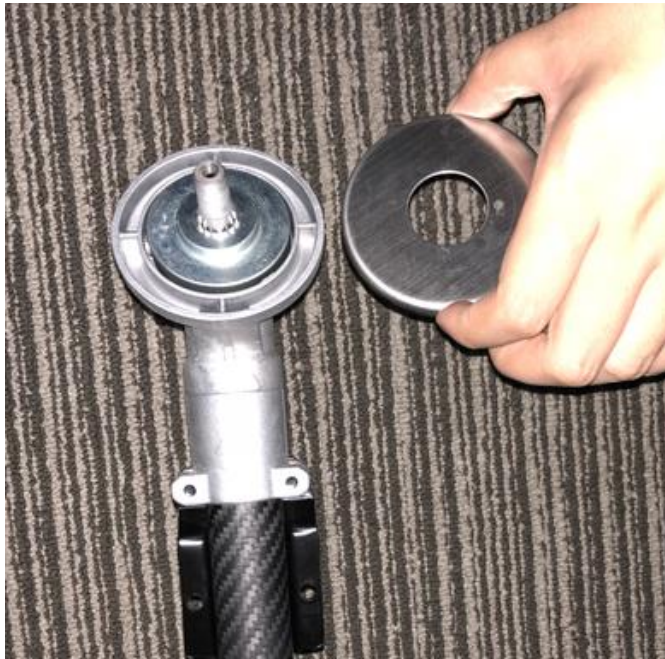
16. Mount the flange cover onto the shaft.

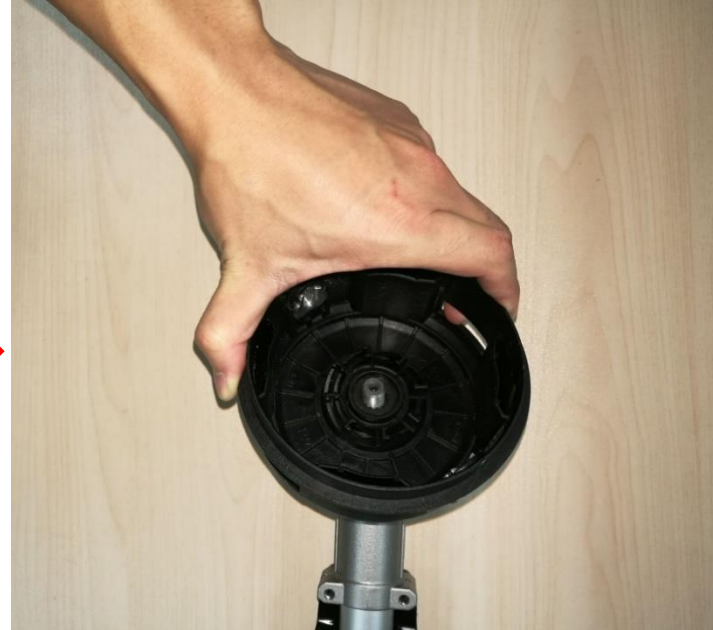
17. Mount the upper housing assembly onto the shaft.

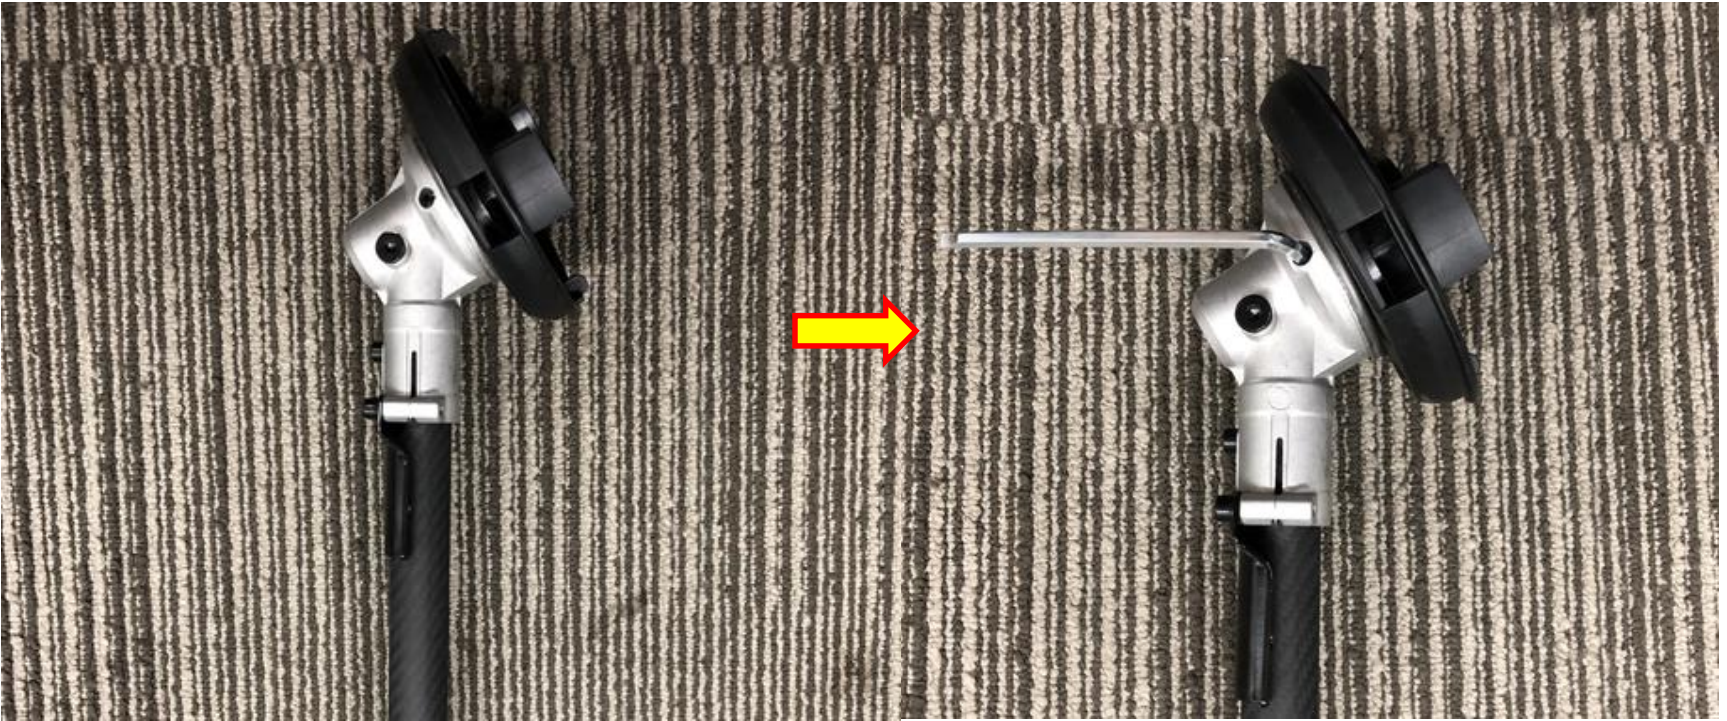
18. Rotate the upper housing assembly to align the slot in the flange with the hole in the gear case.
19. Insert the hex wrench into the aligned holes to act as a stabilizer.

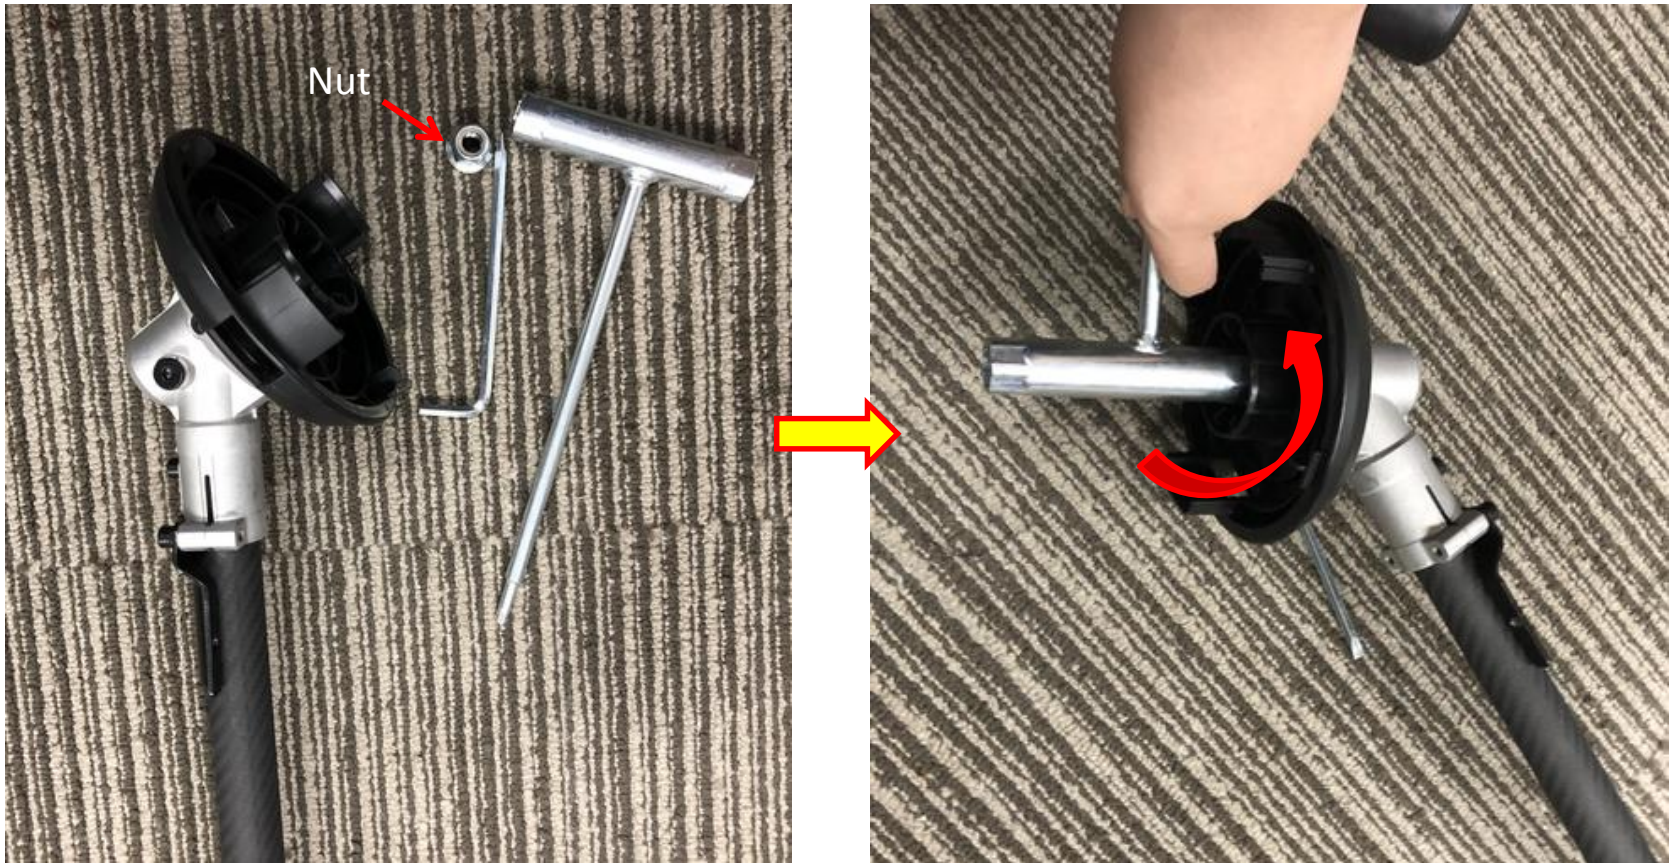
20. Mount the nut onto the shaft and tighten it with multifunction wrench anticlockwise.

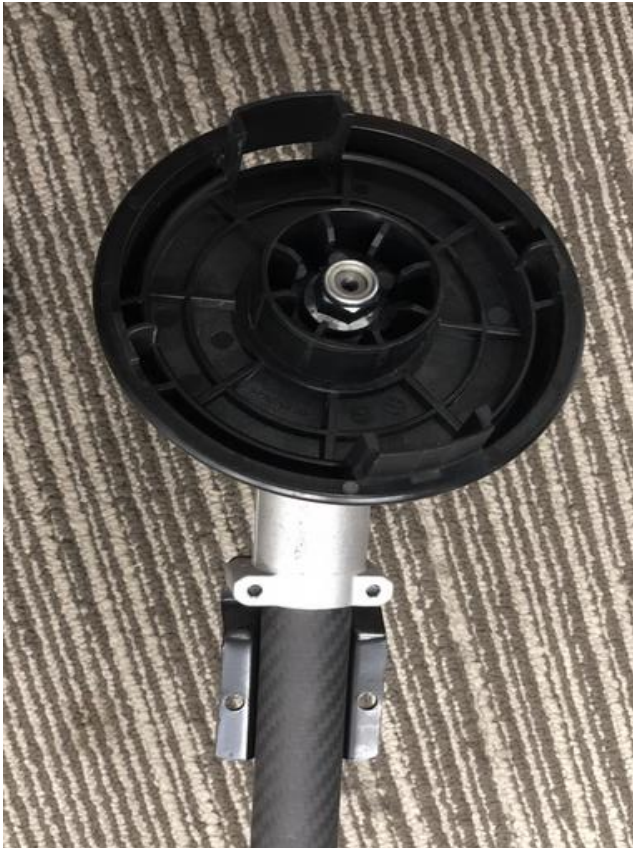
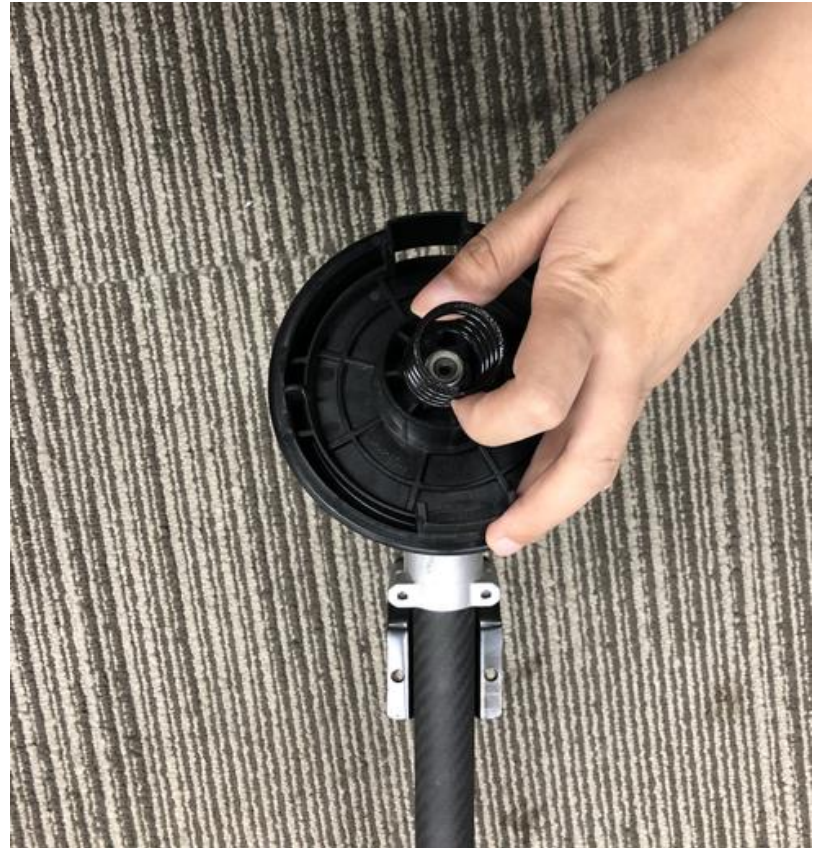
21. Mount the spring onto the upper housing.

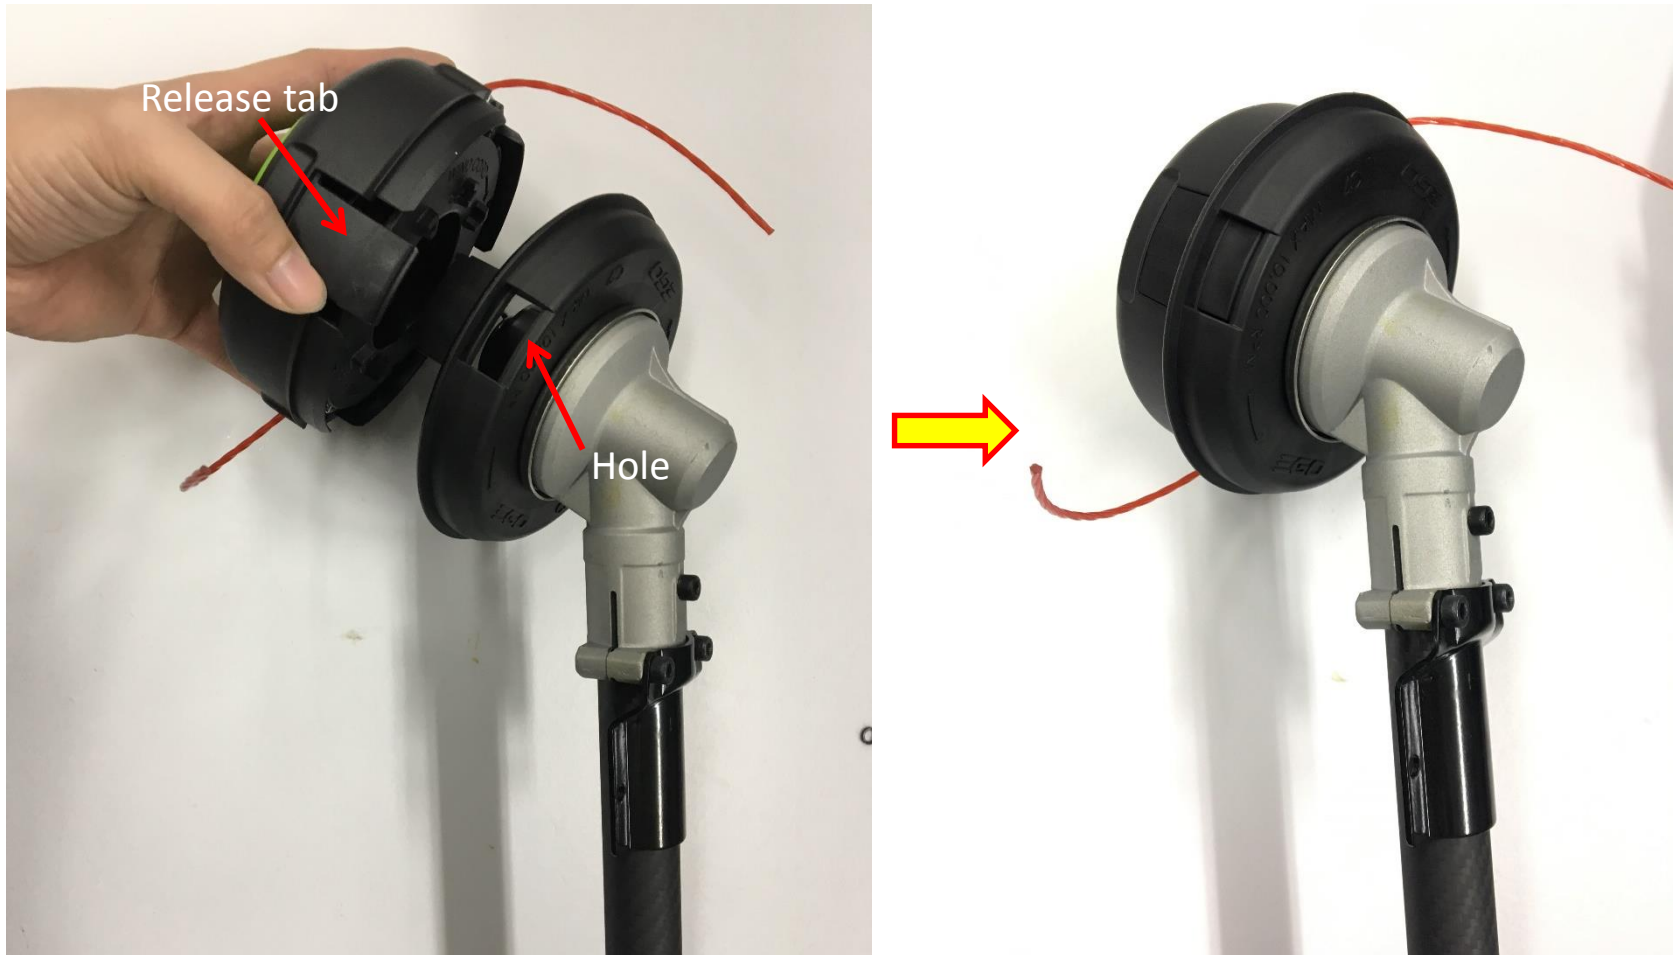
22. Align the release tabs on the lower housing assembly with the holes on the upper housing assembly to assemble them together.

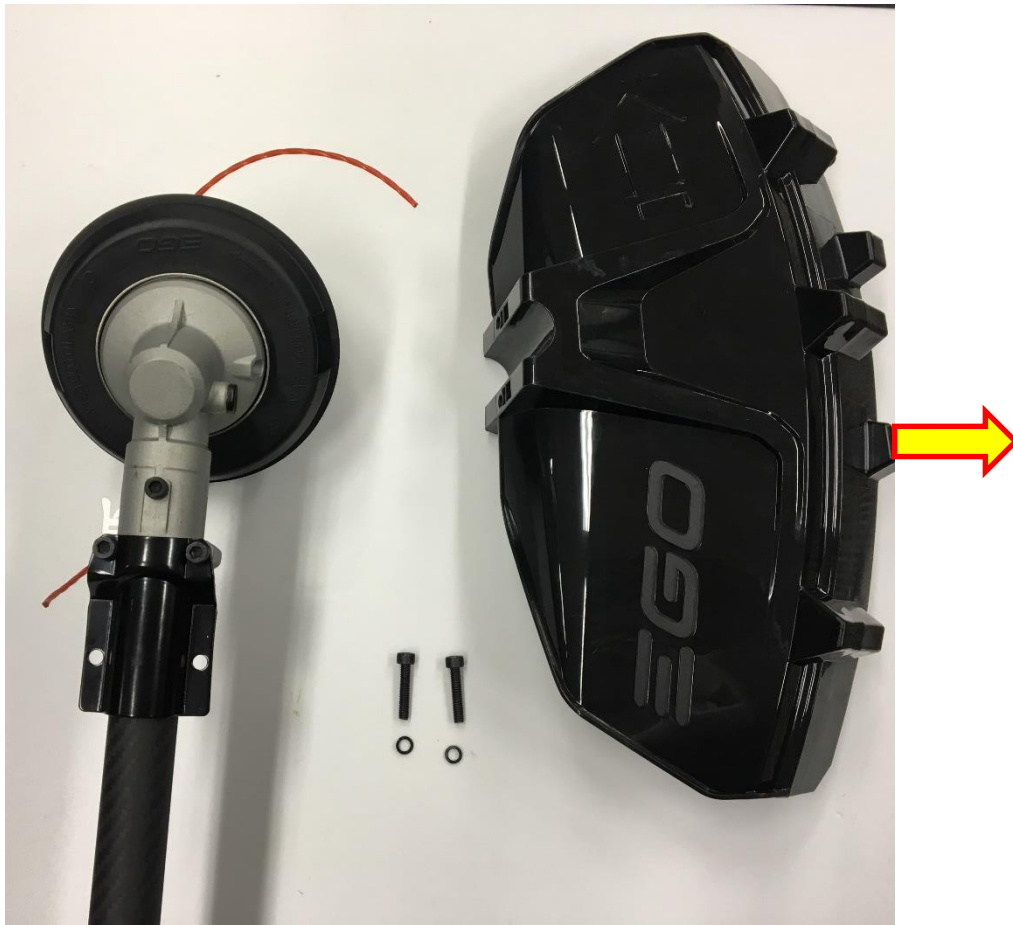
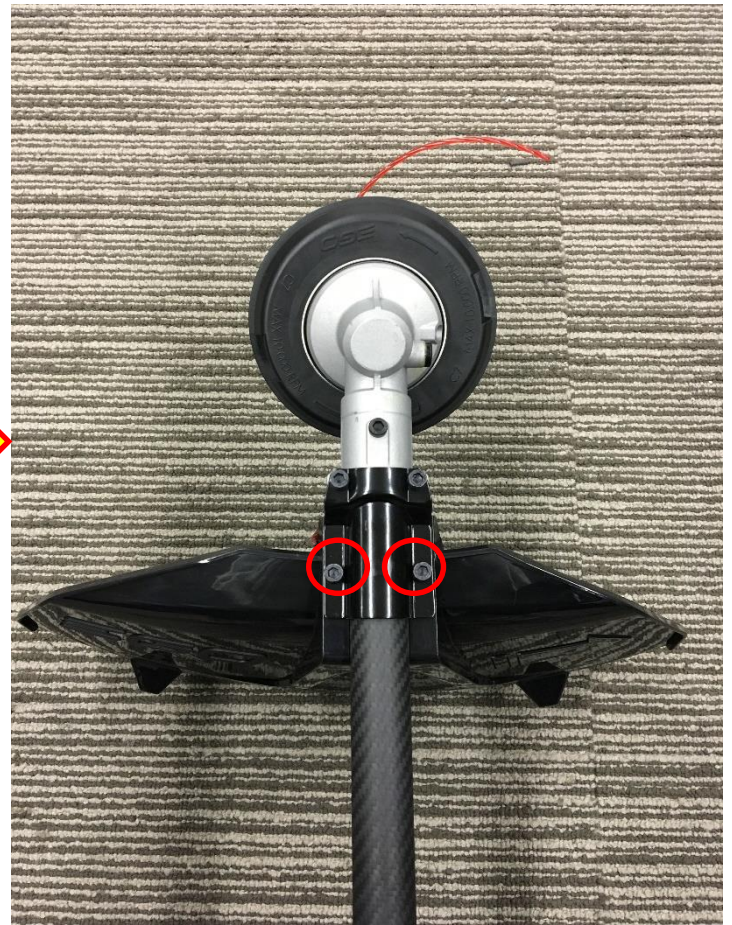
23. Assemble the guard assembly with the fixing board with screws & washer.

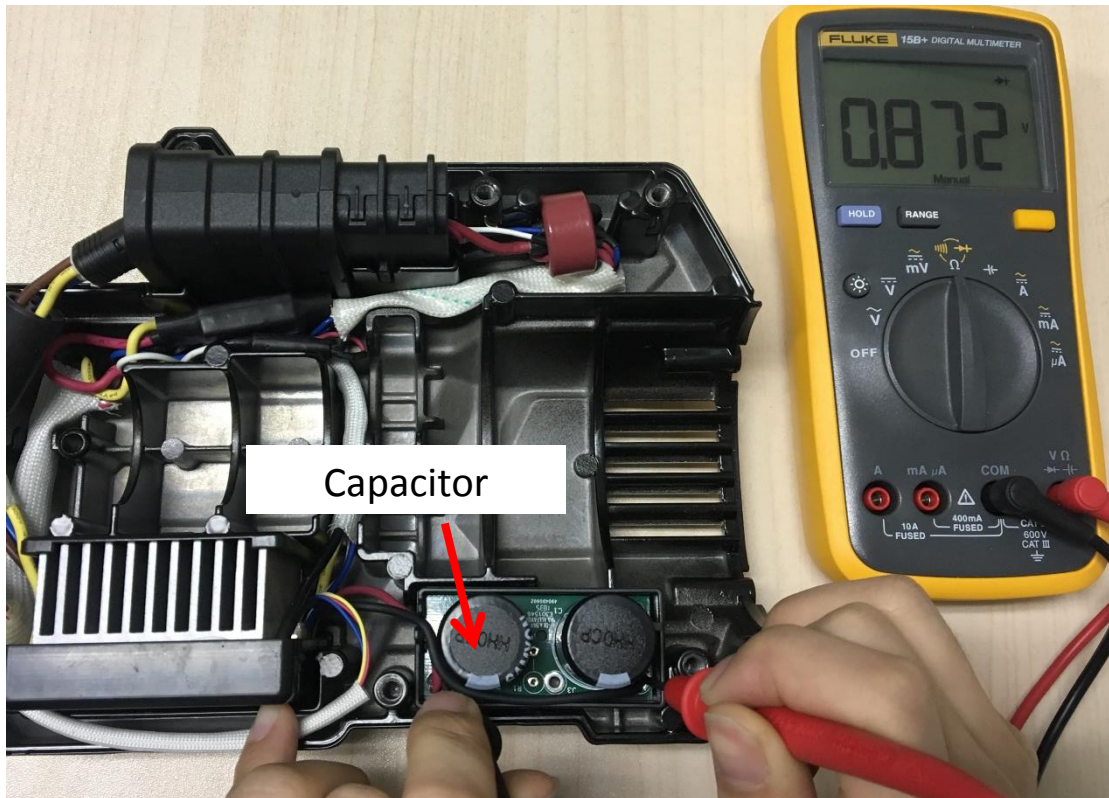
**PCBA Measurement**

1. Following the instructions for “**Replacing the Motor Assembly and PCBA**” to Separate the PCBA.
2. Find the capacitor in the PCBA and set the multimeter function to “Diode measuring”.
3. Contact the red pen pin to the negative electric contact (the joint that connects to black wire).  
Contact the black pen pin to the positive electric contact (red wire).

**Notice:** When the voltage is below 1V and buzzing sound stops, the discharging has finished.

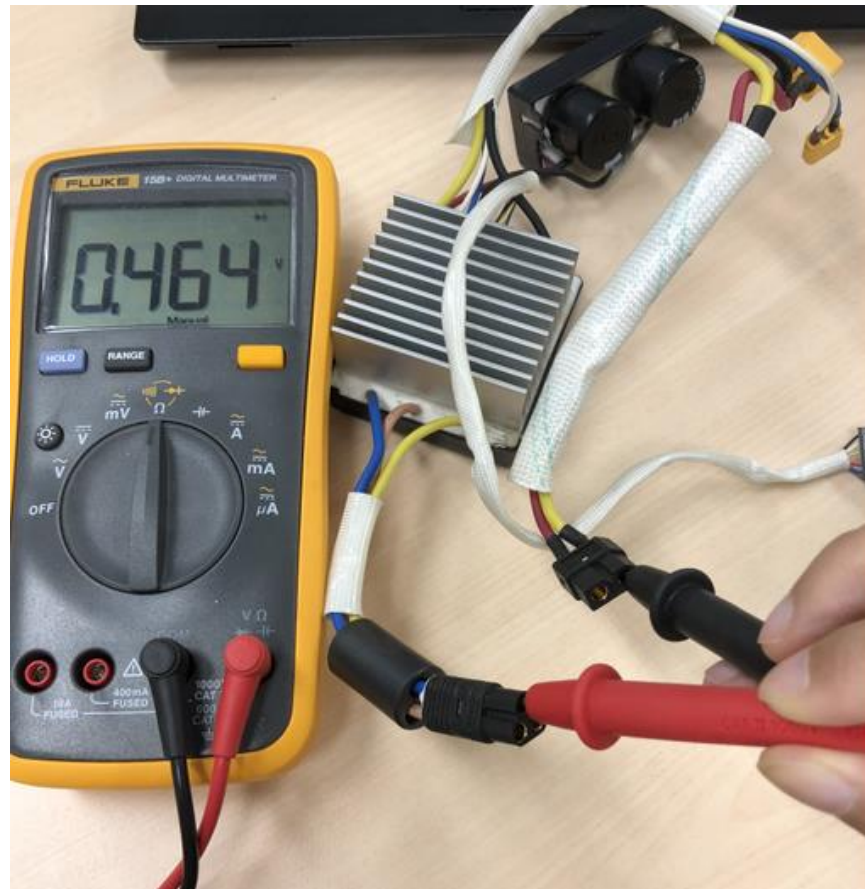
PCBA Measurement

5. Contact the black pen pin to the contact (connect to the yellow line) of the black connector and red pen pin to the three contacts of the black connector (connect to the motor).

**Notice :** If the LCD displays 0.45~0.55V for each measurement, means a good upper MOSFET, go to the next testing step; otherwise means a broken PCBA, replace a new PCBA.

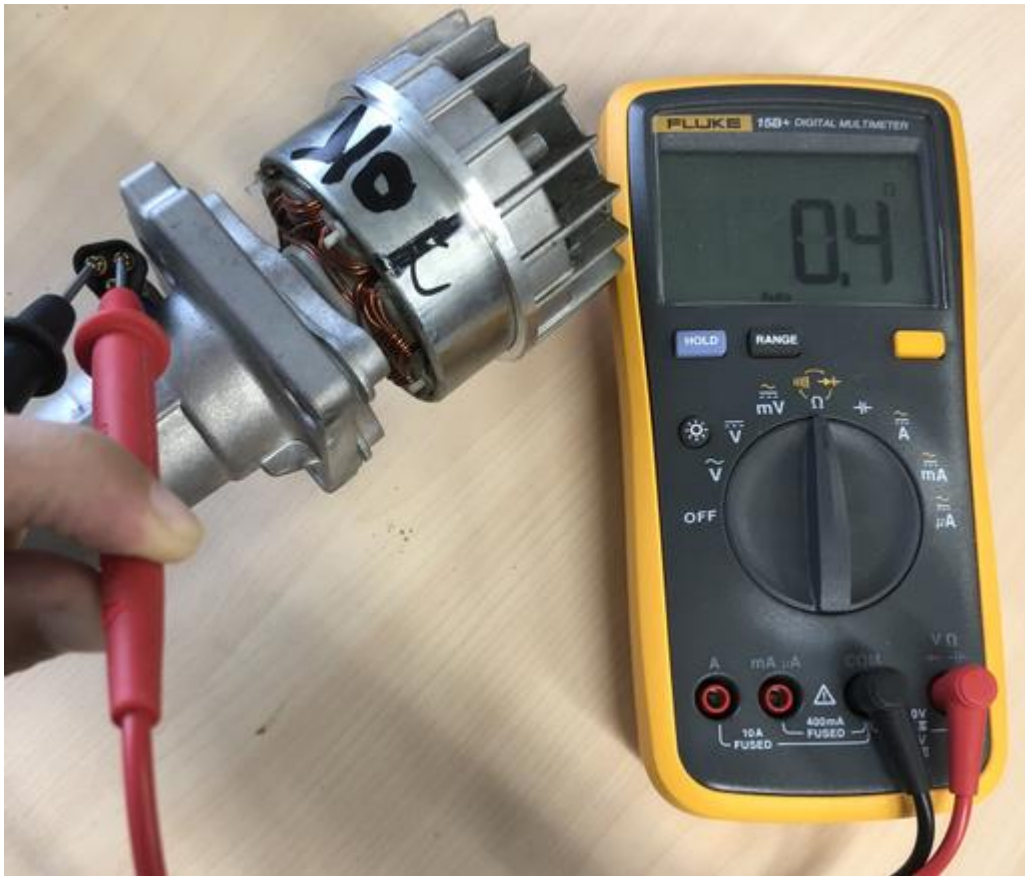
**Motor Measurement**

1. Following the instructions for “**Replacing the Motor Assembly and PCBA**” to Separate the PCBA.
2. Set the multimeter function to “Resistance measuring”.
3. Measure the resistance between any of the two contacts.

**Notice: If the resistance is not infinite, means a good motor. Otherwise, replace the damaged motor**

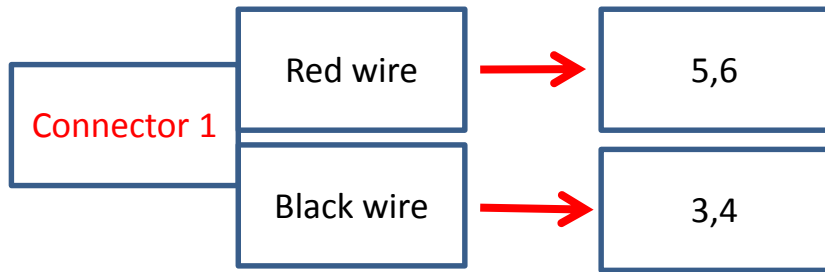
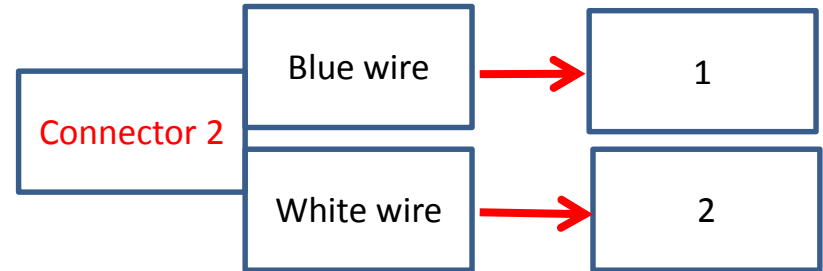
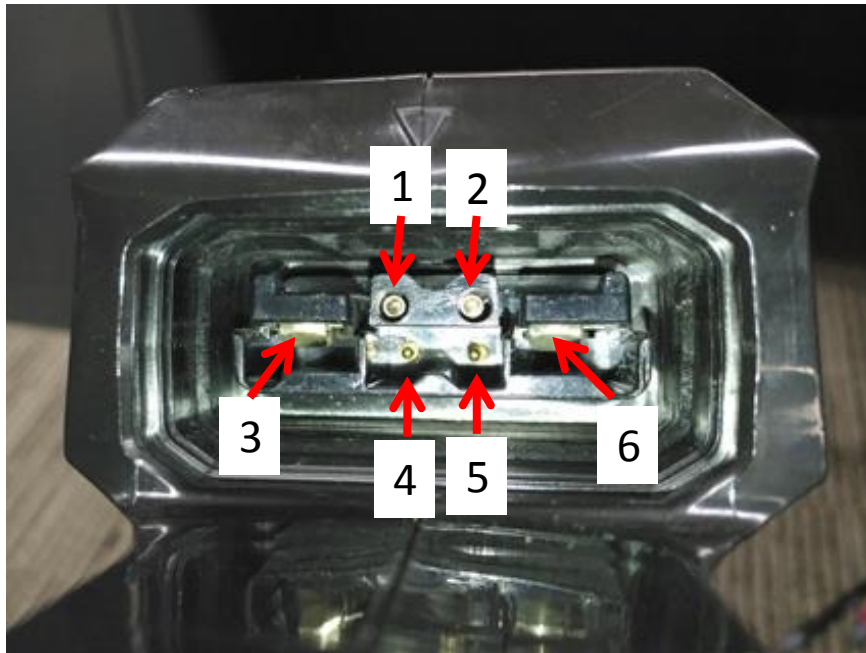
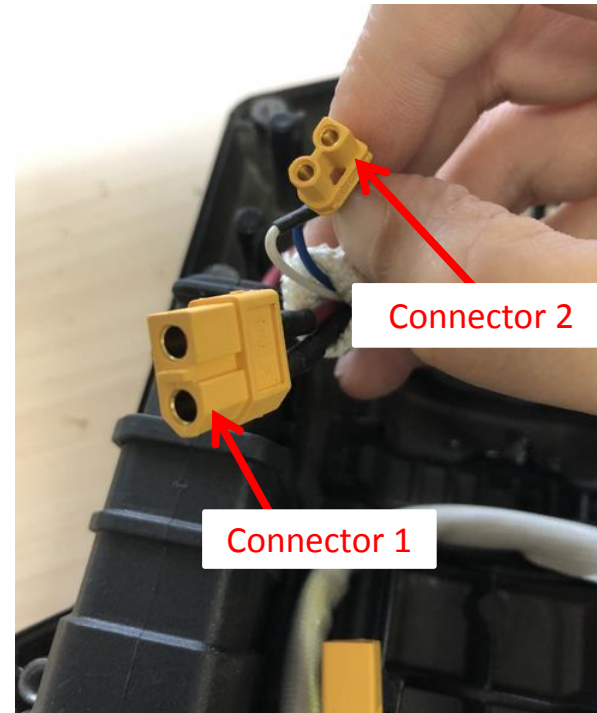
**Internal Wire Assembly Measurement**

1. There is 6 contacts in the socket. Contact the black pen pin to the 6 contacts and the red pen pin to their corresponding contacts of the two connectors.

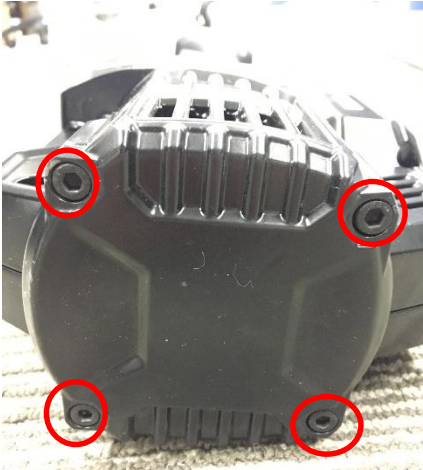
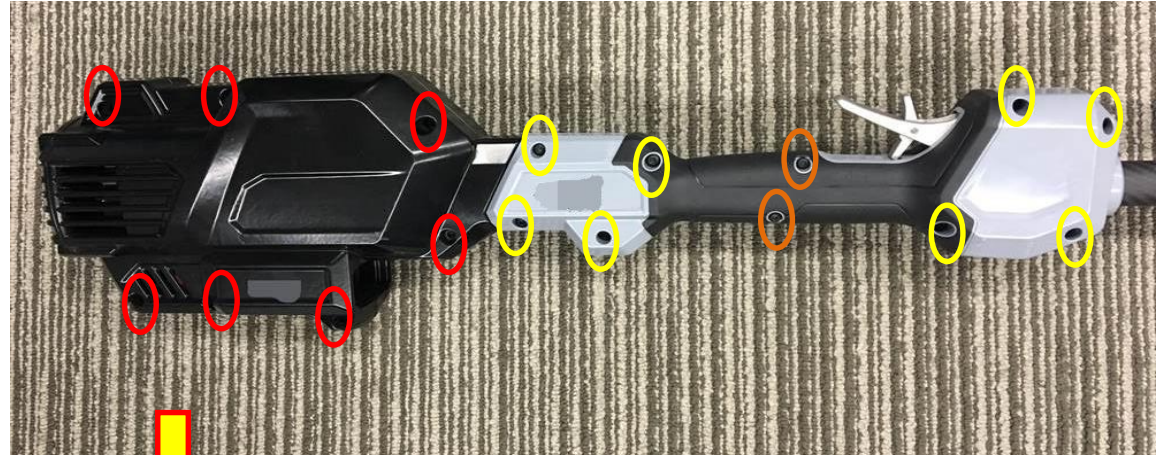
1. Loosen Hexagon socket screws & 8 screws & 2 tapping screws to disassemble the housing assembly.
