# REPAIR GUIDELINE

Line trimmer \_STX3800

*Version: 1*

*Issue Date: 01/11/2019*

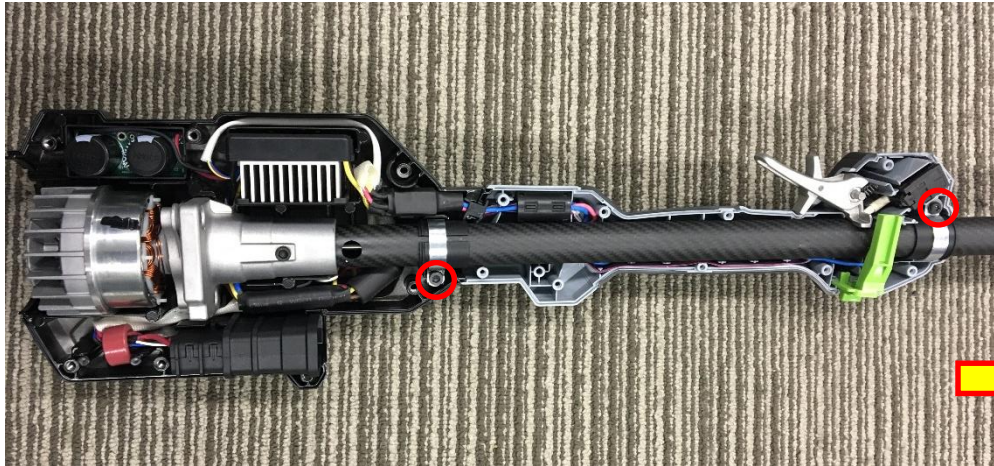
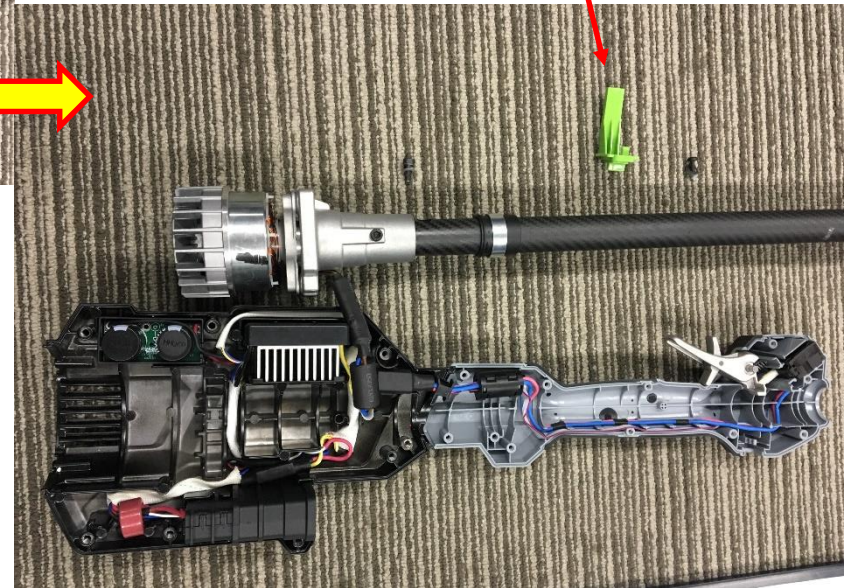
Push button

2. Loosen the screw on the fixed ring.
3. Take push button, the shaft and motor out its groove.

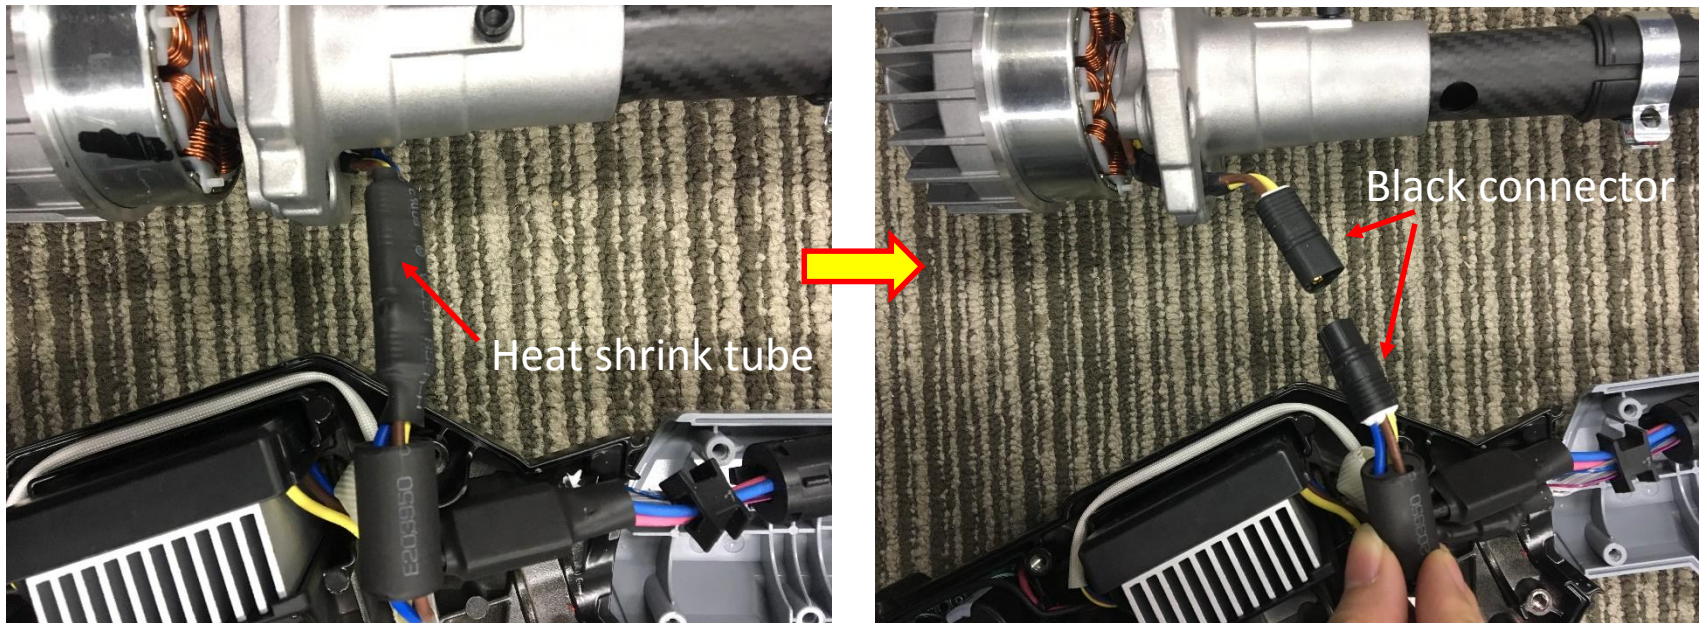
4. Remove the heat shrink tube and disconnect the black connector to detach the motor and PCBA.

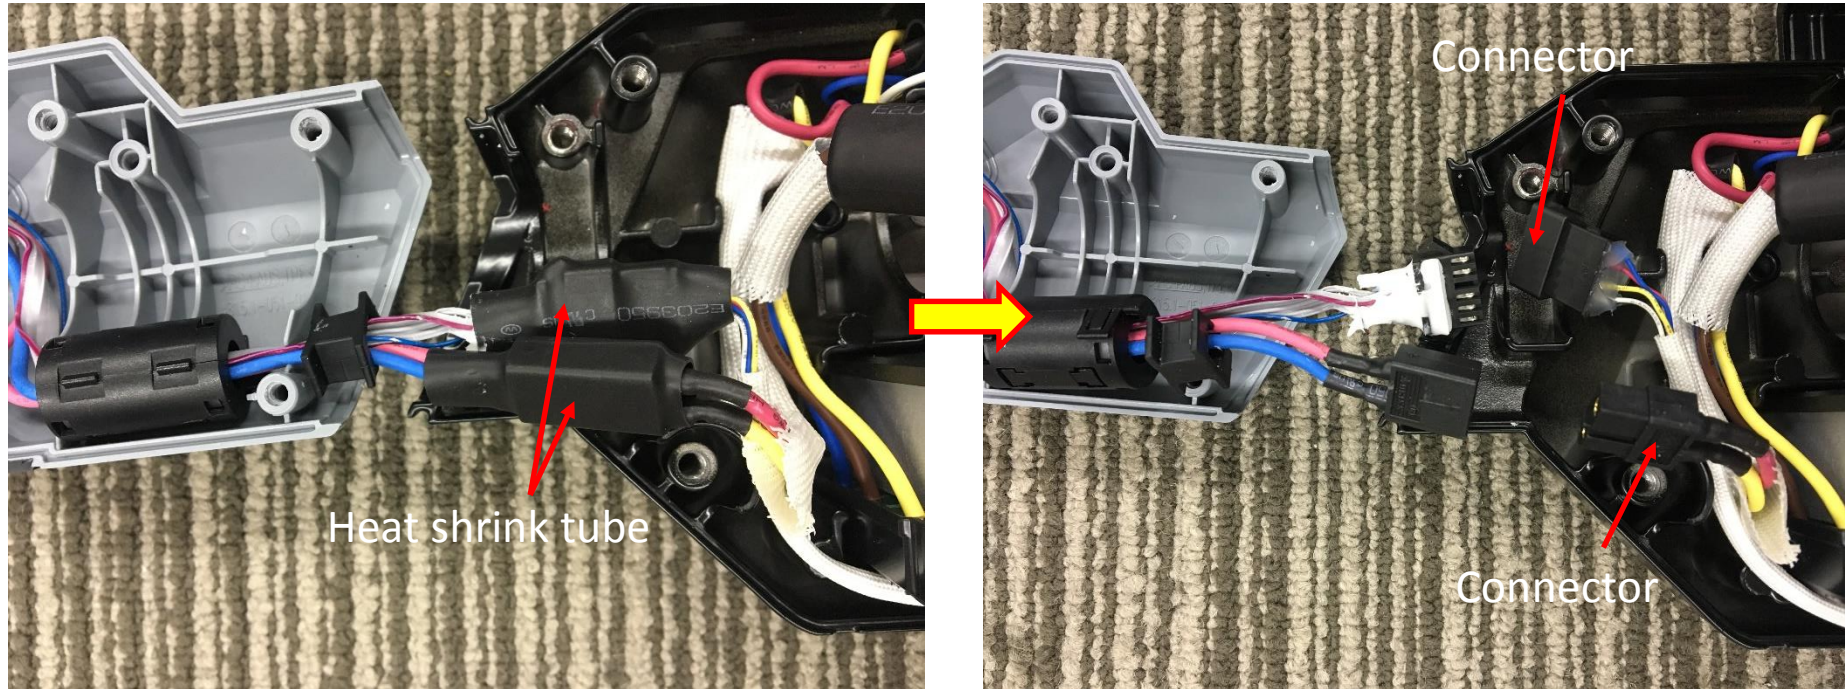
5. Remove the two heat shrink tubes and disconnect the two connectors.

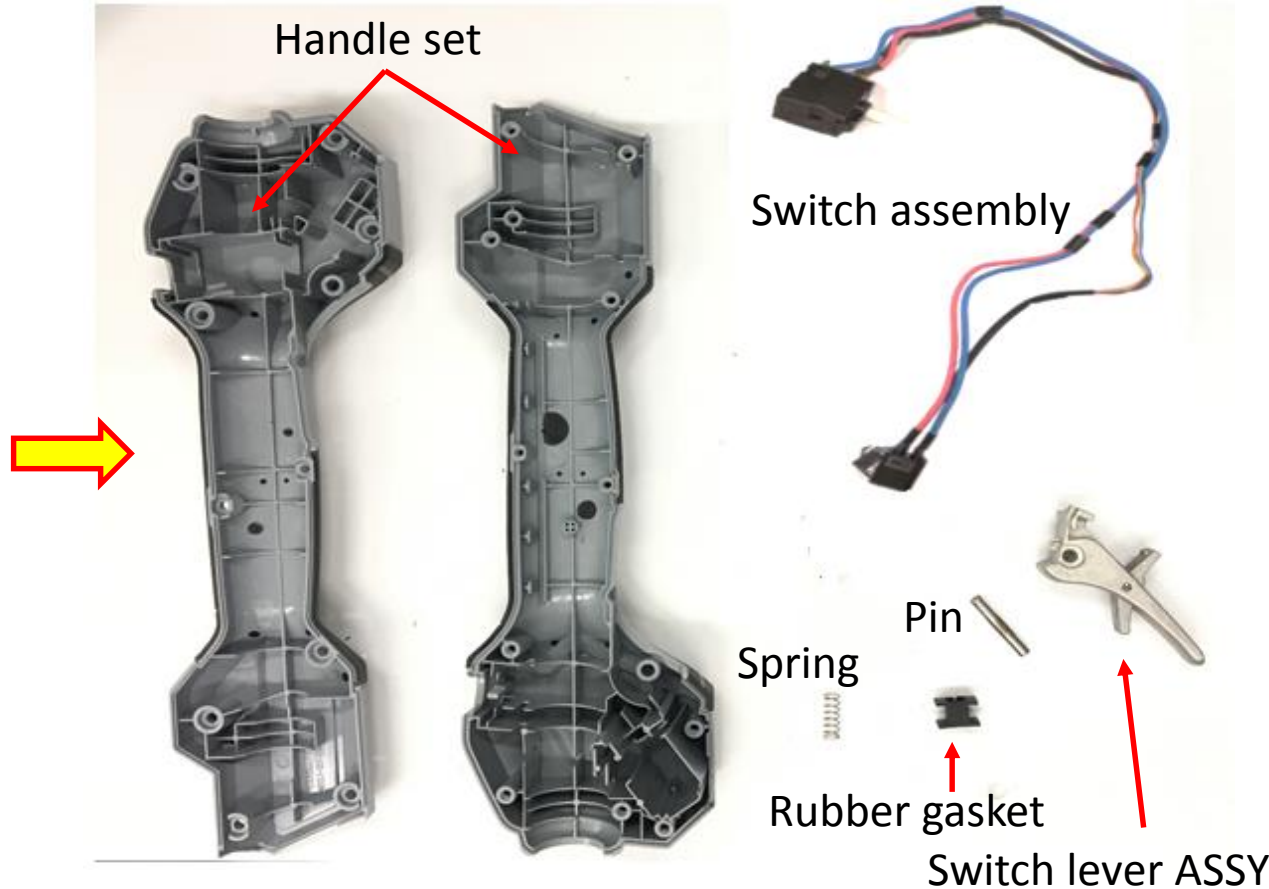
6. Remove all the switches as well as their cables from the handle set, replace the damaged part.

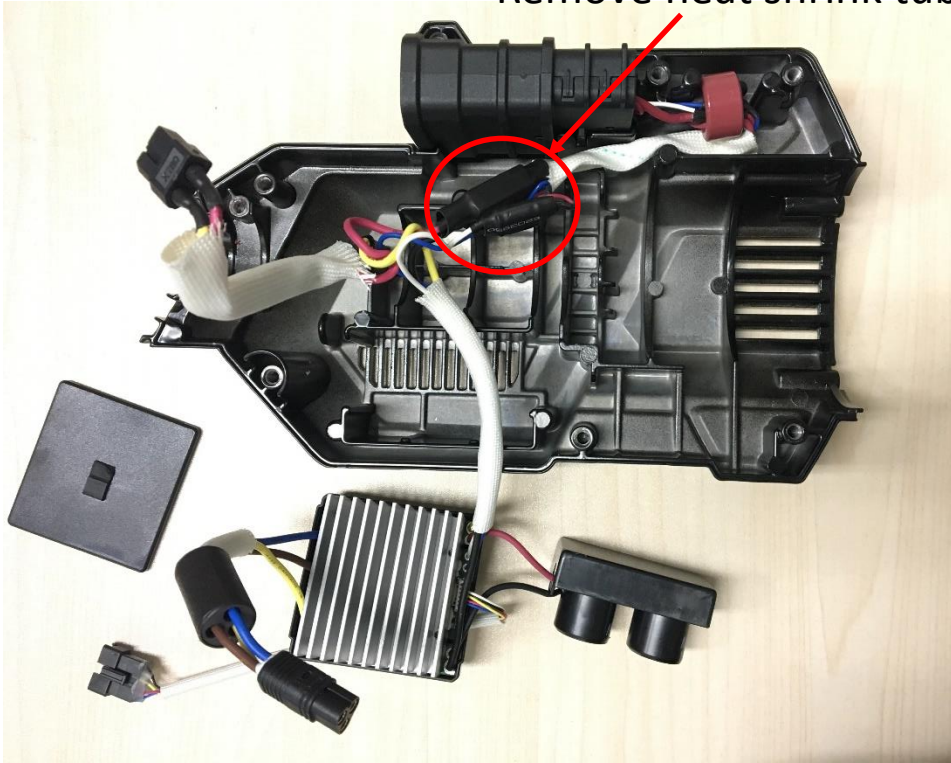
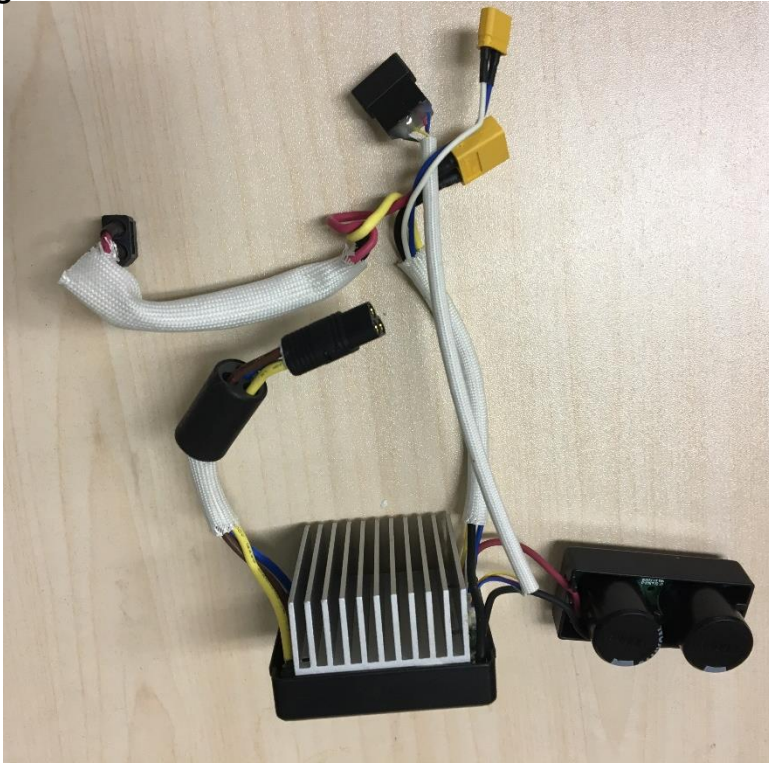
- 7. Take the PCBA away and separate the two connectors from PCBA. If PCBA is damaged, replace it with a new one.

Remove heat shrink tubes

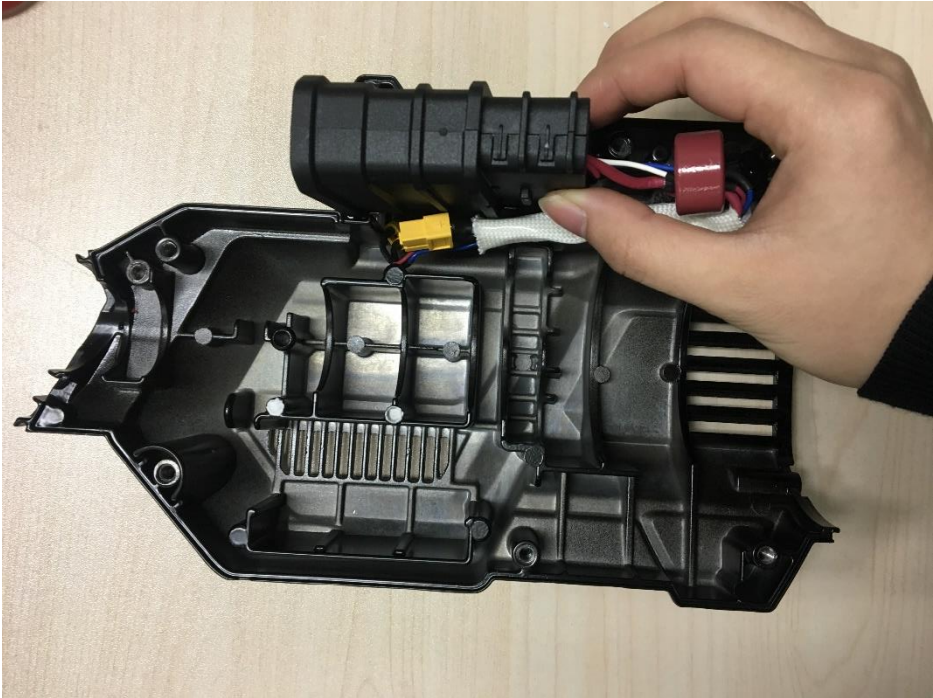
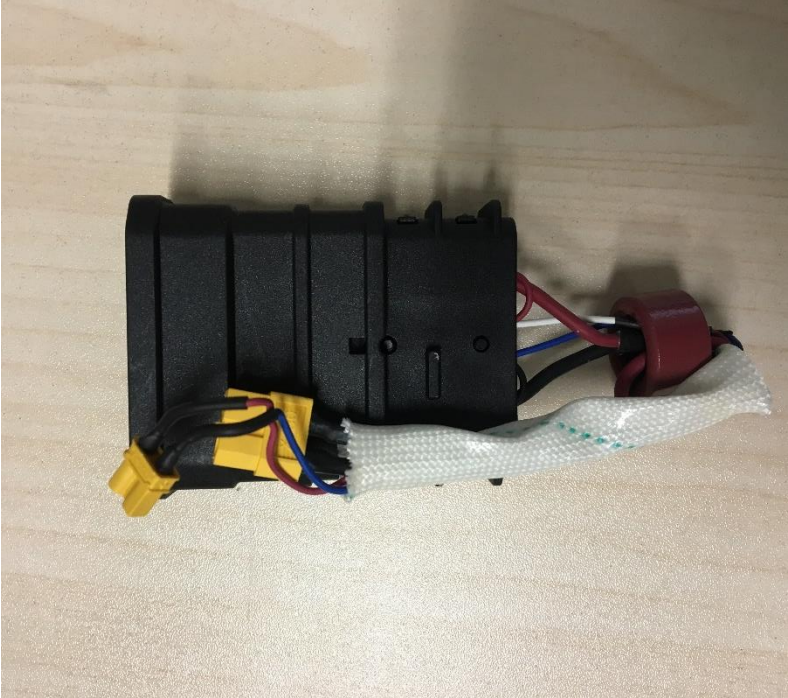
- 8. Take the internal wire ASSY away. If the internal wire ASSY is damaged, replace it with a new one.

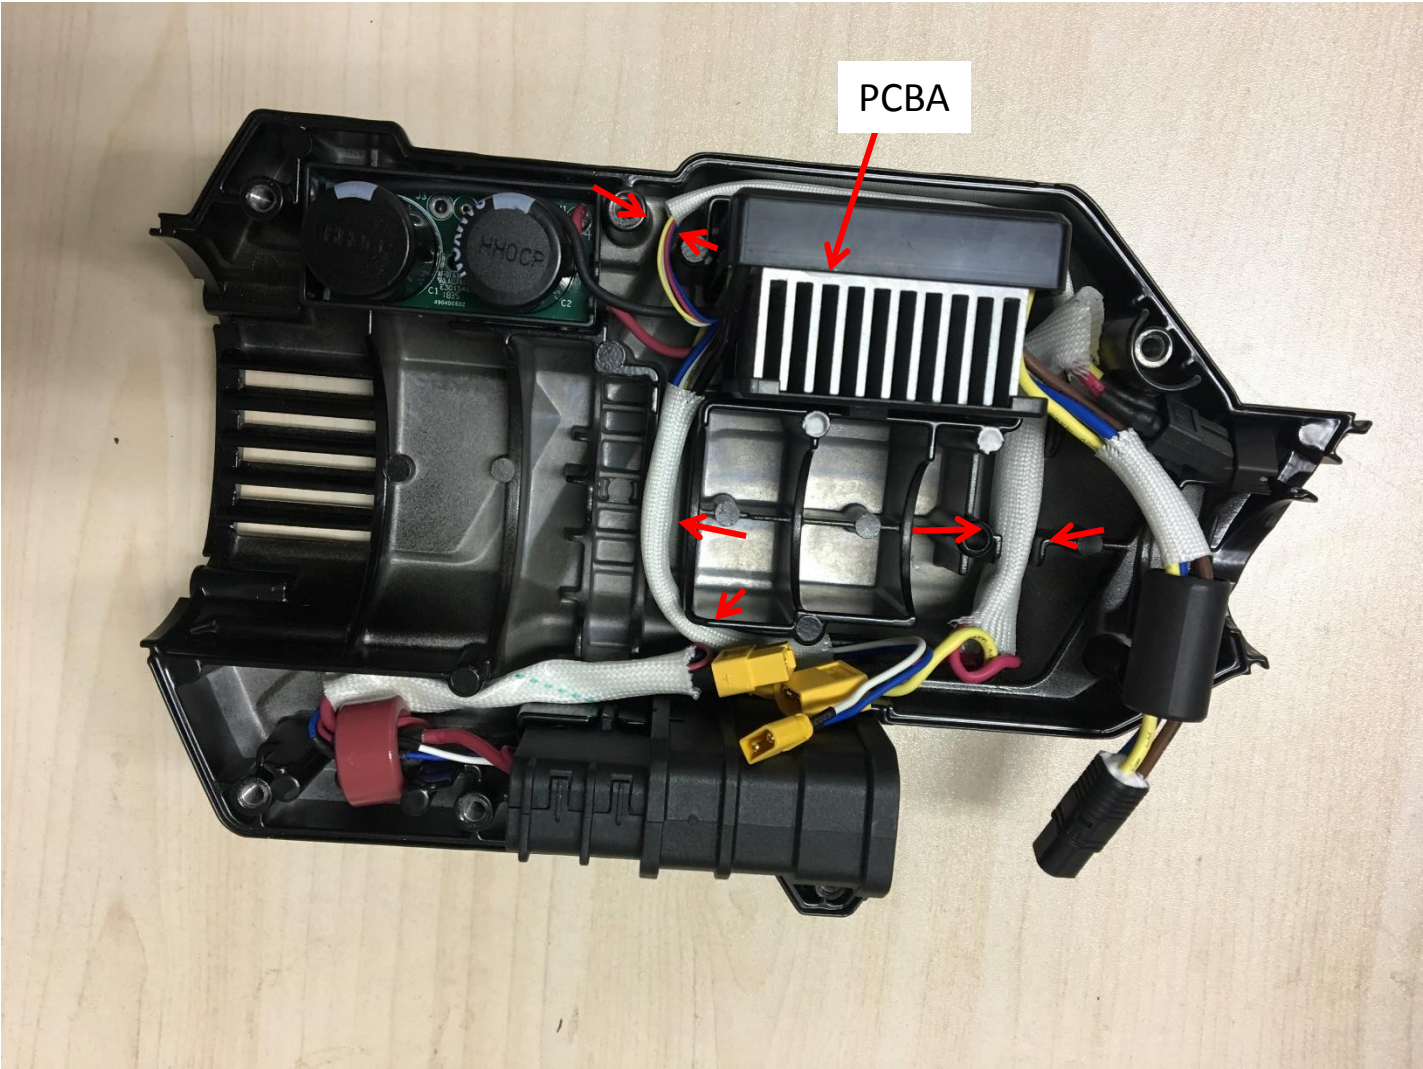
- 9. Align the wires into its groove and mount the PCBA into the housing.

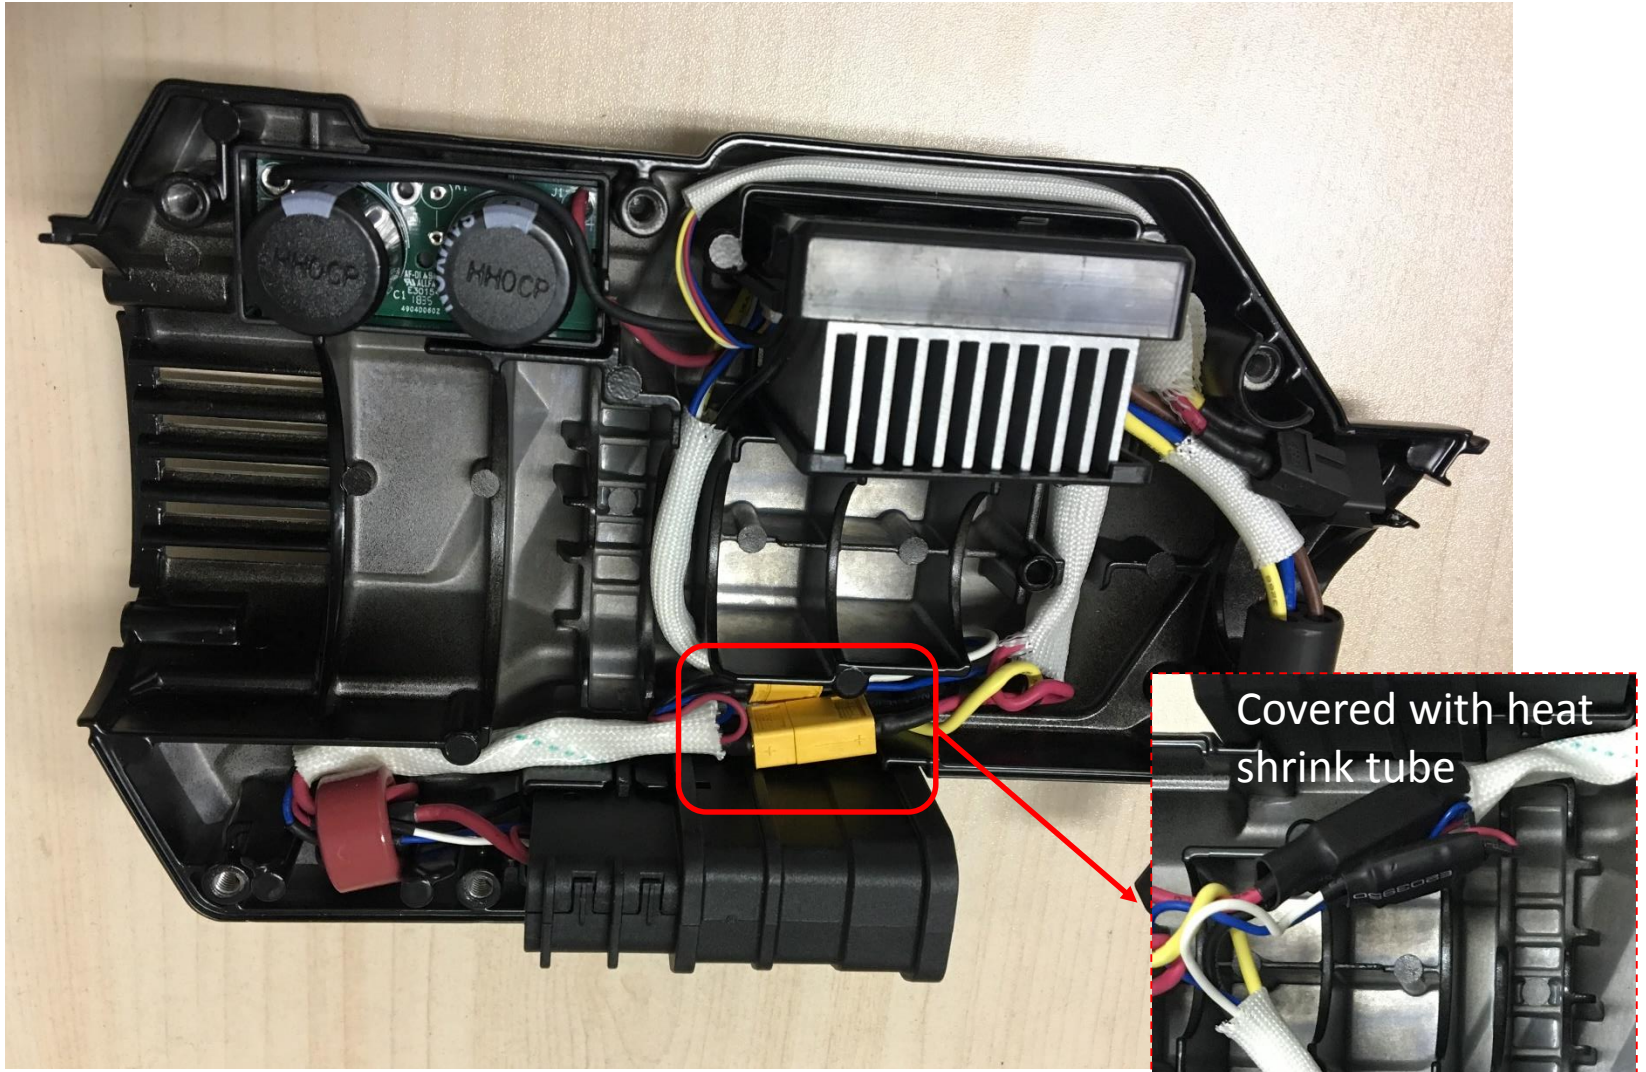
10. Connect the two connectors(yellow in picture) . Then align them into groove.

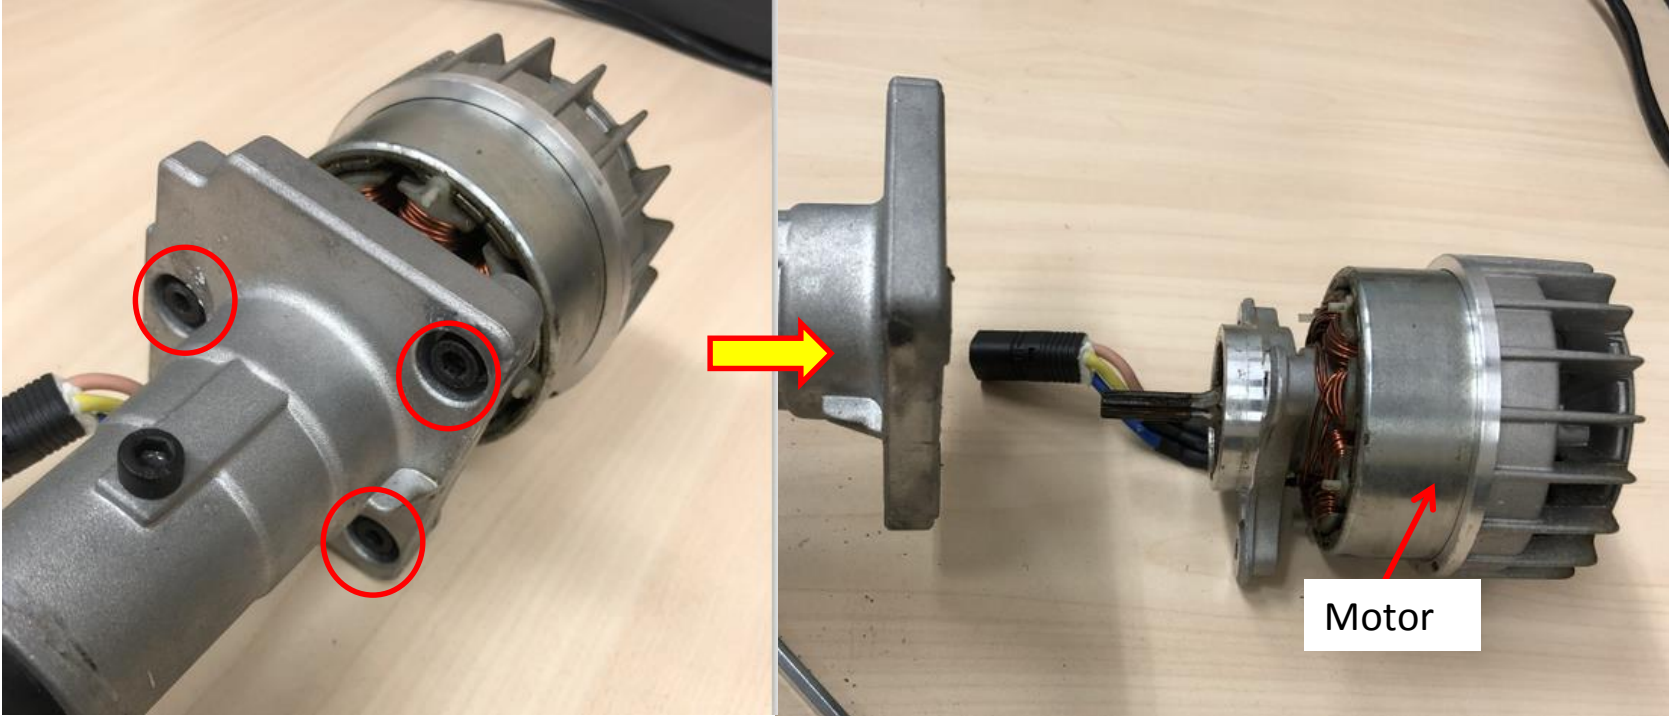
11. Loosen 3 screws to separate the motor from the shaft assembly.

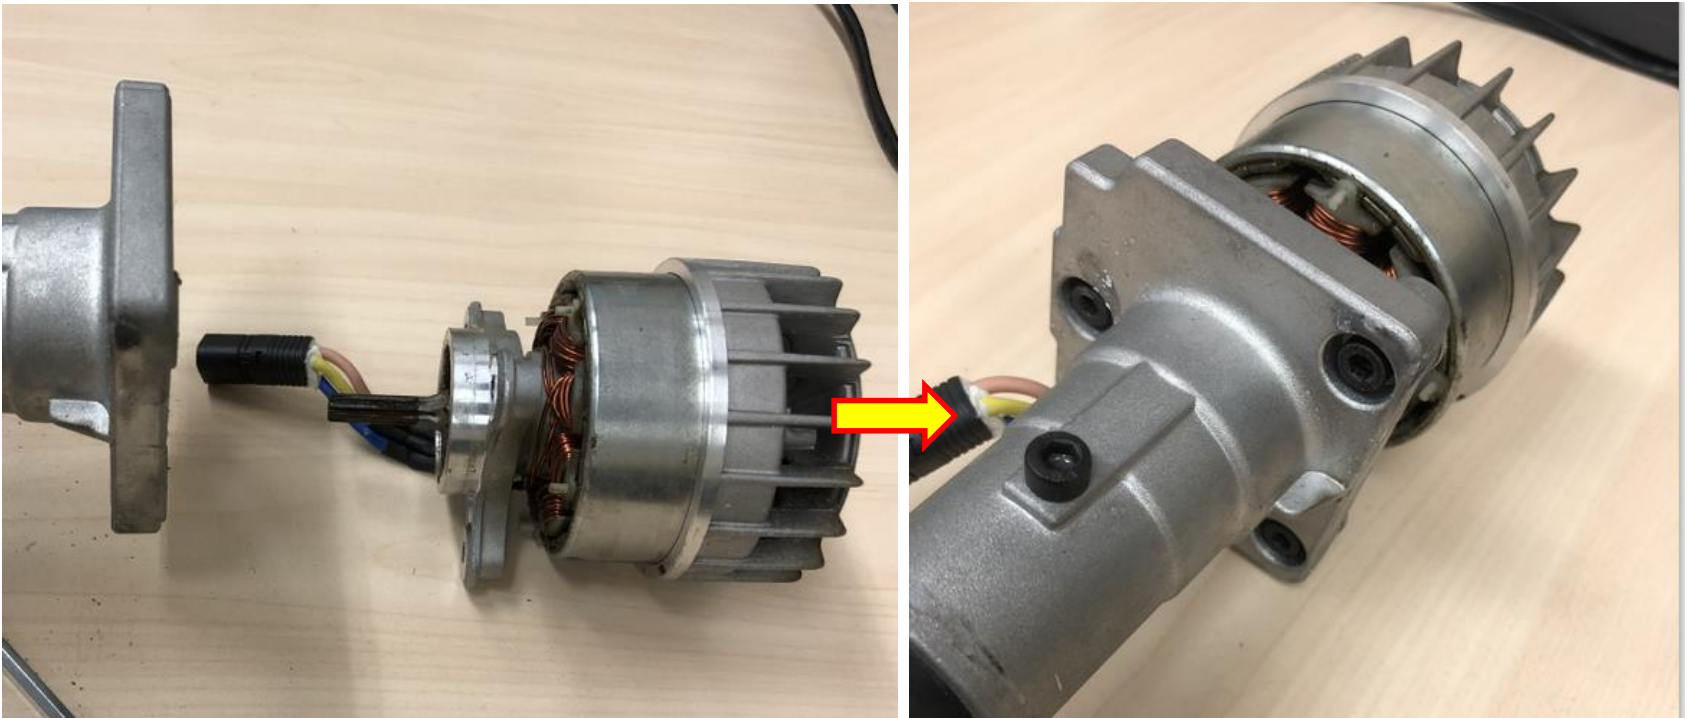
12. Replace the motor with a new one and then assemble the motor with the gear case assembly with screws.

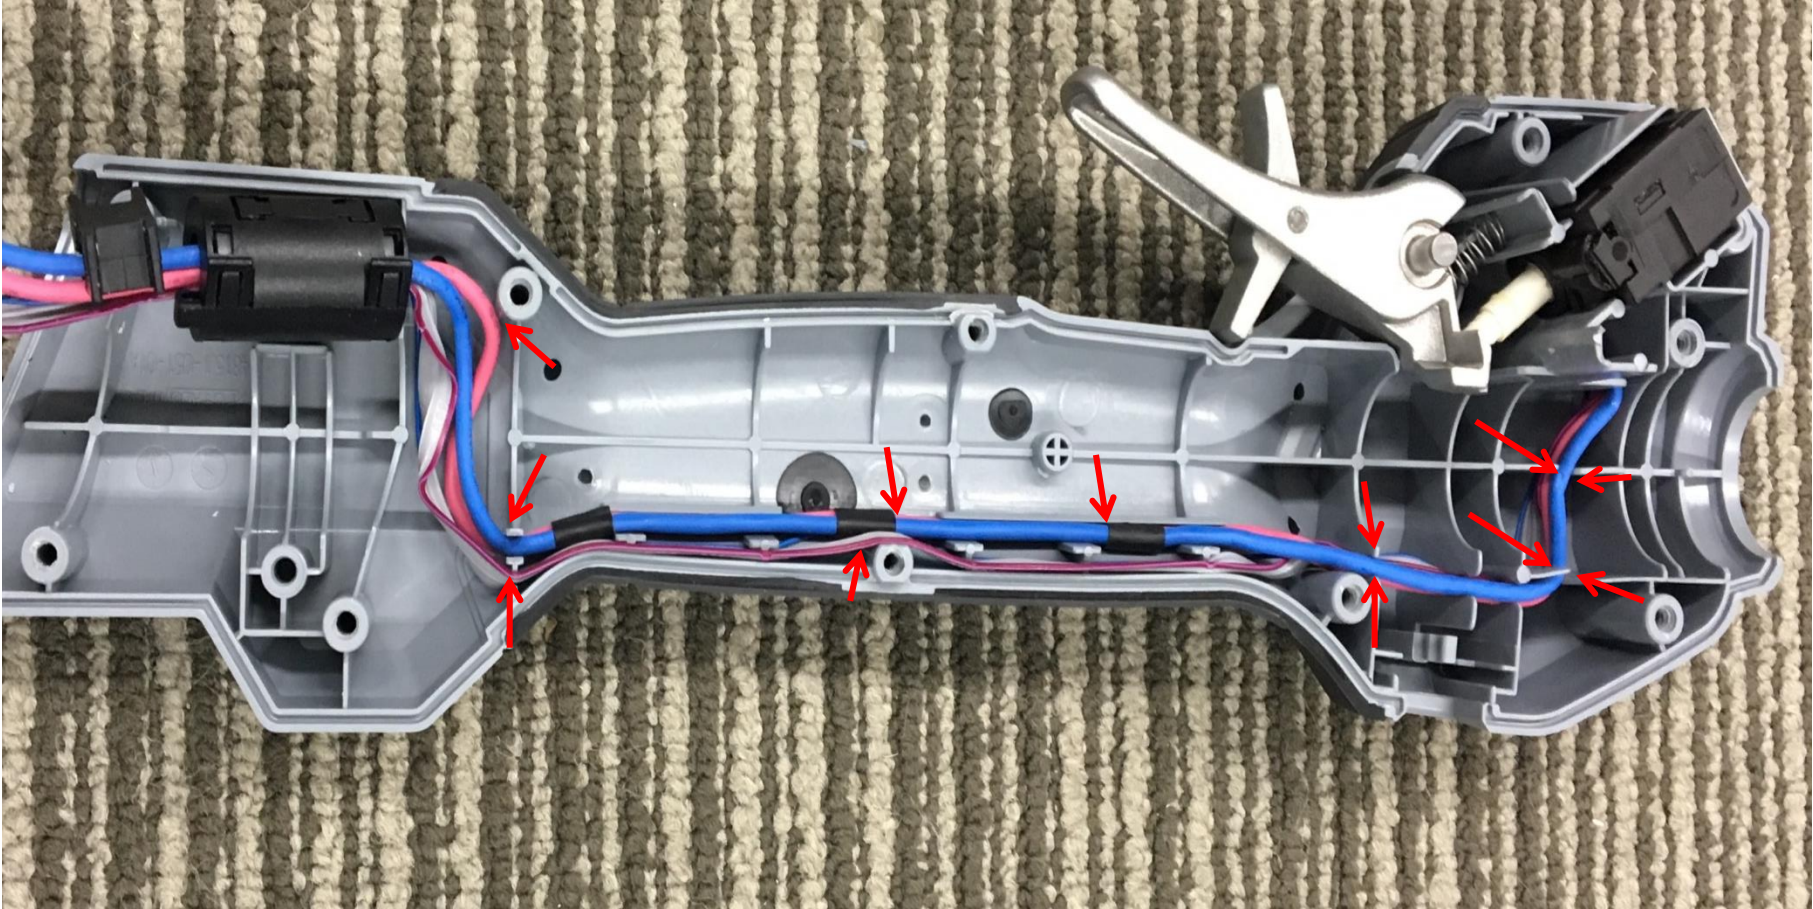
14. Assemble the handle set and align the wires.

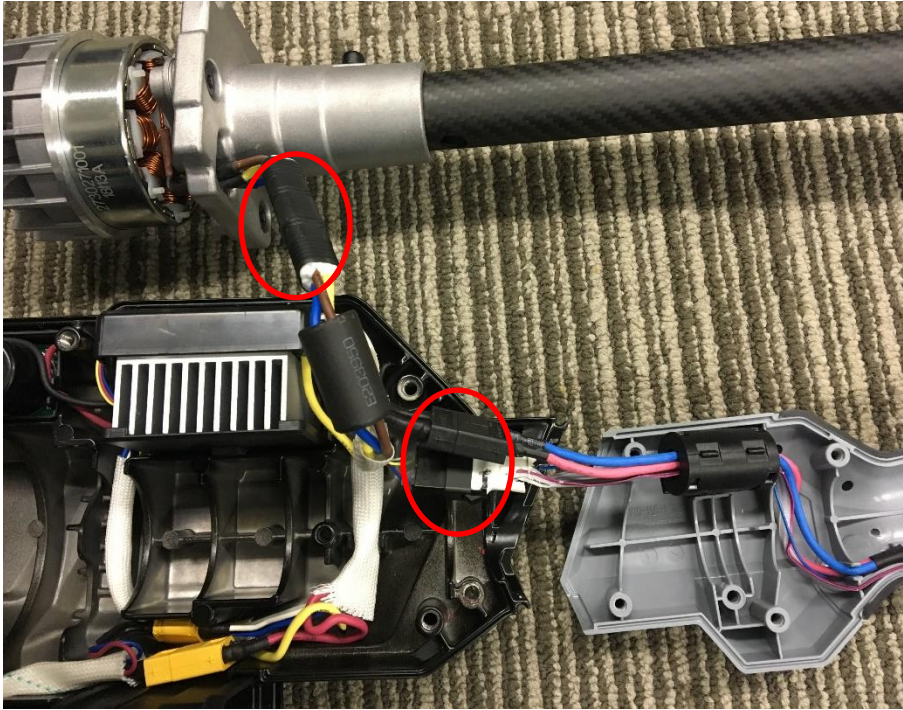
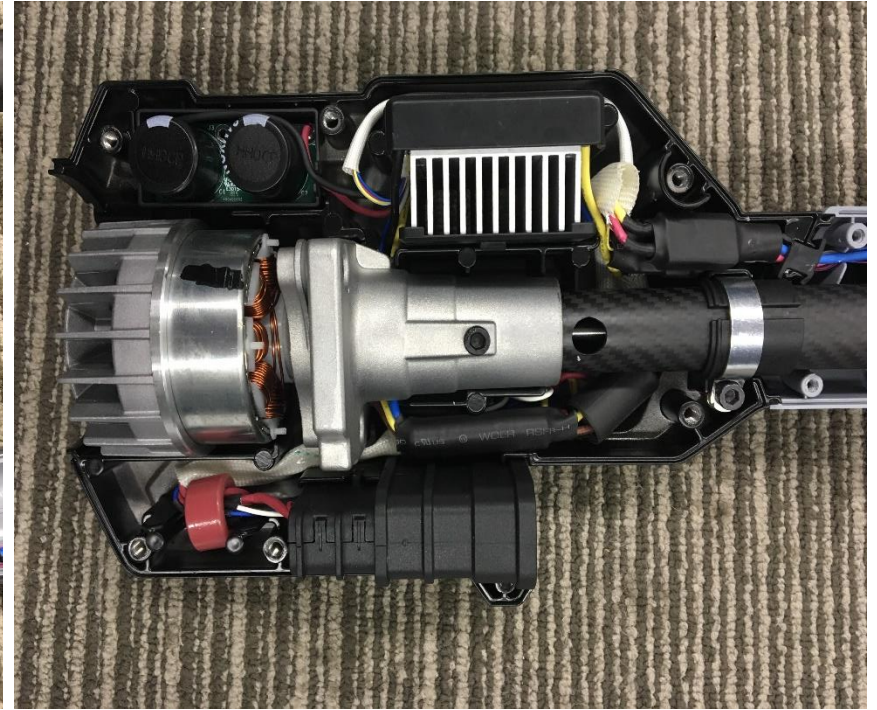
15. Connect the three connector and cover them with heat shrink tube, put the shaft with motor into the housing.

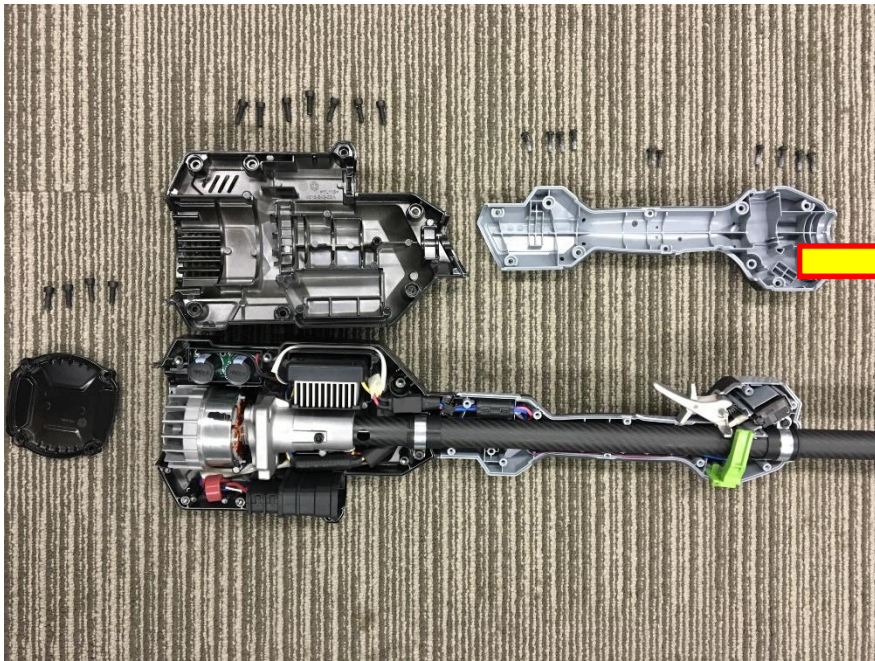
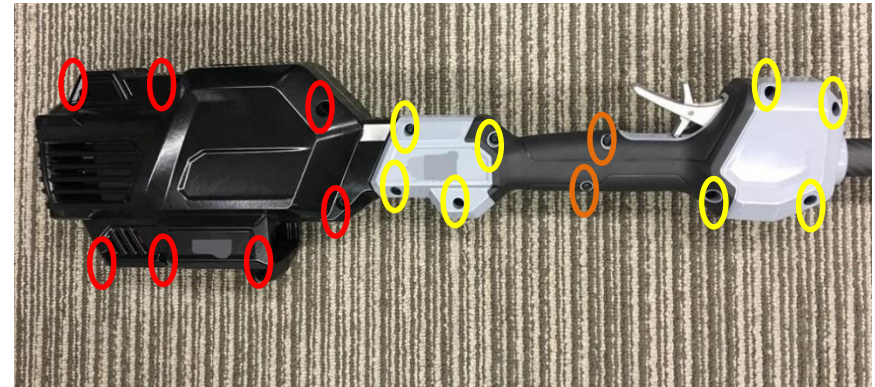
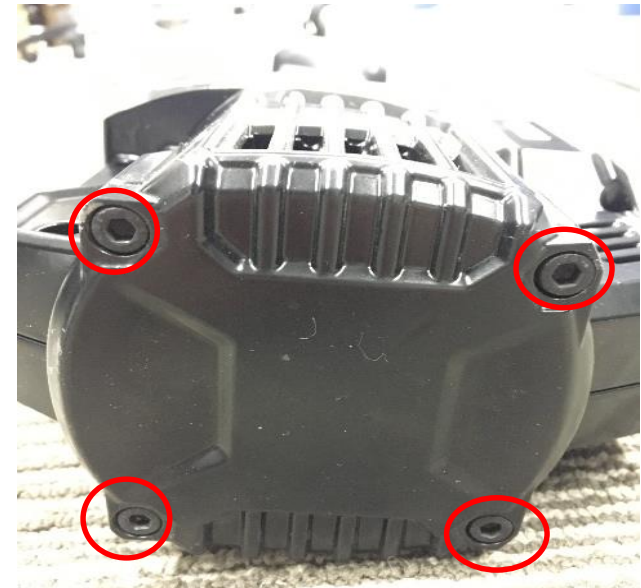
17. Assemble the housing assembly with 17 screws. Then assemble the Rear Cover with 4 screws.

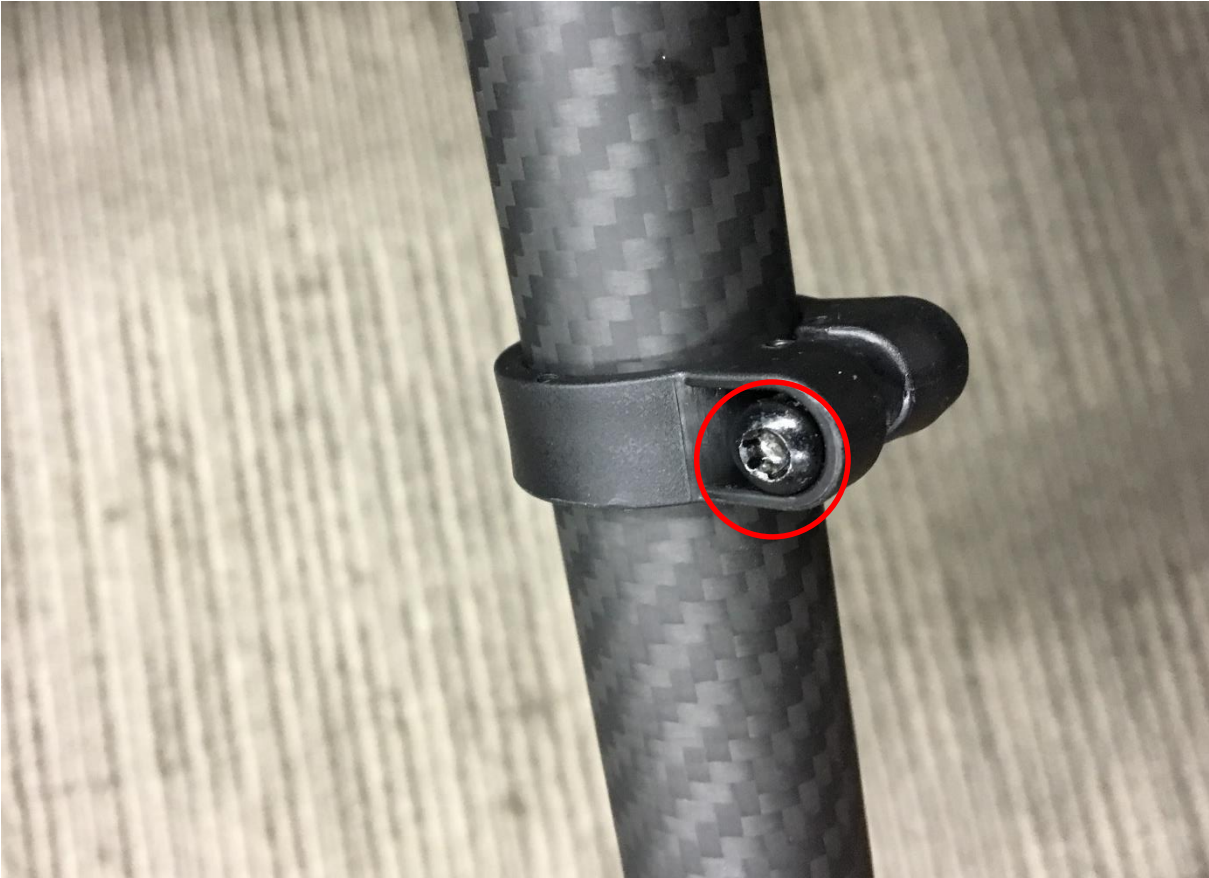
- 2. Remove the screw and take retaining ring from the shaft .

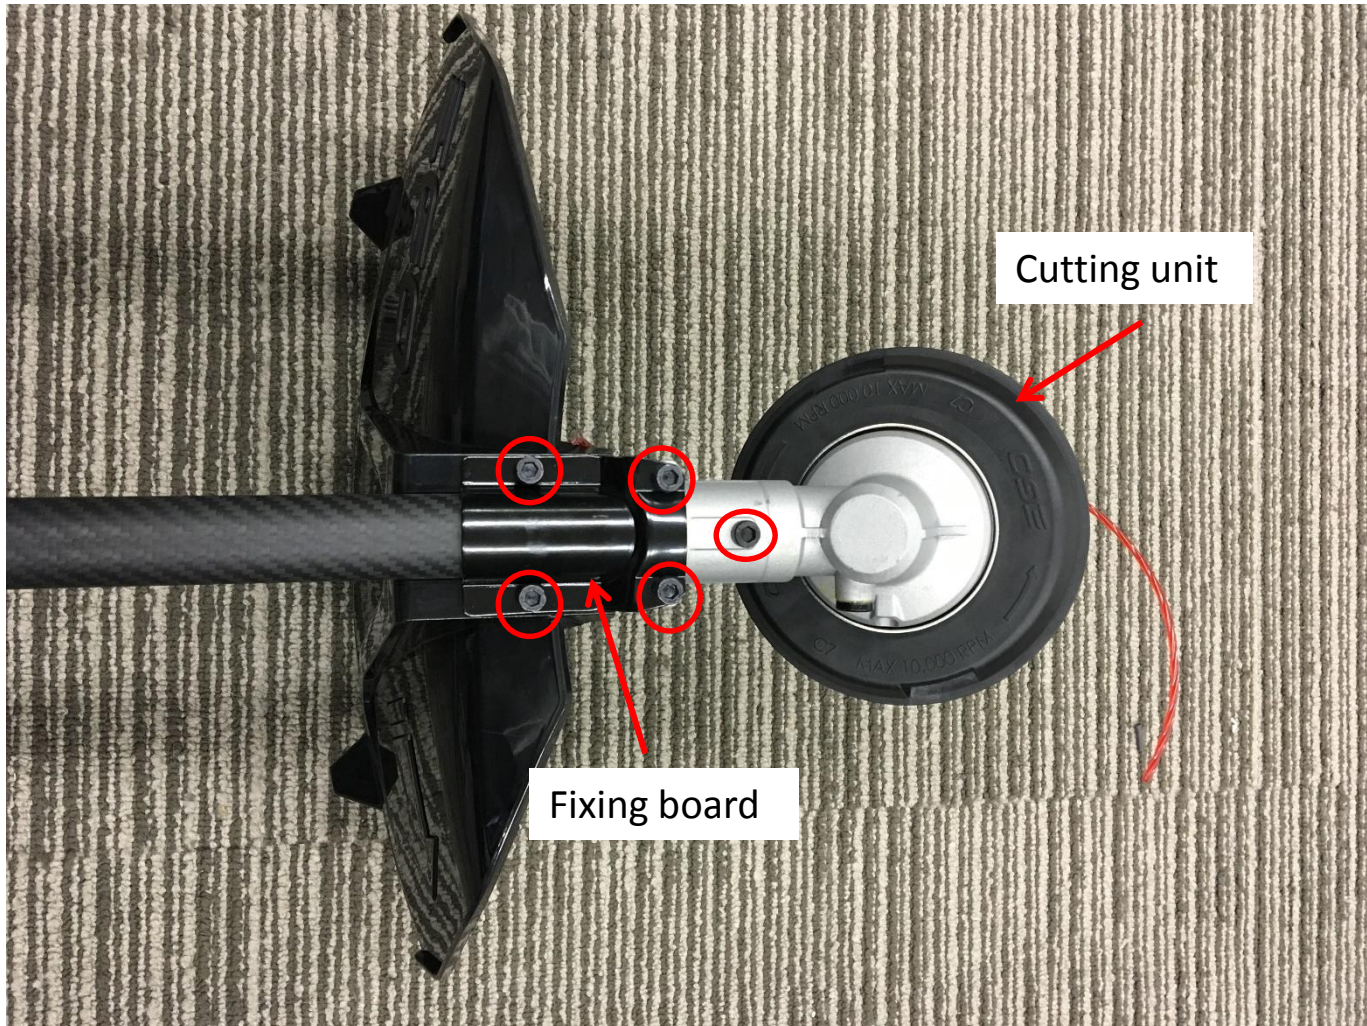
3. Loosen the five screws to separate cutting unit fixing board & guard from the shaft.

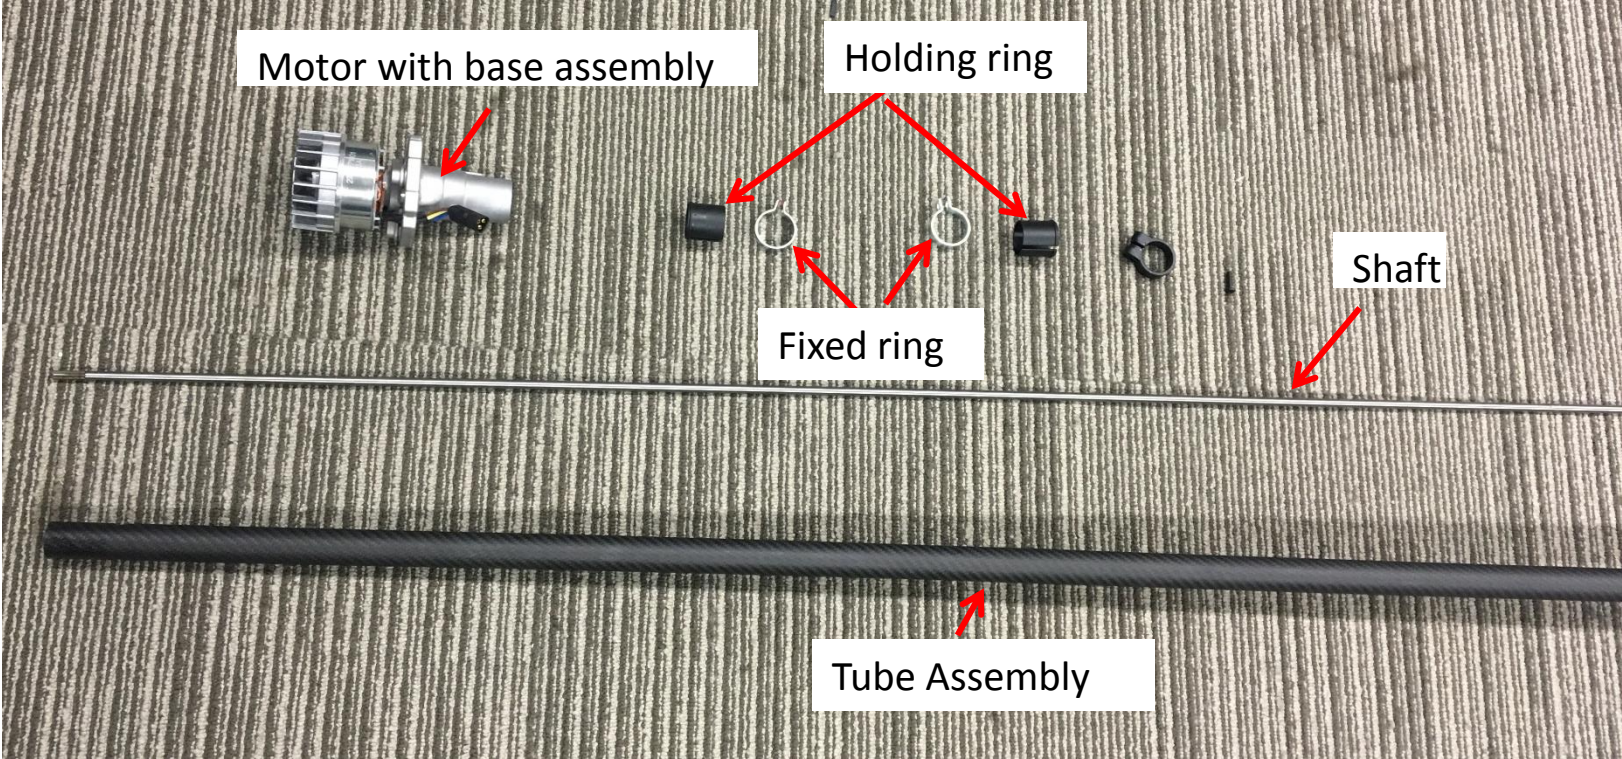
4. Pull out the shaft from the tube ASSY and replace the shaft or the tube ASSY with a new one.
