# REPAIR GUIDELINE

## Brush Cutter \_BCX3800

*Version: 2*

*Issue Date: 23/05/2019*

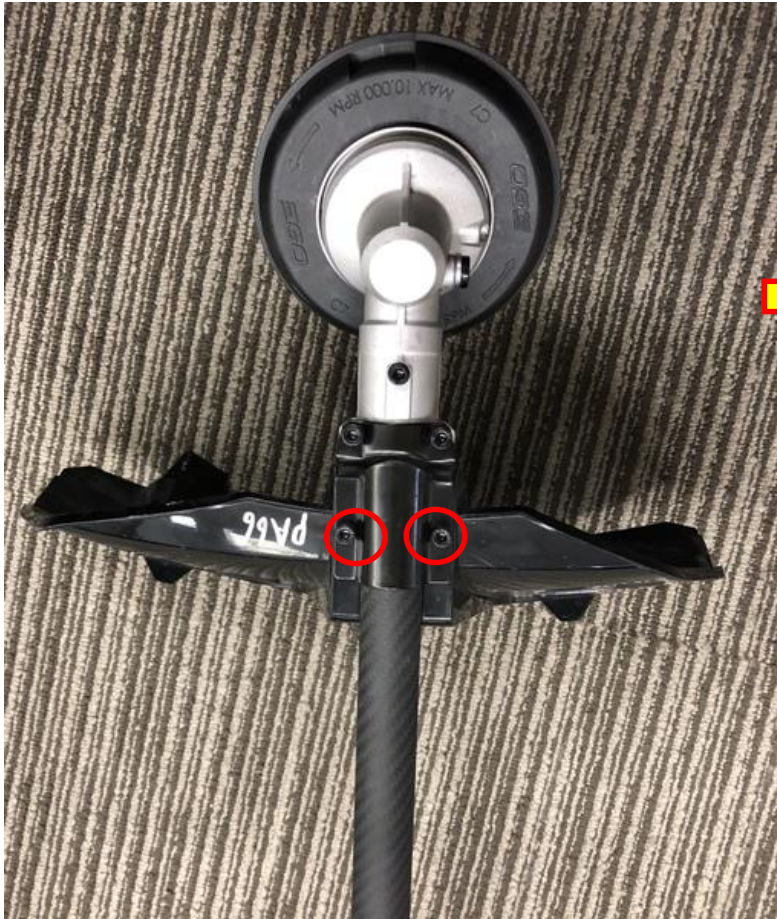
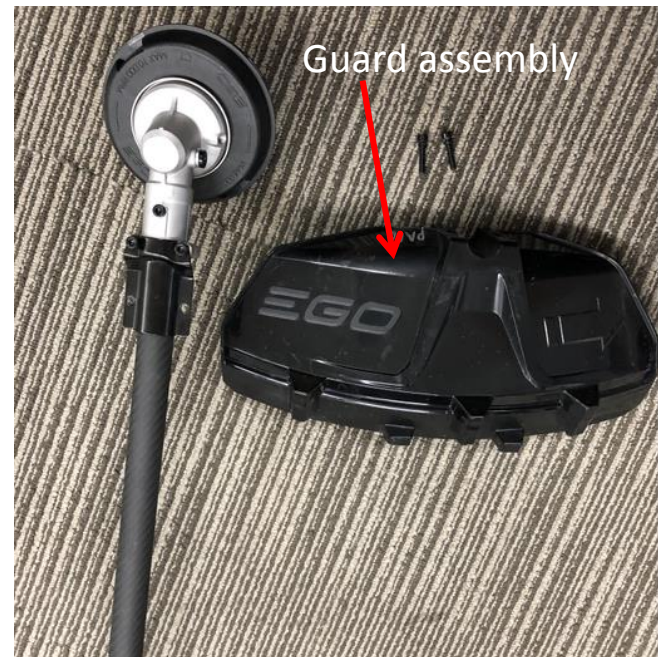
1. Loosen 2 screws to disassemble the guard assembly, if the guard assembly is broken, replace it with a new one.

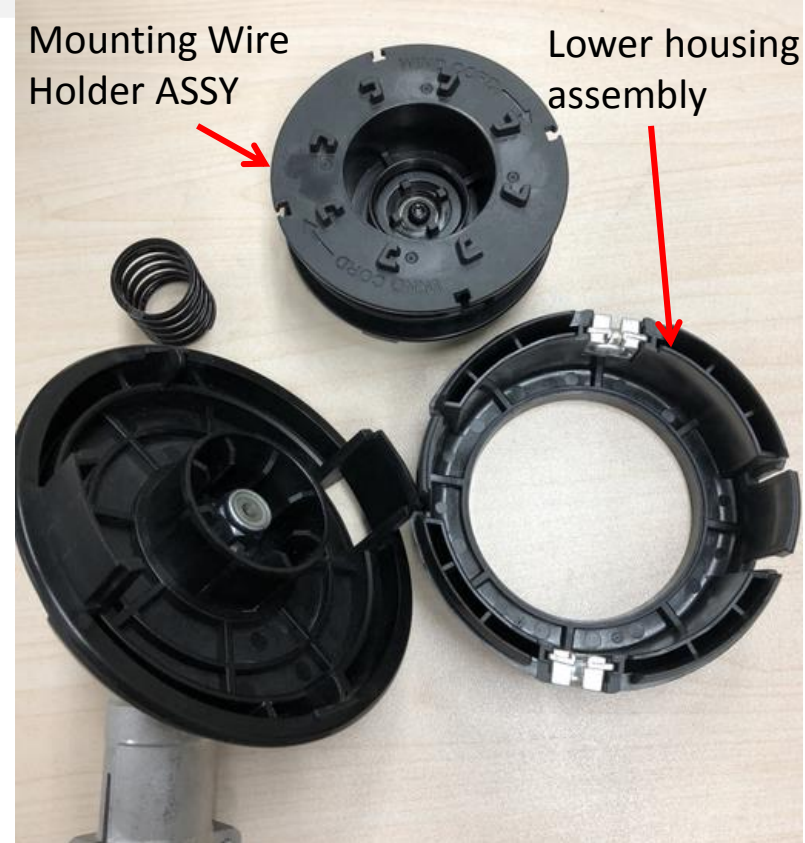
2. Press the release tabs to remove the lower housing assembly & mounting wire holder ASSY.

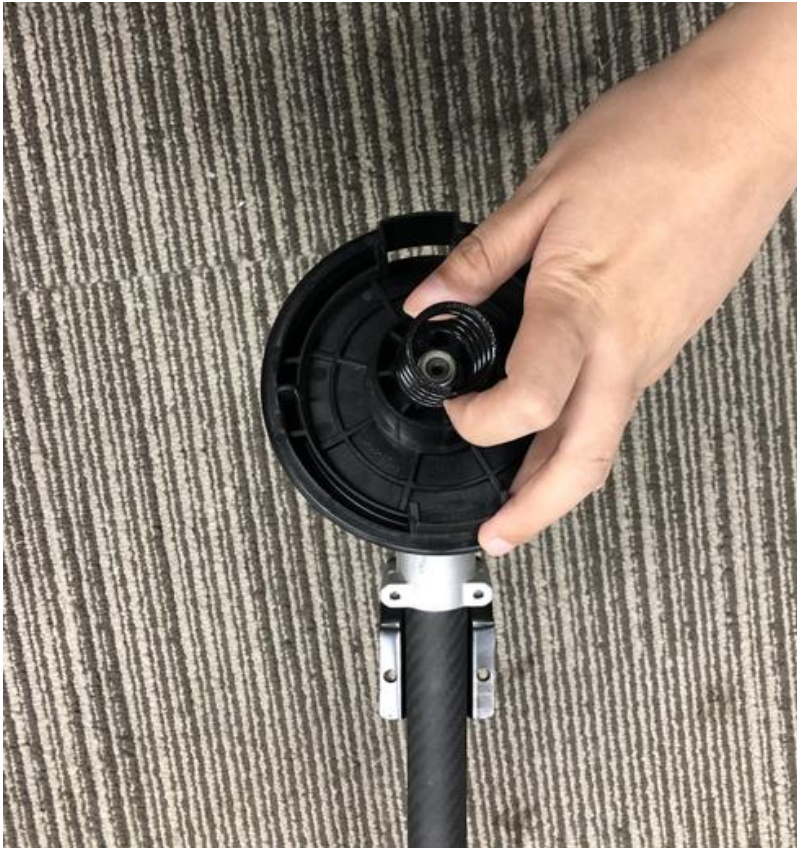
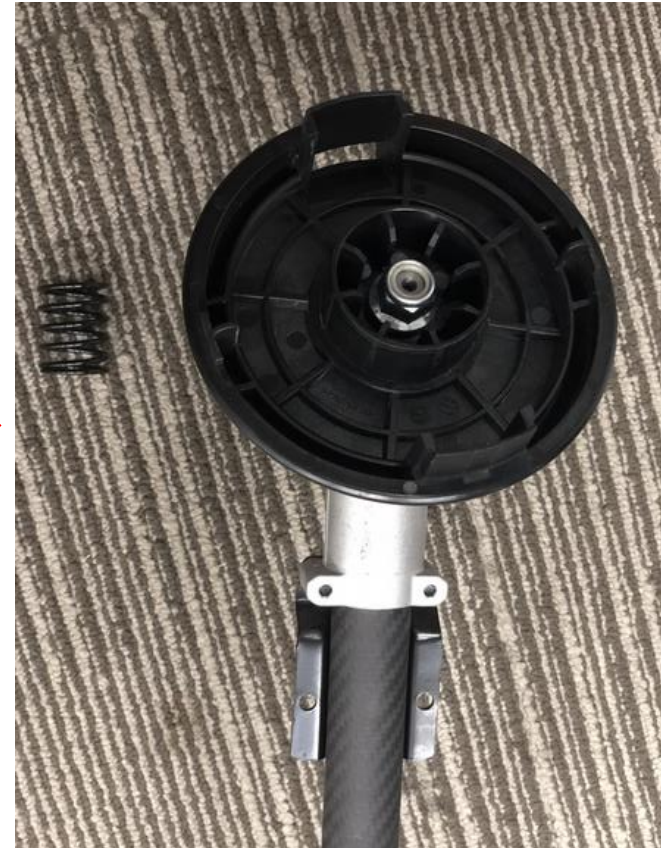
3. Take the spring out of the upper housing assembly.

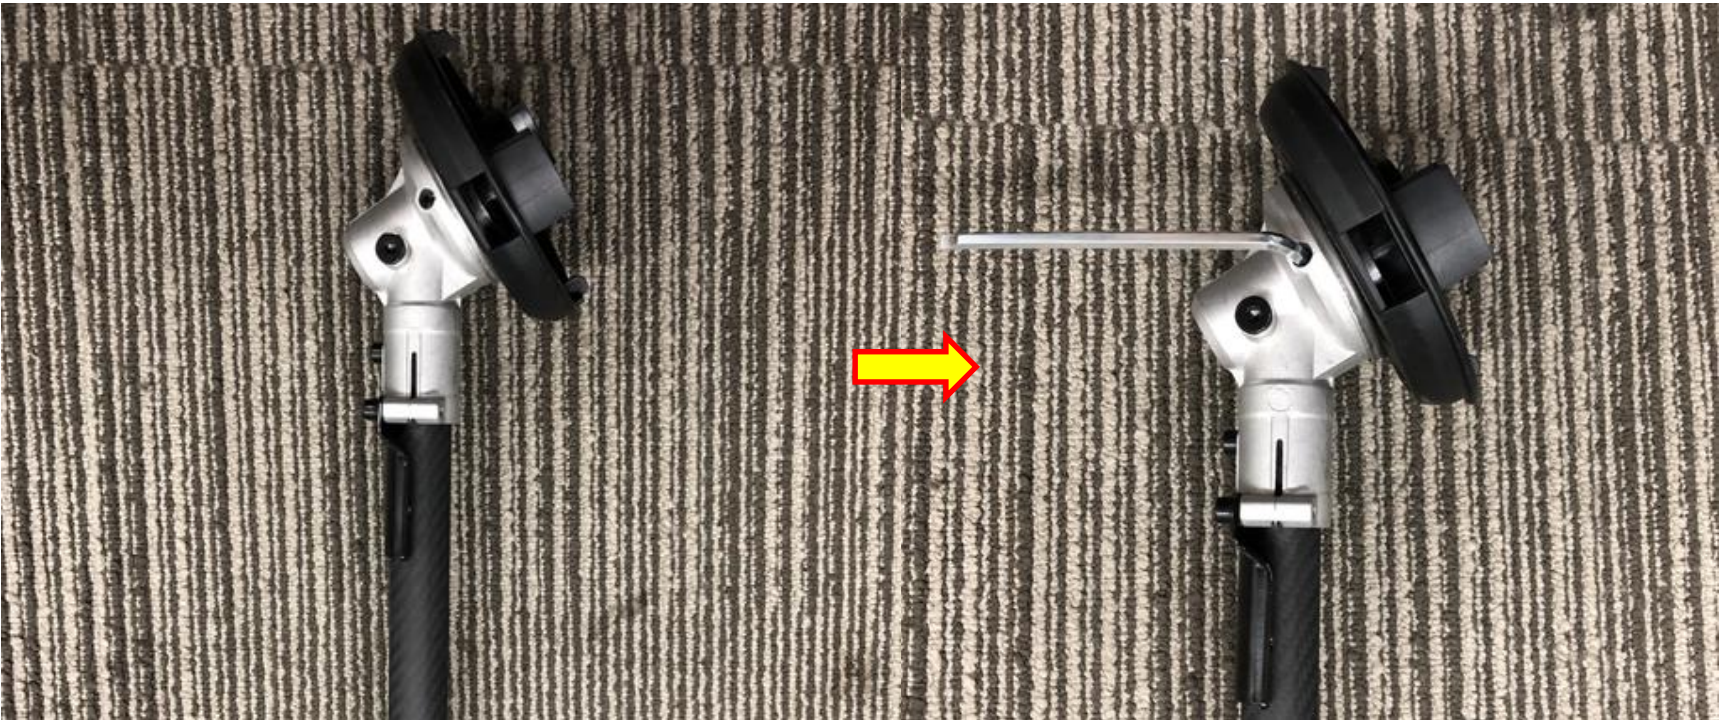
4. Rotate the upper housing assembly to align the slot in the flange with the hole in the gear case.
5. Insert the hex wrench into the aligned holes to act as a stabilizer.

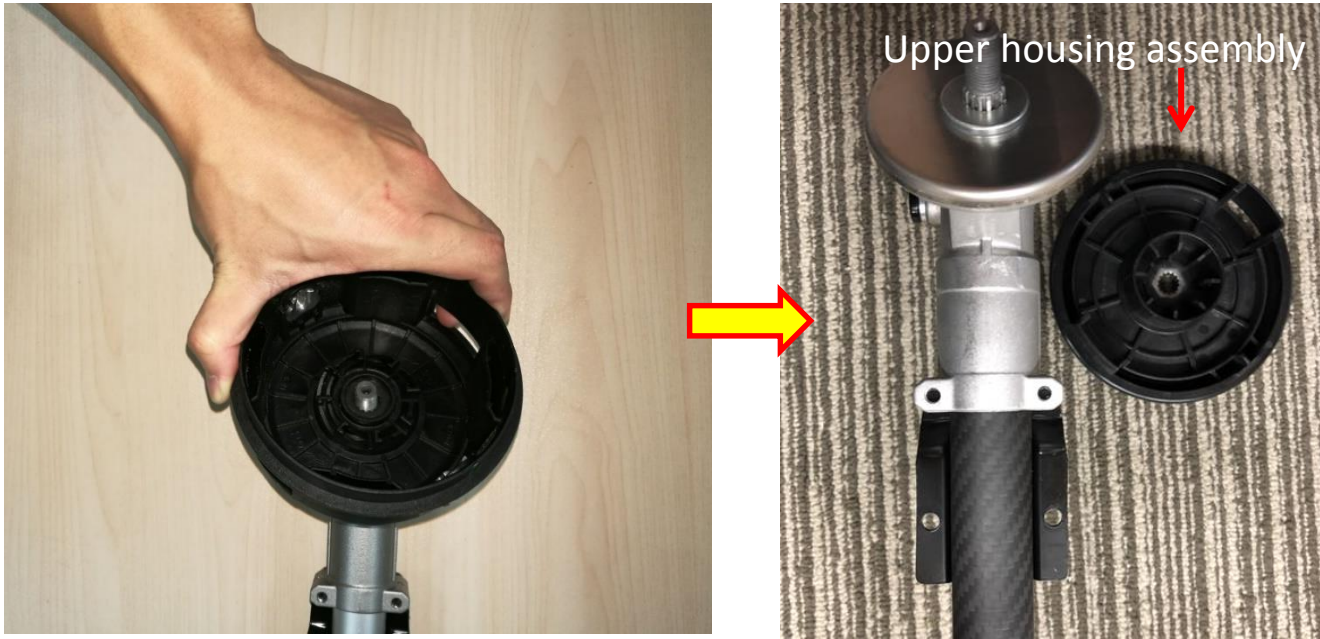
7. Take the upper housing assembly out of the shaft.

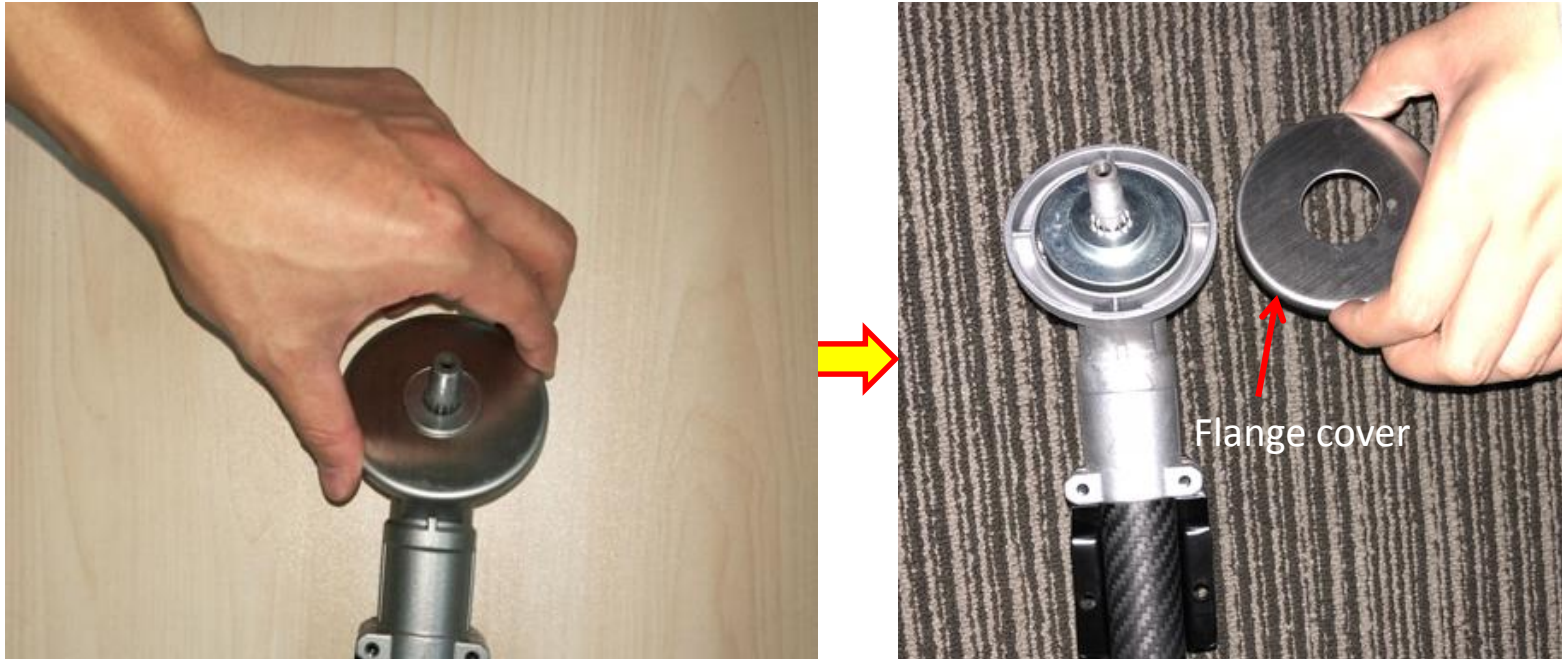
8. Take the flange cover out of the shaft.

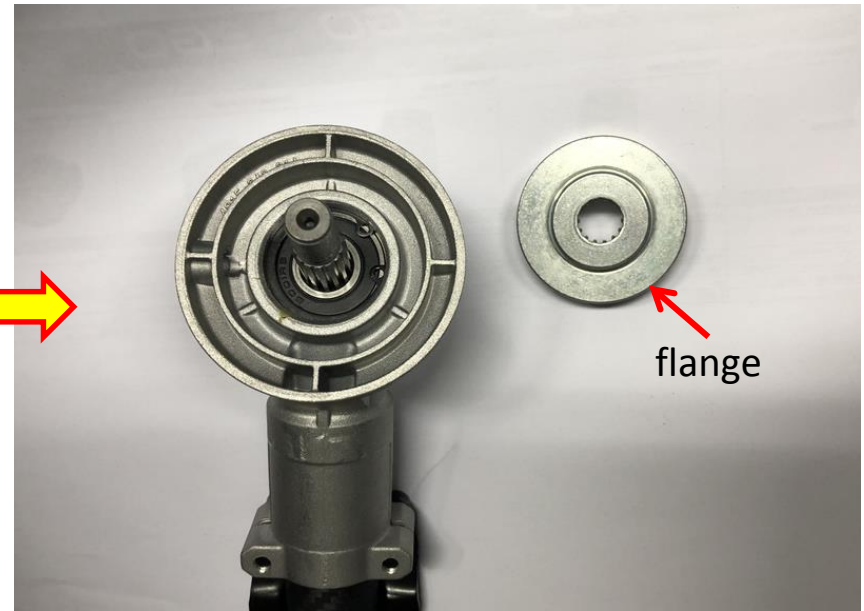
9. Take the flange out of the shaft.

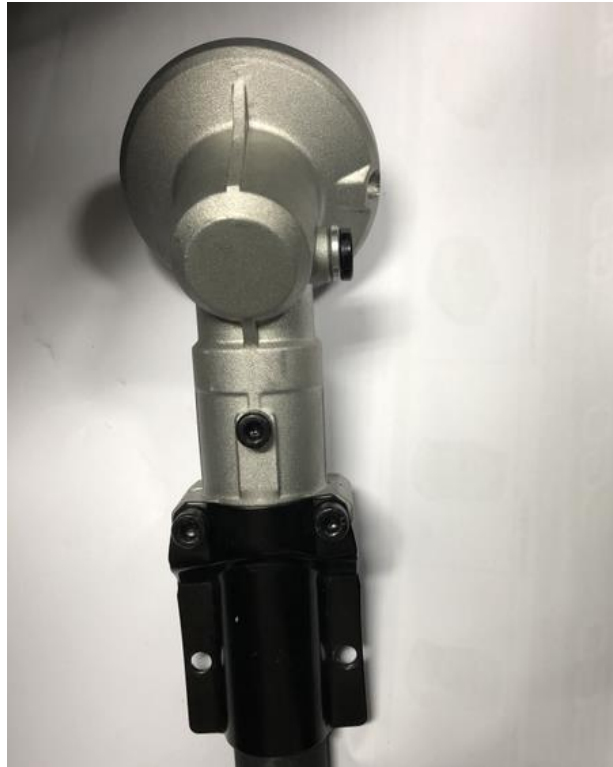
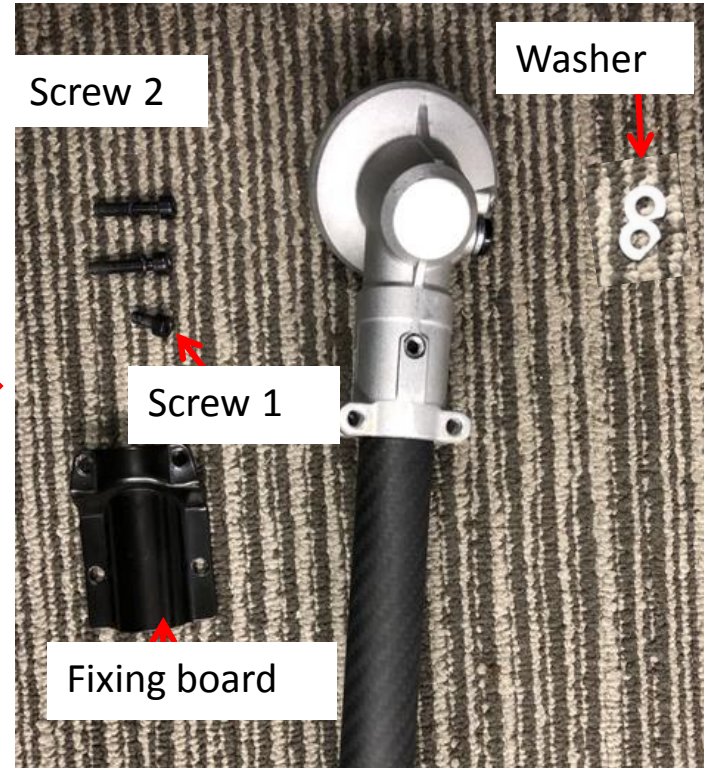
10. Loosen 3 screws to remove the fixing board.

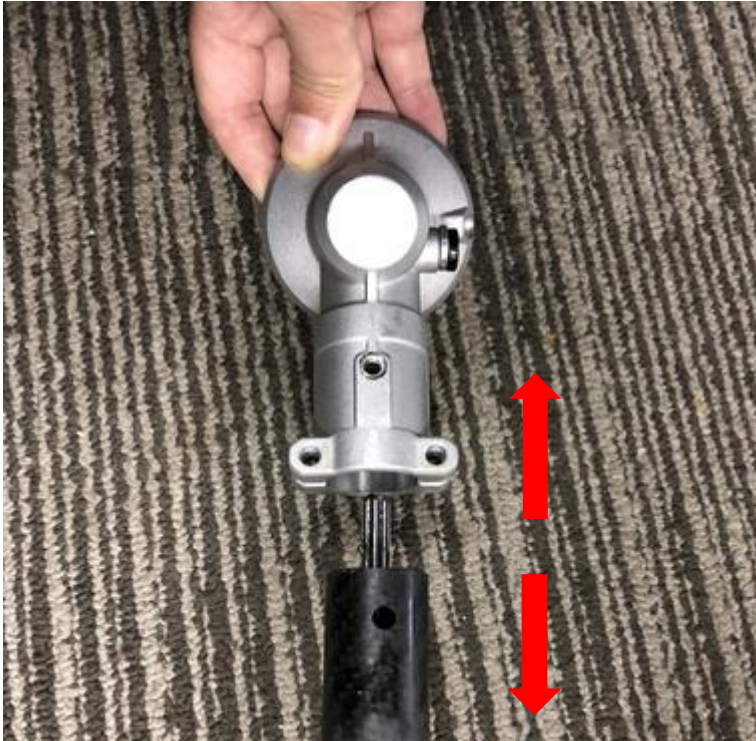
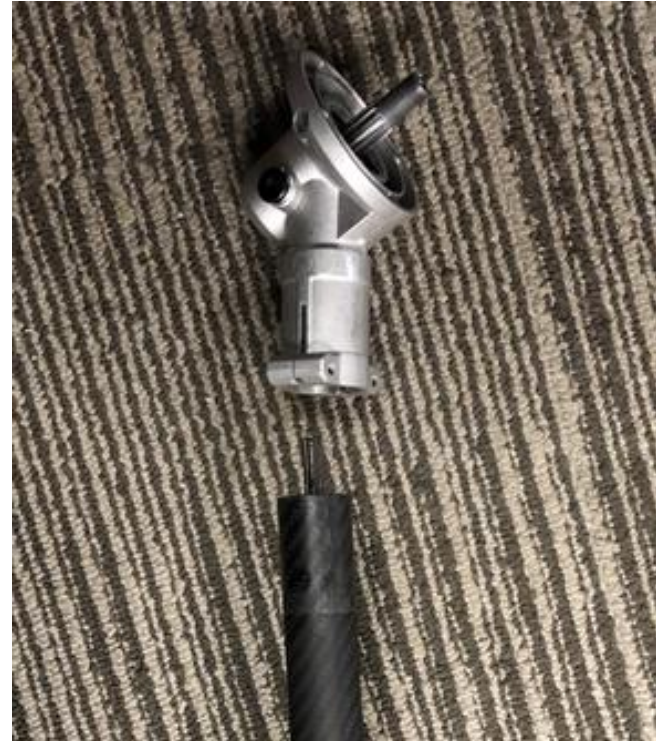
11. Pull the connecting tube with one hand and pull the gear case with the other hand to separate them from each other.

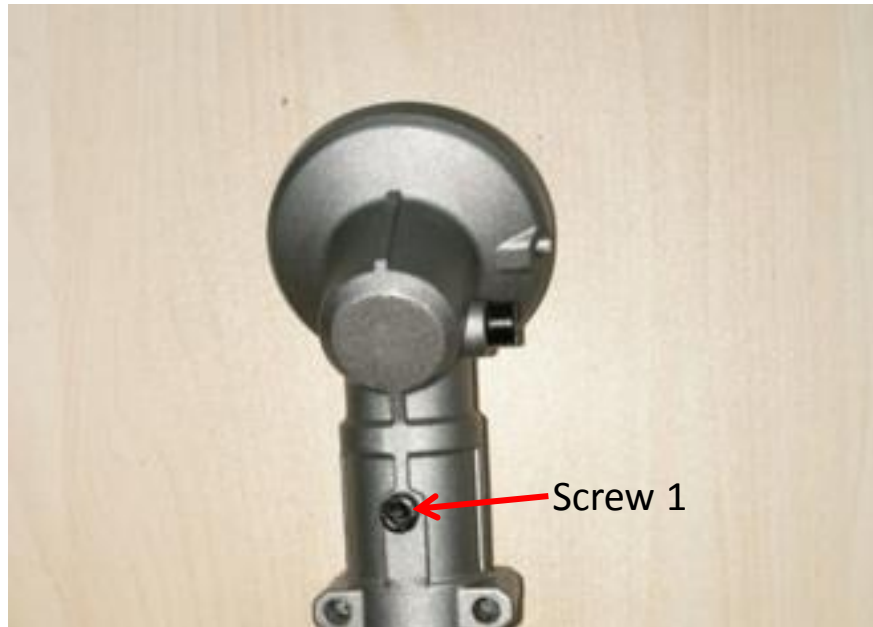
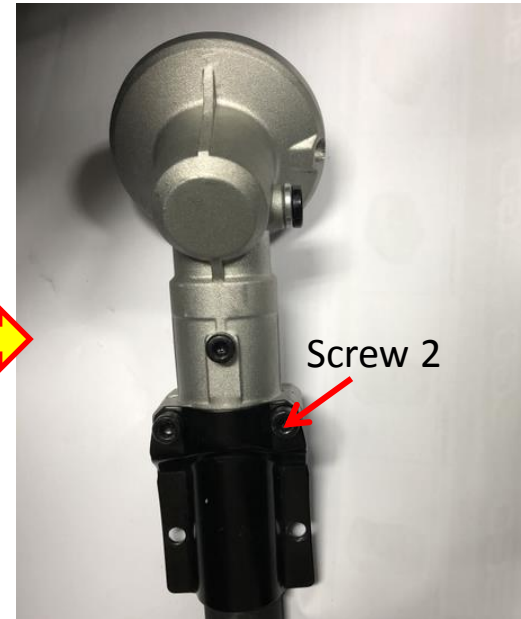
13. Tighten the gear case with the connecting tube with screw.

14. Tighten the fixing board with the gear case with screws.

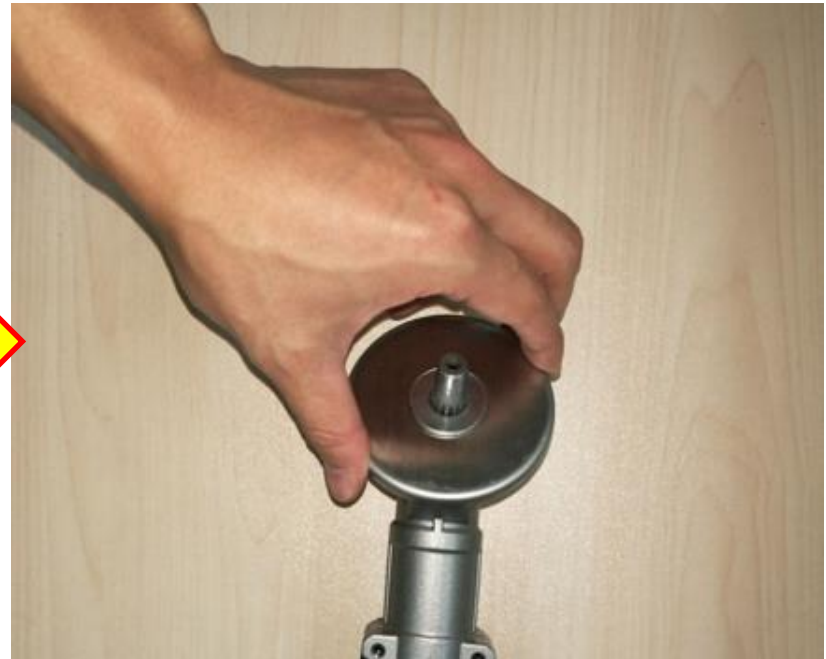
16. Mount the flange cover onto the shaft.

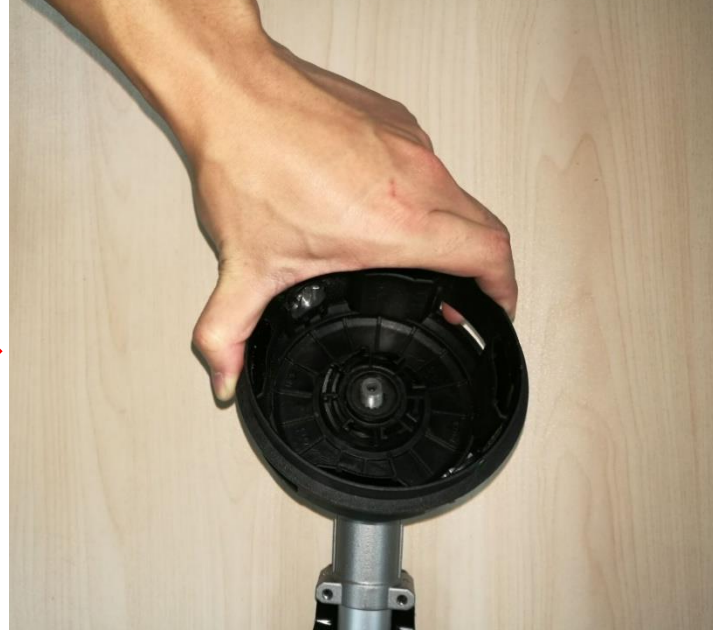
17. Mount the upper housing assembly onto the shaft.

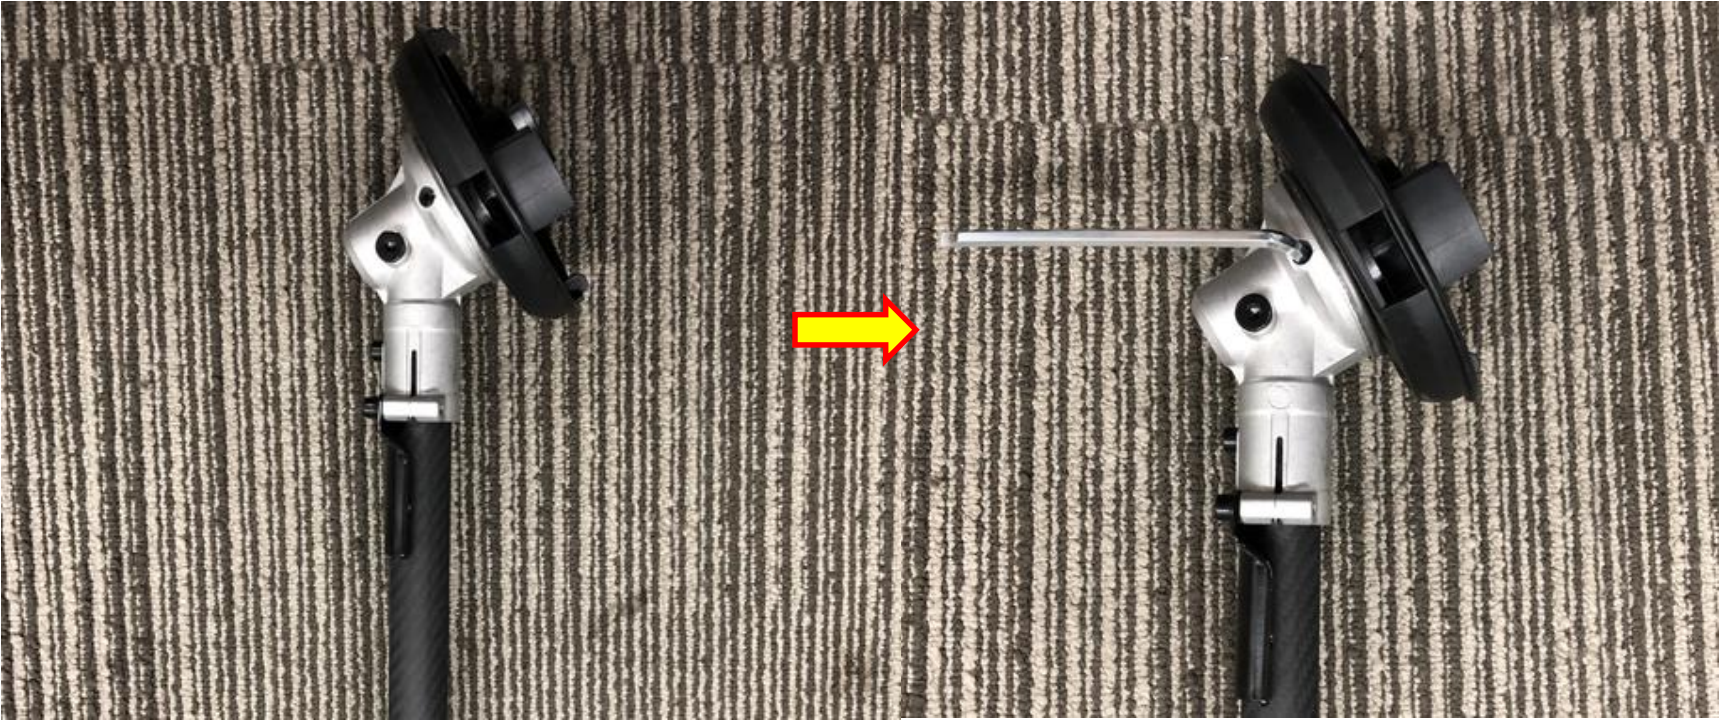
18. Rotate the upper housing assembly to align the slot in the flange with the hole in the gear case.
19. Insert the hex wrench into the aligned holes to act as a stabilizer.

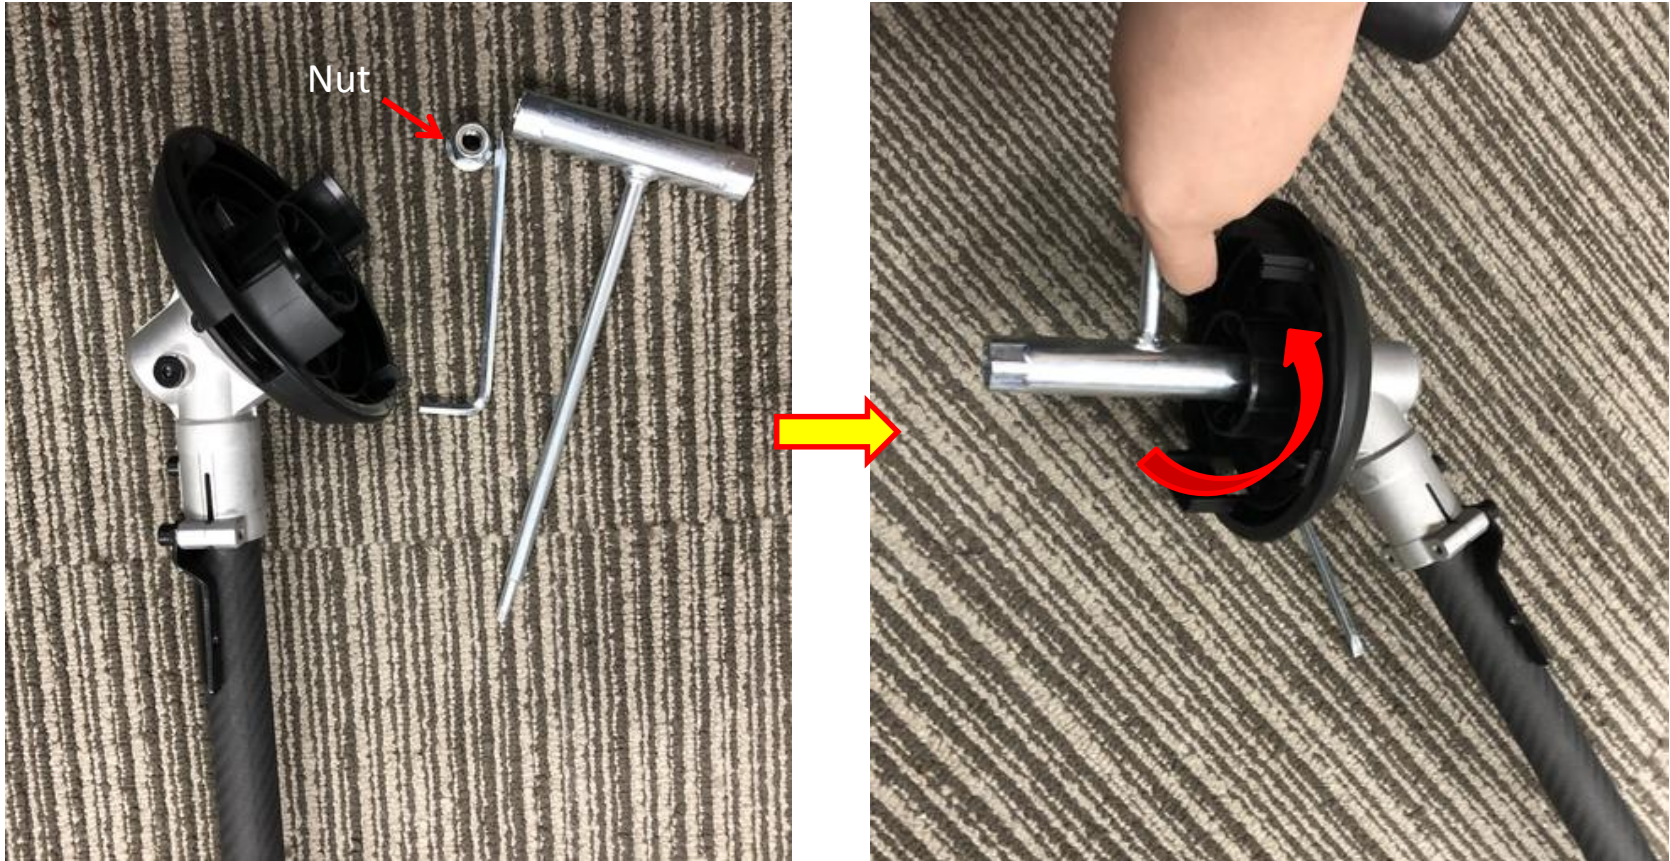
22. Mount the nut onto the shaft and tighten it with multifunction wrench anticlockwise.

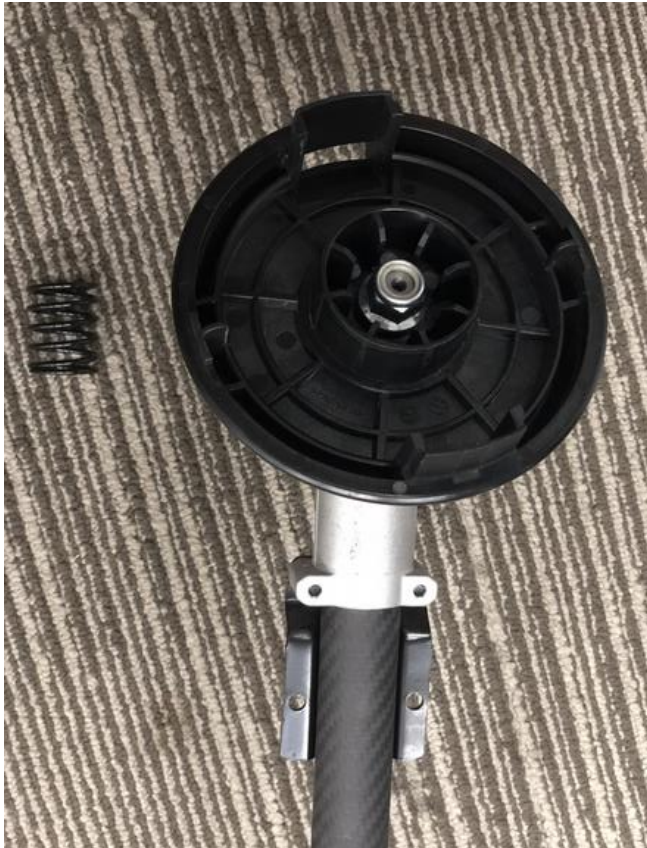
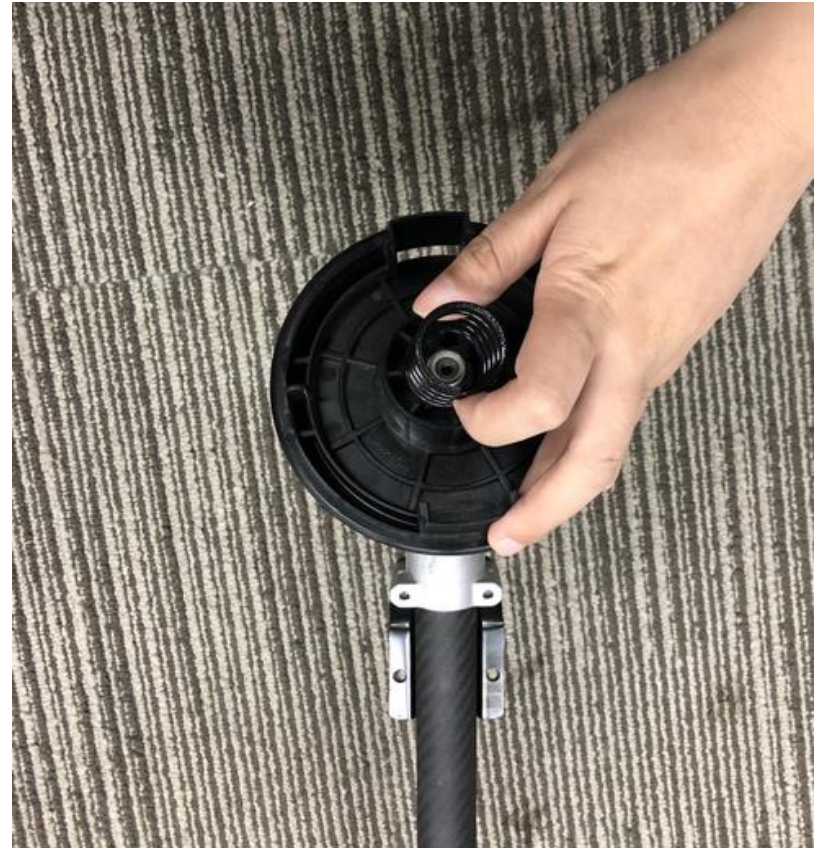
23. Mount the spring onto the upper housing assembly.

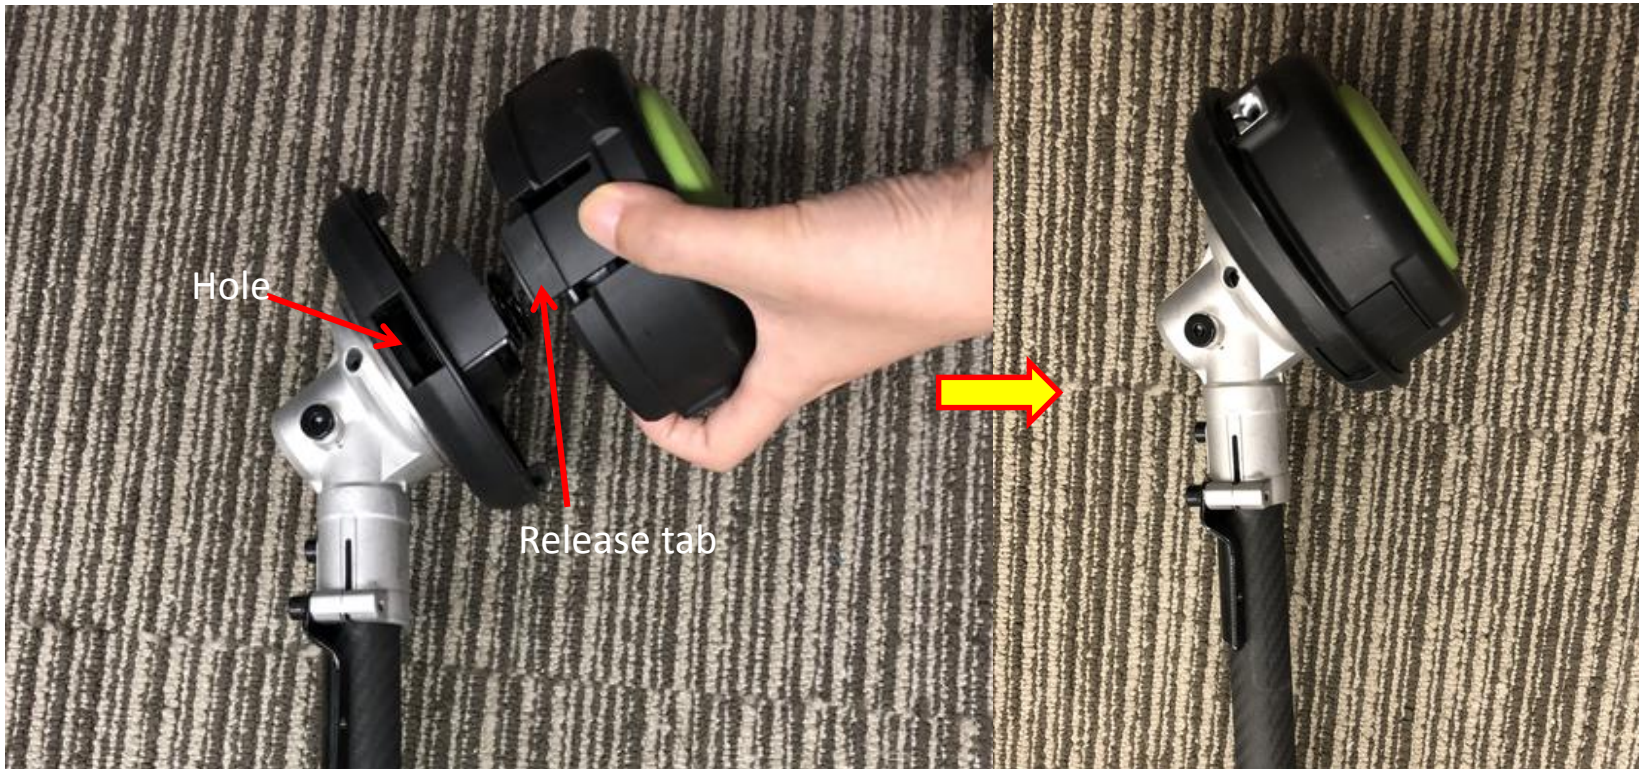
24. Align the release tabs on the lower housing assembly with the holes on the upper housing assembly to assemble them together.

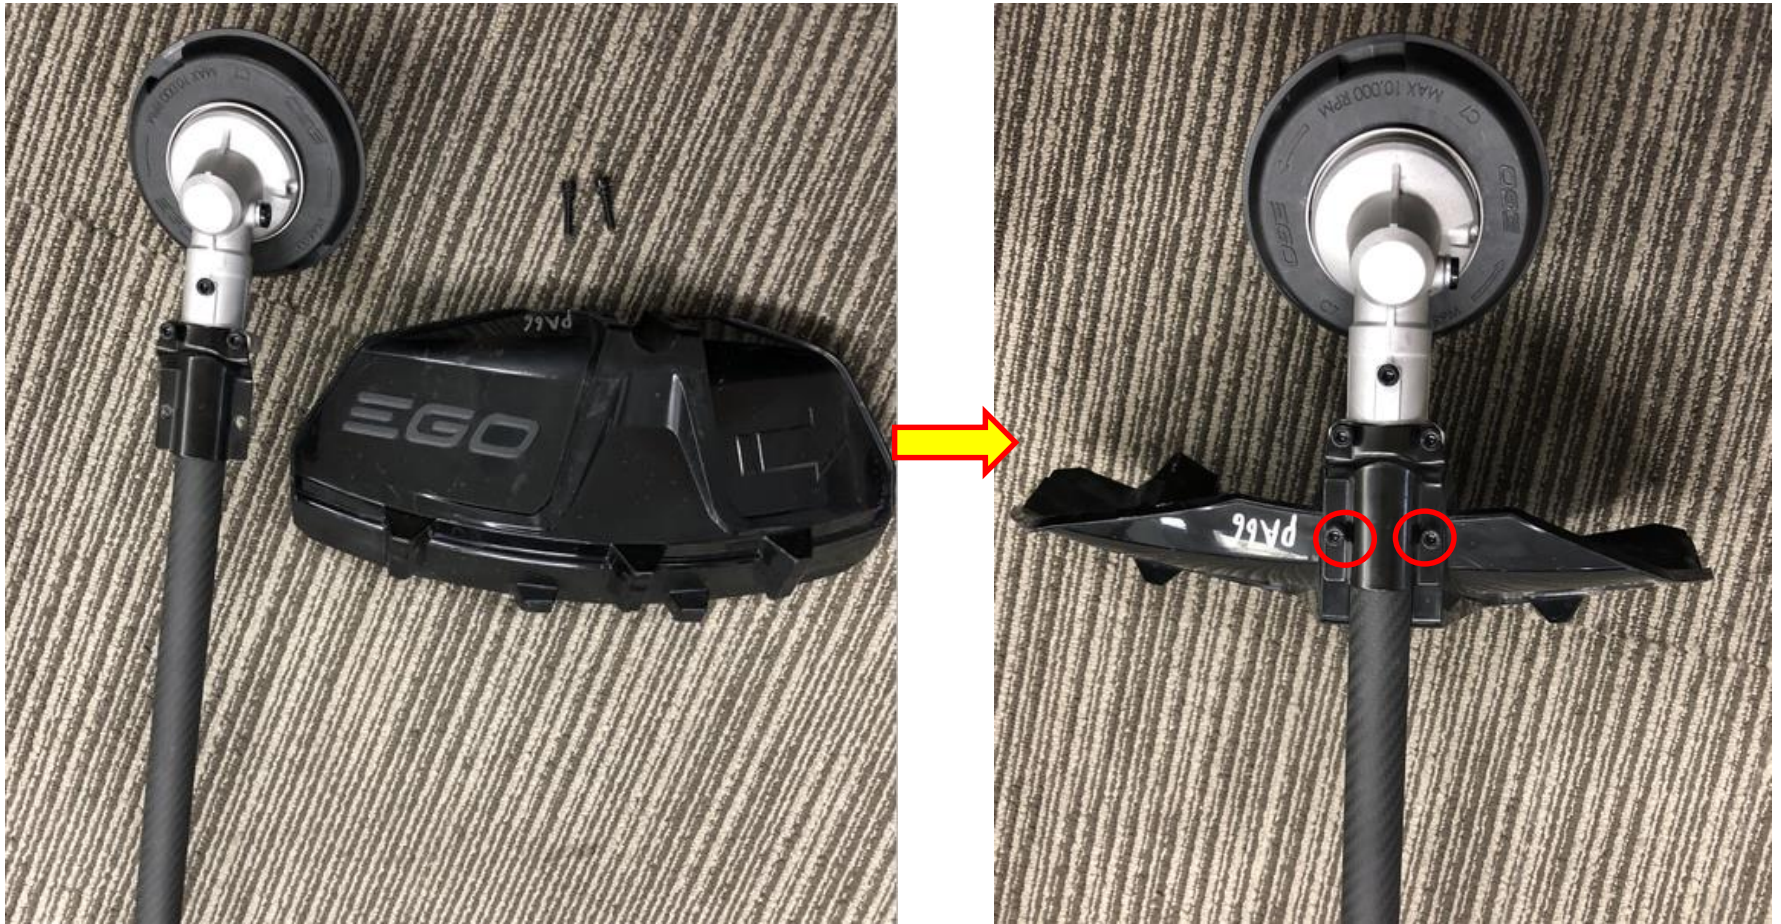
25. Assemble the guard assembly with the fixing board with screws & washer.

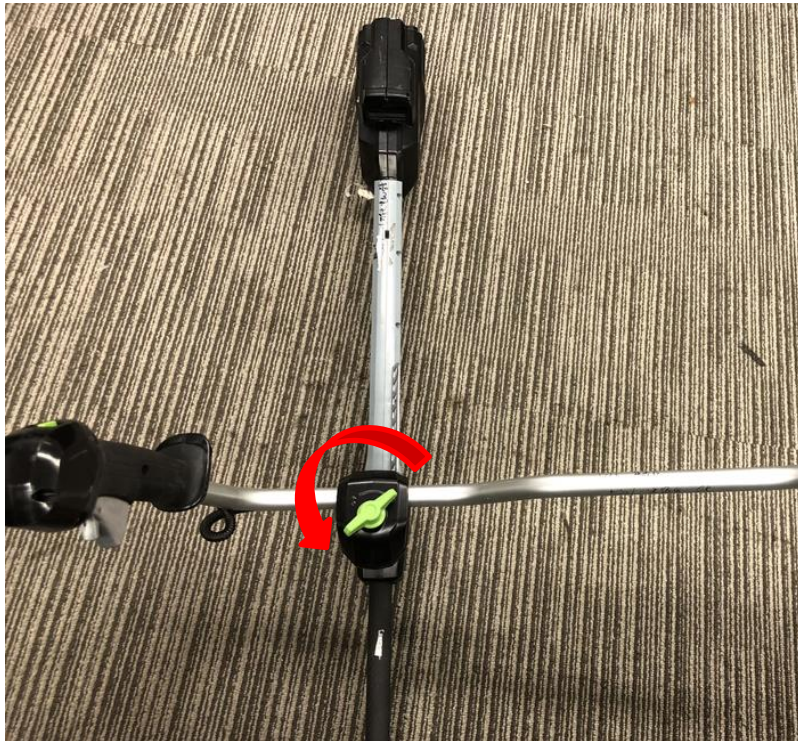
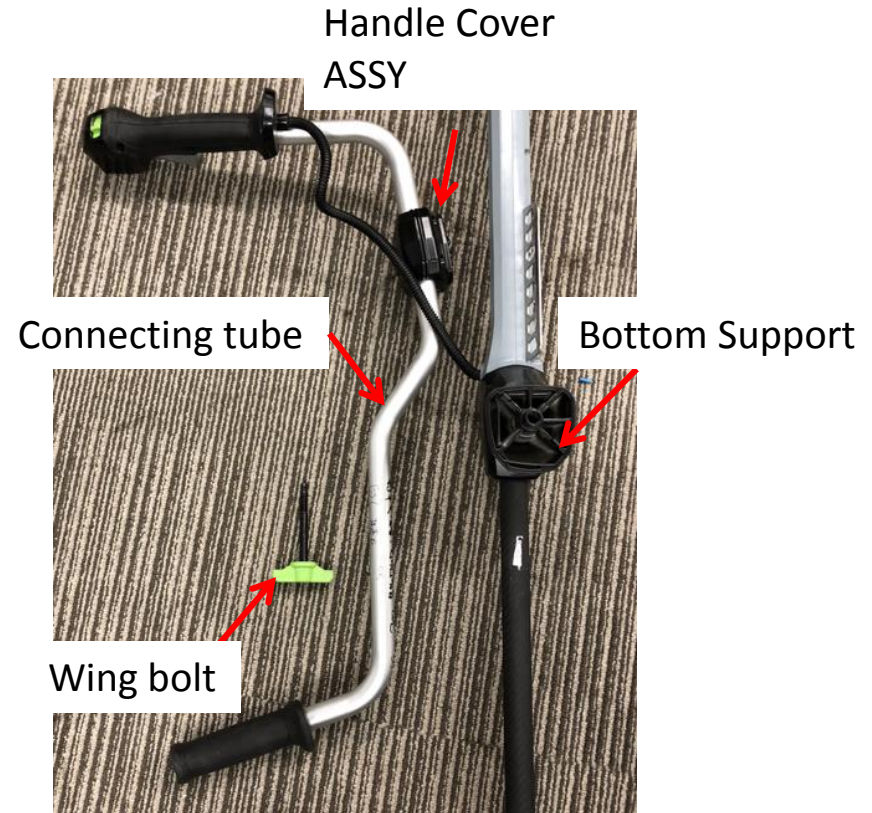
1. Stop the motor and remove the battery pack from the line trimmer.
2. Rotate the wing bolt counterclockwise to separate the handle cover ASSY from the bottom support and put the connecting tube aside.

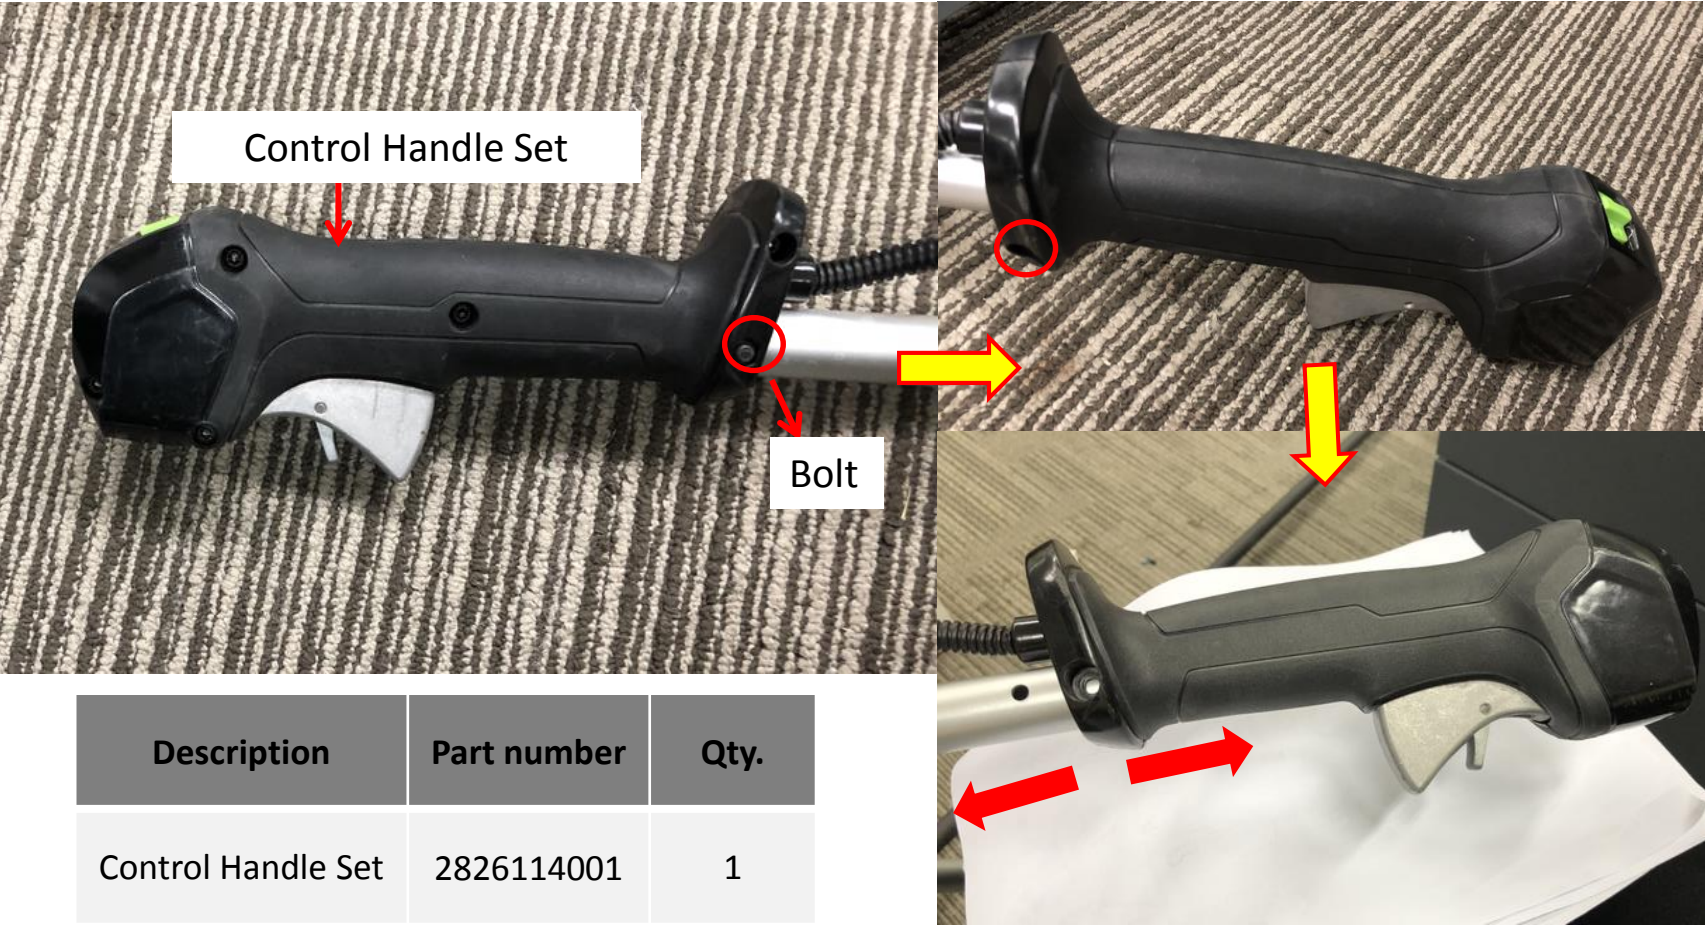
3. loosen the 1 bolt to pull out the control handle set from connecting tube.

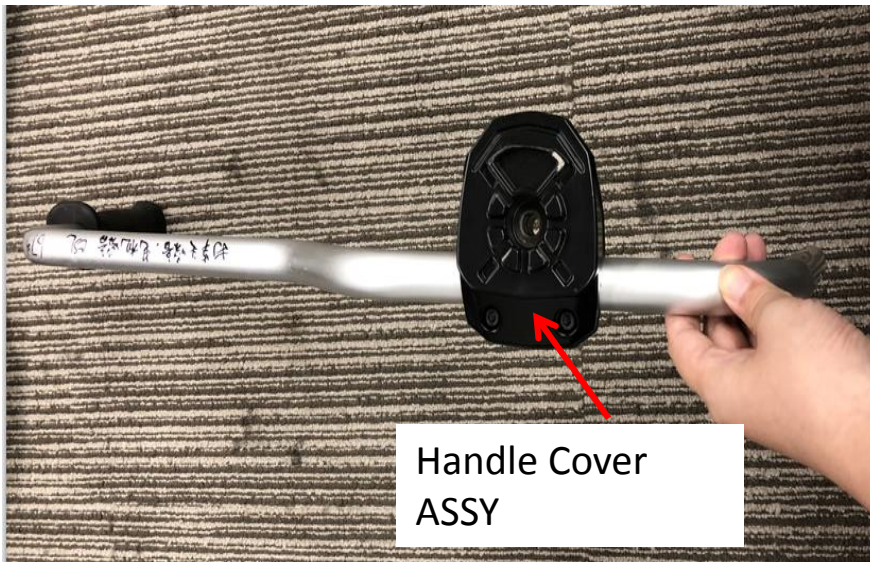
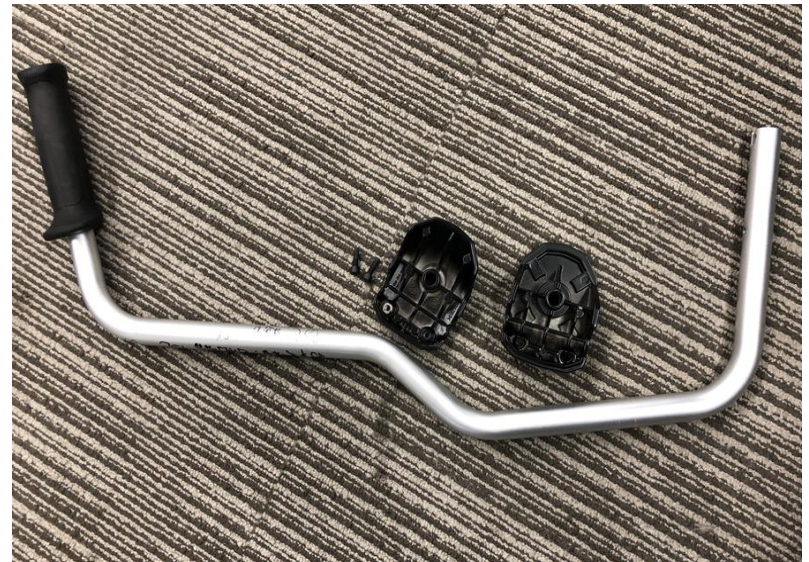
- Loosen screws on the connecting tube base set and disassemble them. Replace the connecting tube with a new one.

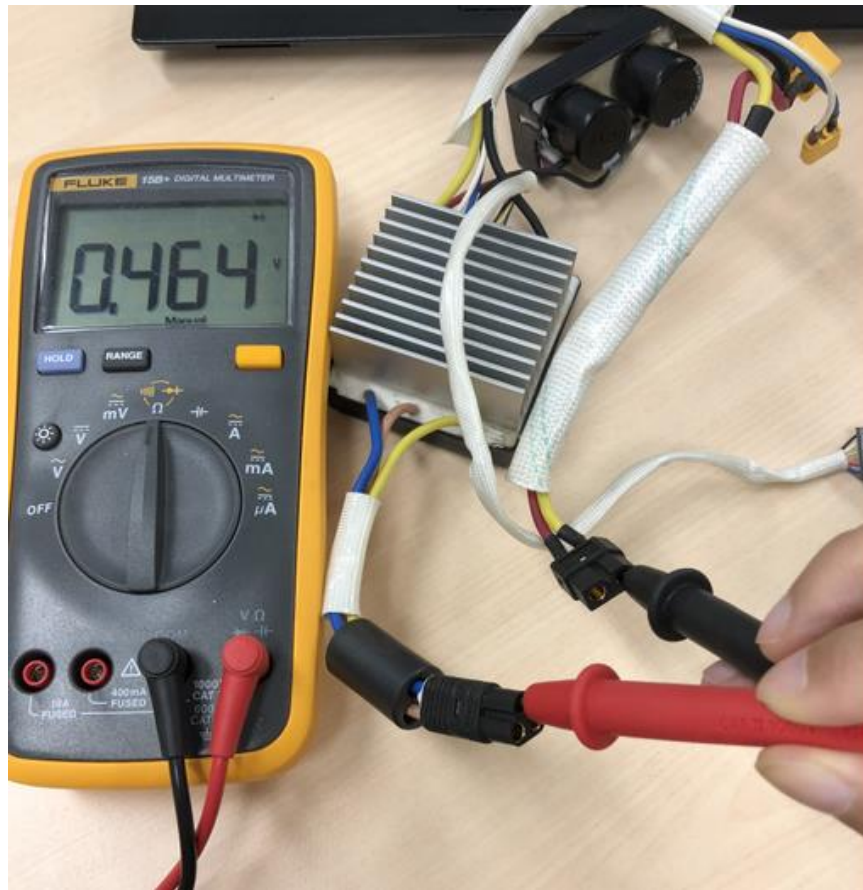
PCBA Measurement

5. Contact the black pen pin to the contact (connect to the yellow line) of the black connector and red pen pin to the three contacts of the black connector (connect to the motor).

**Notice :** If the LCD displays 0.45~0.55V for each measurement, means a good upper MOSFET, go to the next testing step; otherwise means a broken PCBA, replace a new PCBA.
