# REPAIR GUIDELINE

## Brush Cutter \_BCX3800

*Version: 2*

*Issue Date: 23/05/2019*

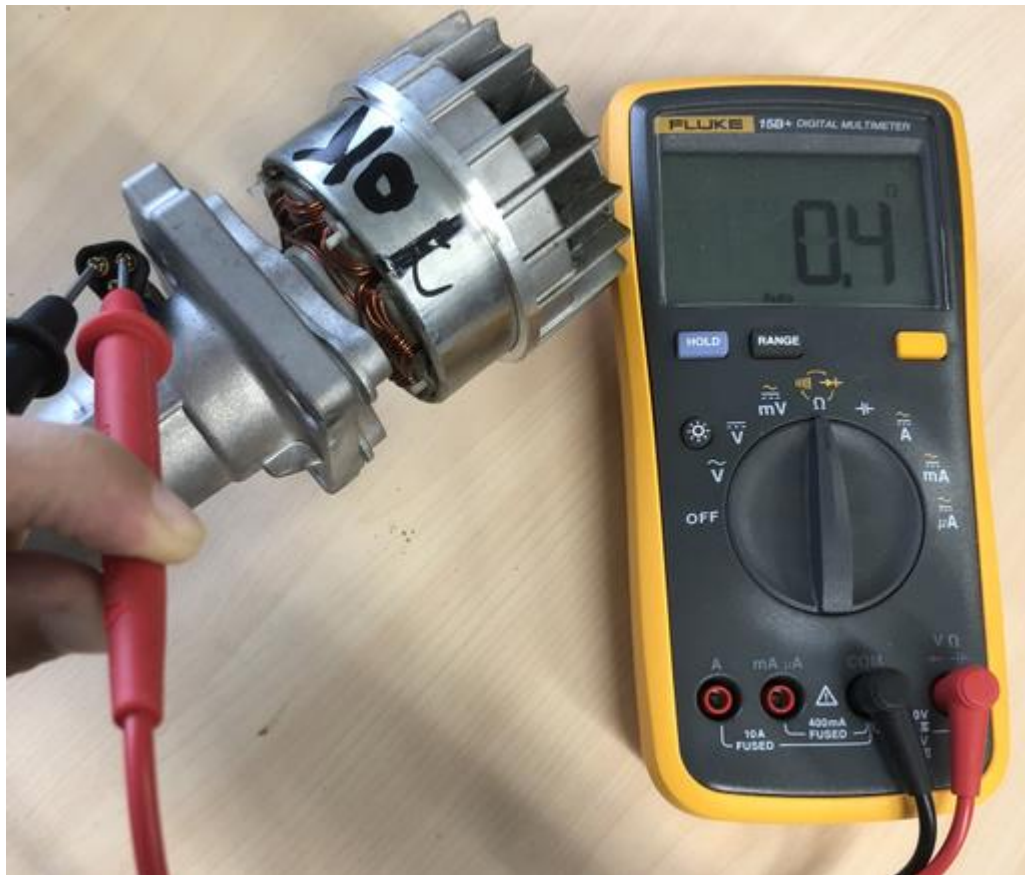
**Motor Measurement**

1. Following the instructions for “**Replacing the Motor Assembly and PCBA**” to Separate the PCBA.
2. Set the multimeter function to “Resistance measuring”.
3. Measure the resistance between any of the two contacts.

**Notice: If the resistance is not infinite, means a good motor. Otherwise, replace the damaged motor**

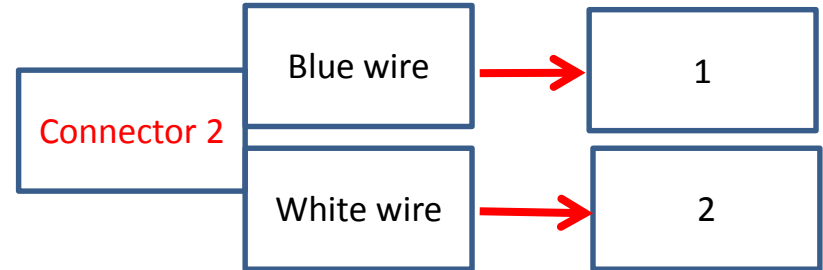
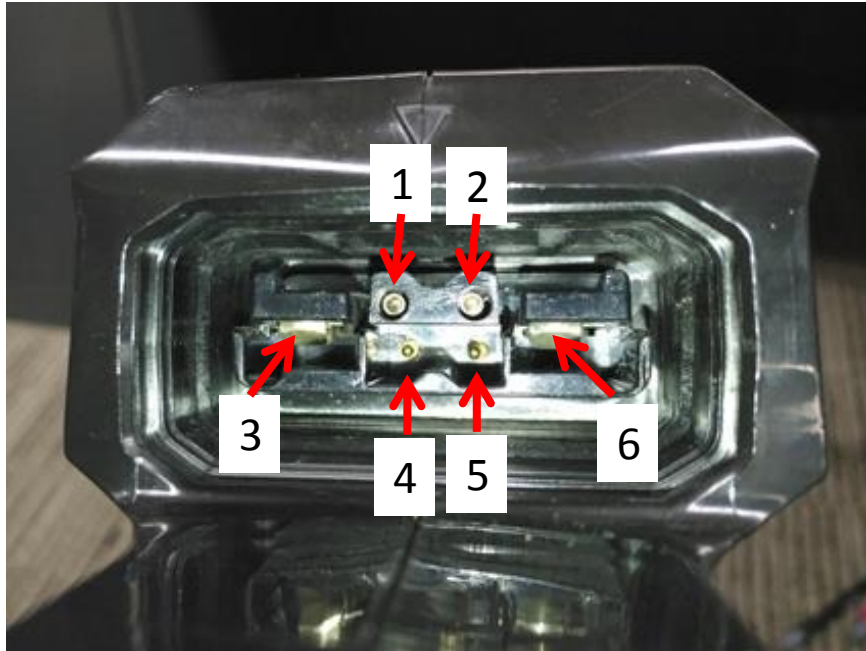
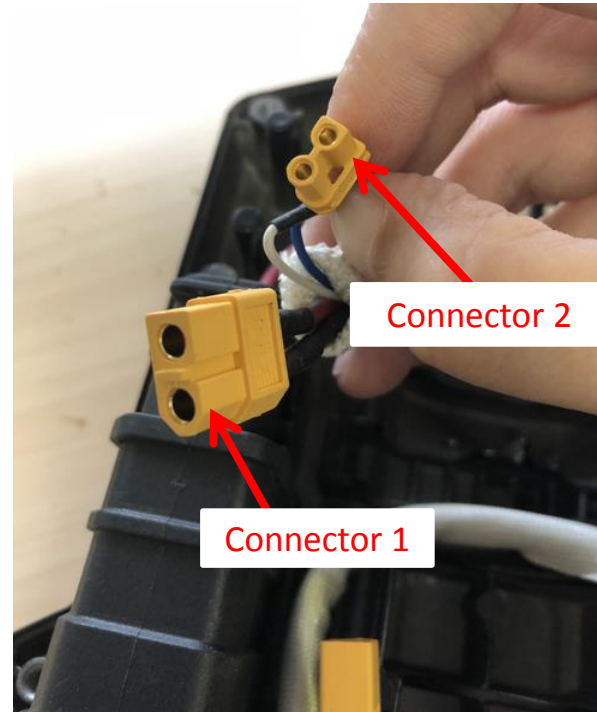
- 1. There is 6 contacts in the socket. Contact the black pen pin to the 6 contacts and the red pen pin to their corresponding contacts of the two connectors.

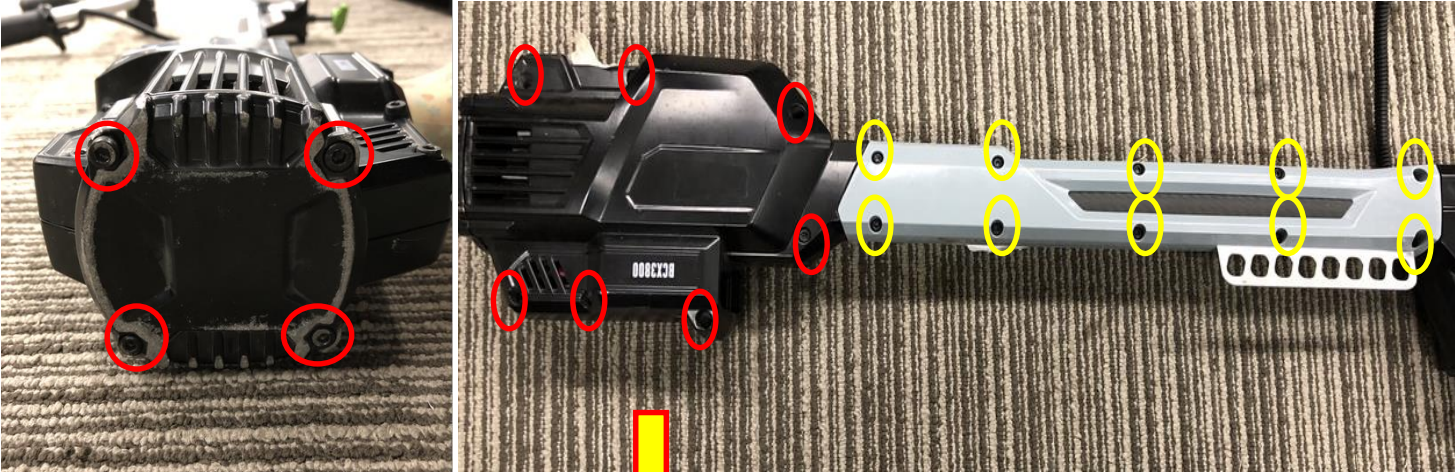
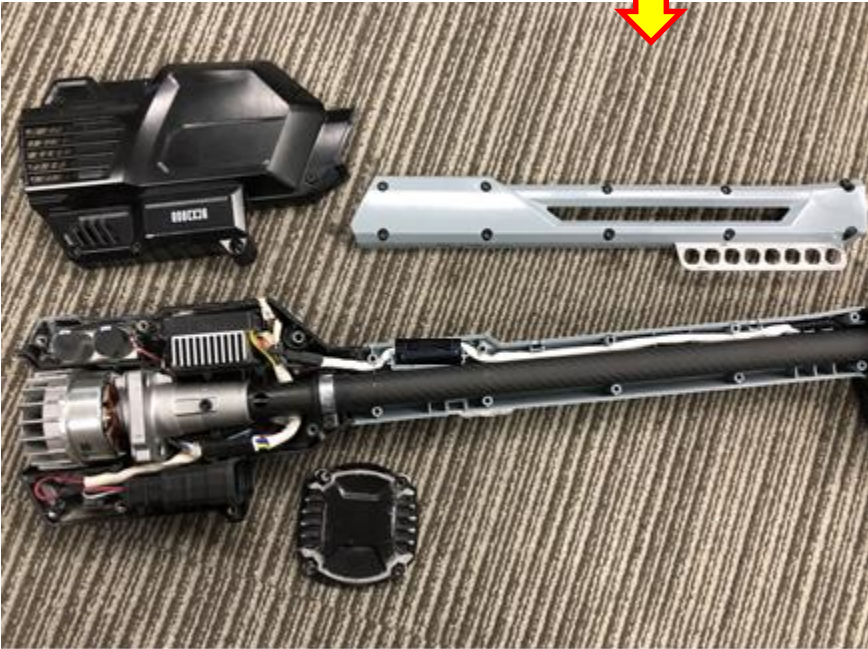
1. Loosen 11 tapping screws & 10 screws to disassemble the housing assembly.

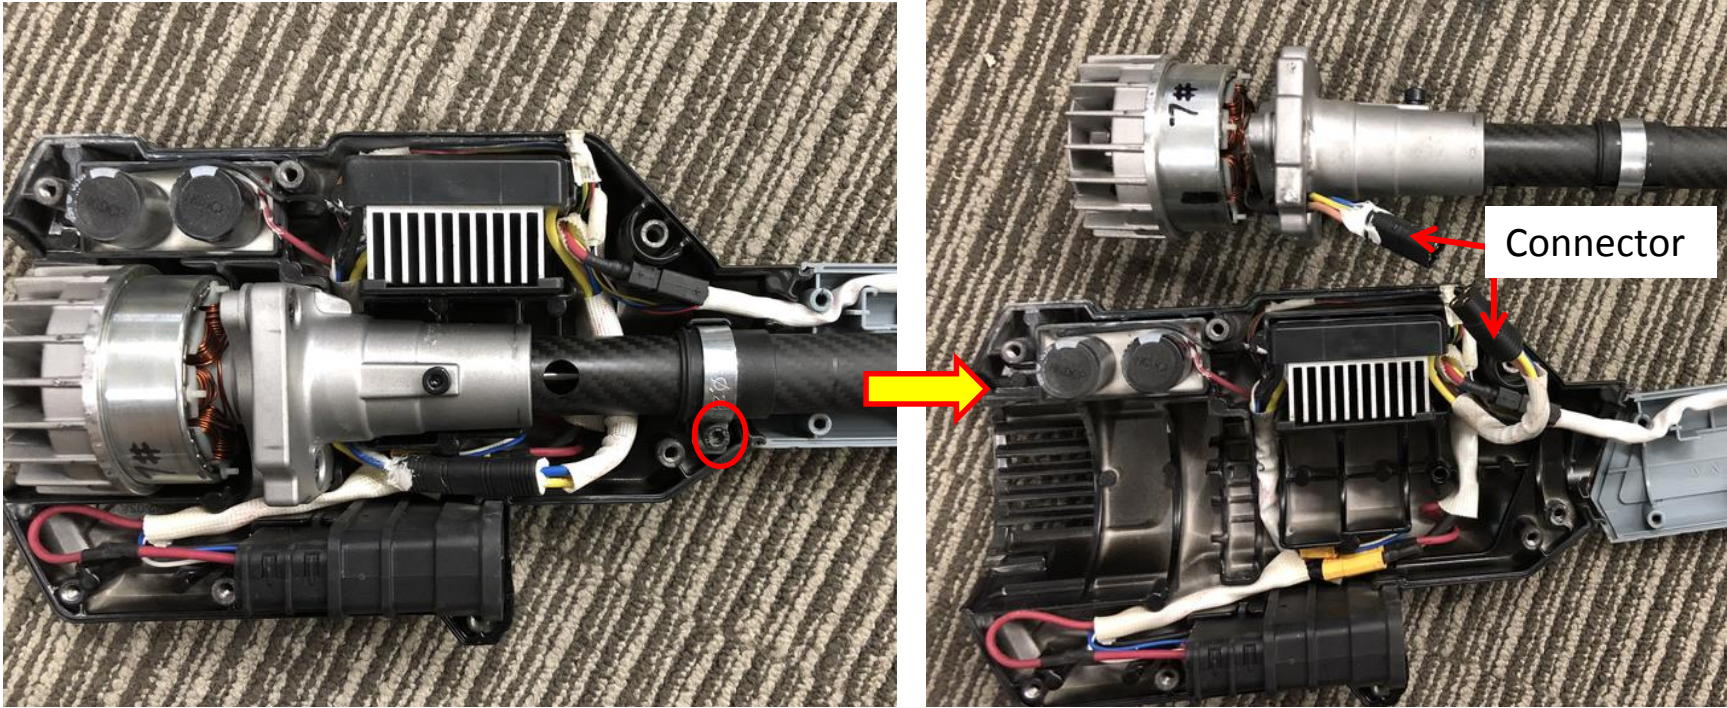
- 2. Loosen the screw on the fixed ring.
- 3. Take the shaft and motor out its groove and disconnect the connector.

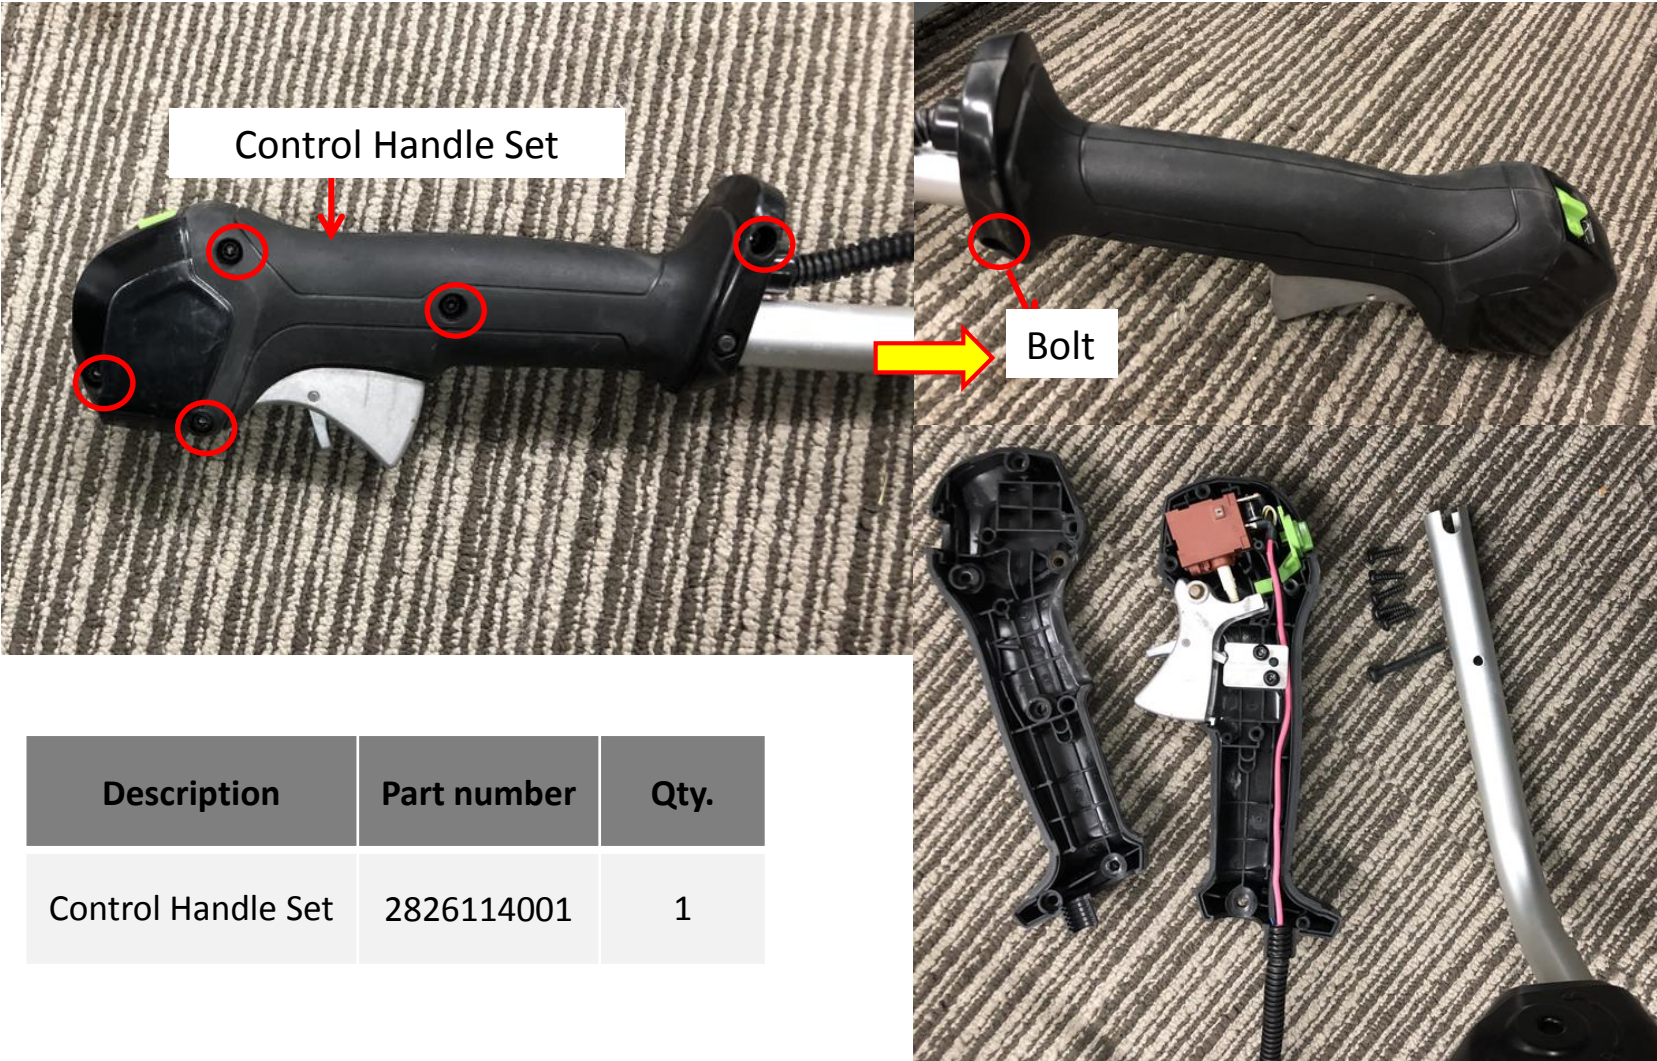
4. loosen the 5 screws and 1 bolt on the Control Handle Set to open it. remove the push button, switch lever ASSY, plunge frame and pin. If any part broken, replace it.

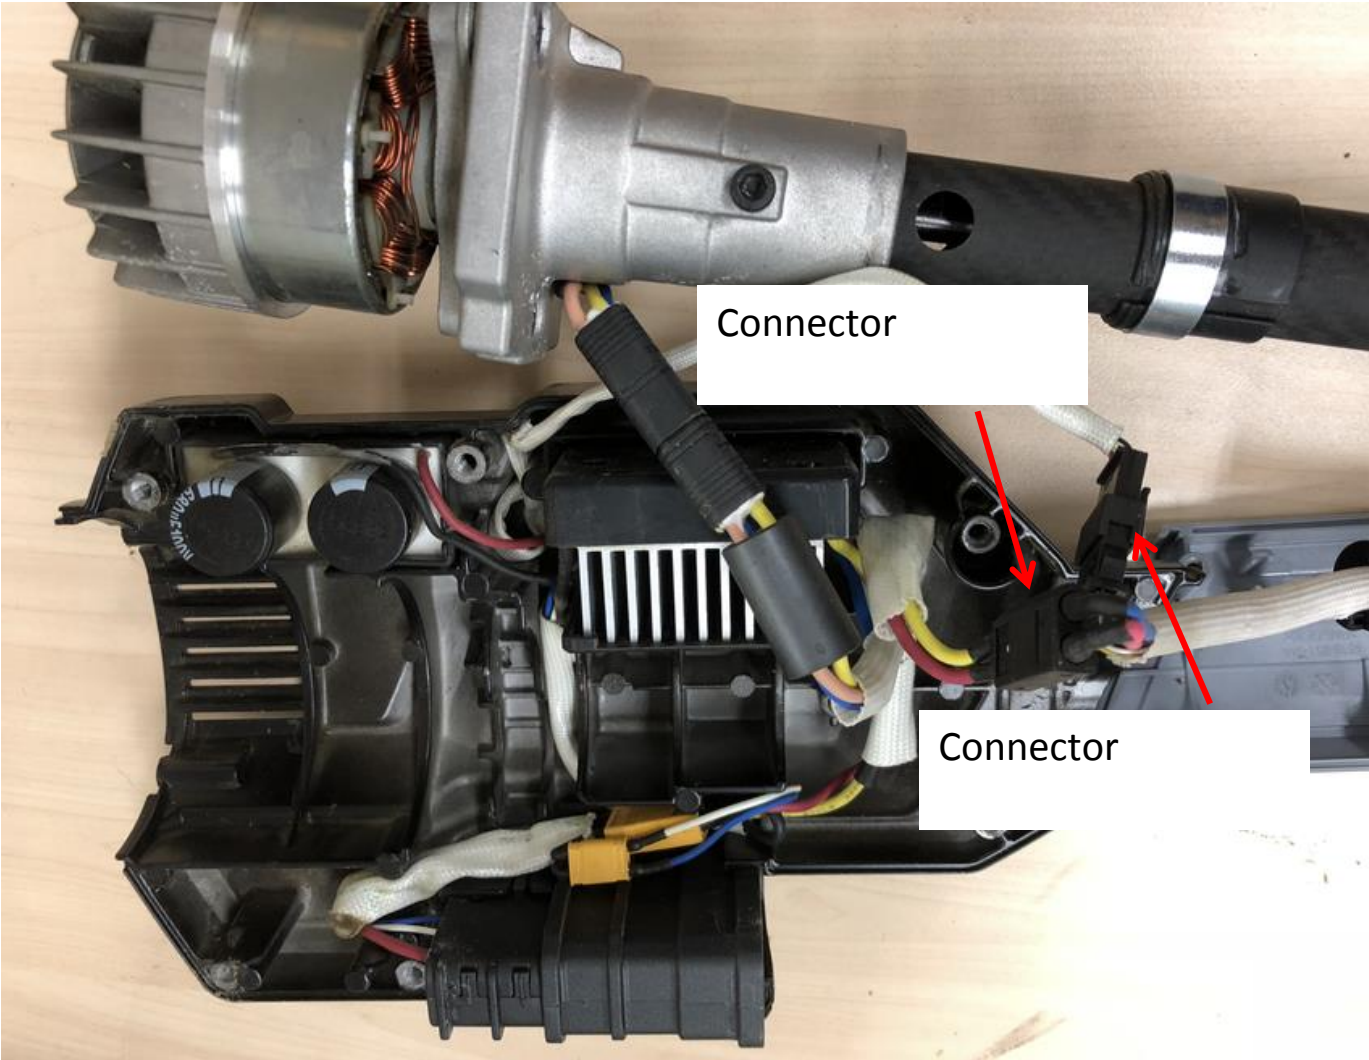
5. Disconnect the two connectors.

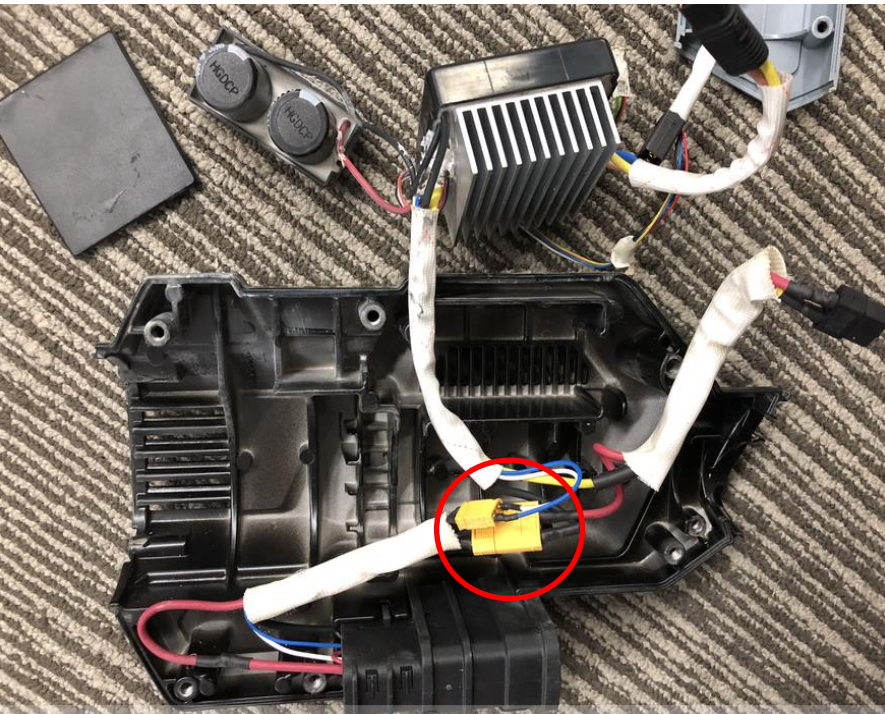
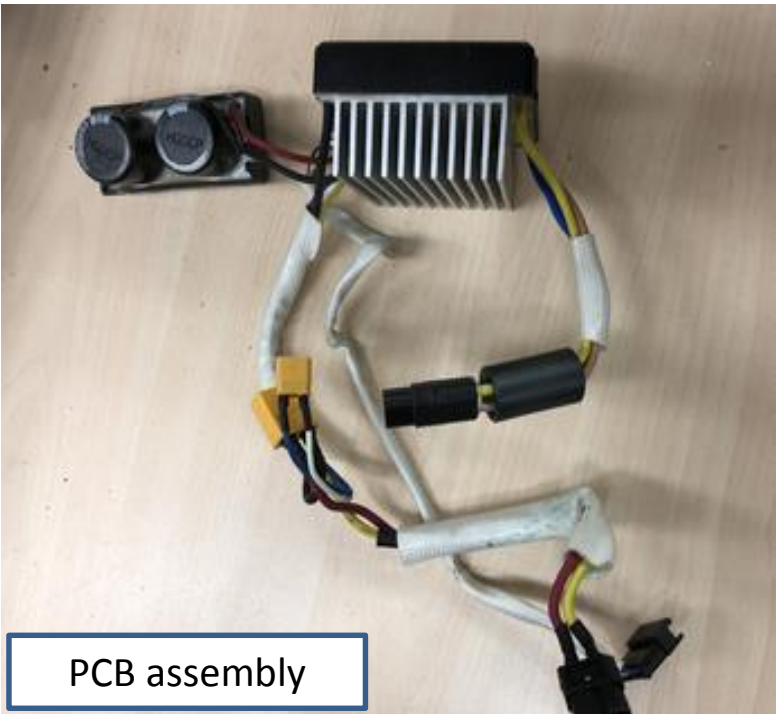
6. Take the PCBA away and separate the two connectors from PCBA. If PCBA is damaged, replace it with a new one.

**Notice:** For the products (EST20180500001X-EST20181000900X), Switch Assembly should be replaced simultaneously with PCB assembly. Since the PCB & Switch assembly had been upgraded.

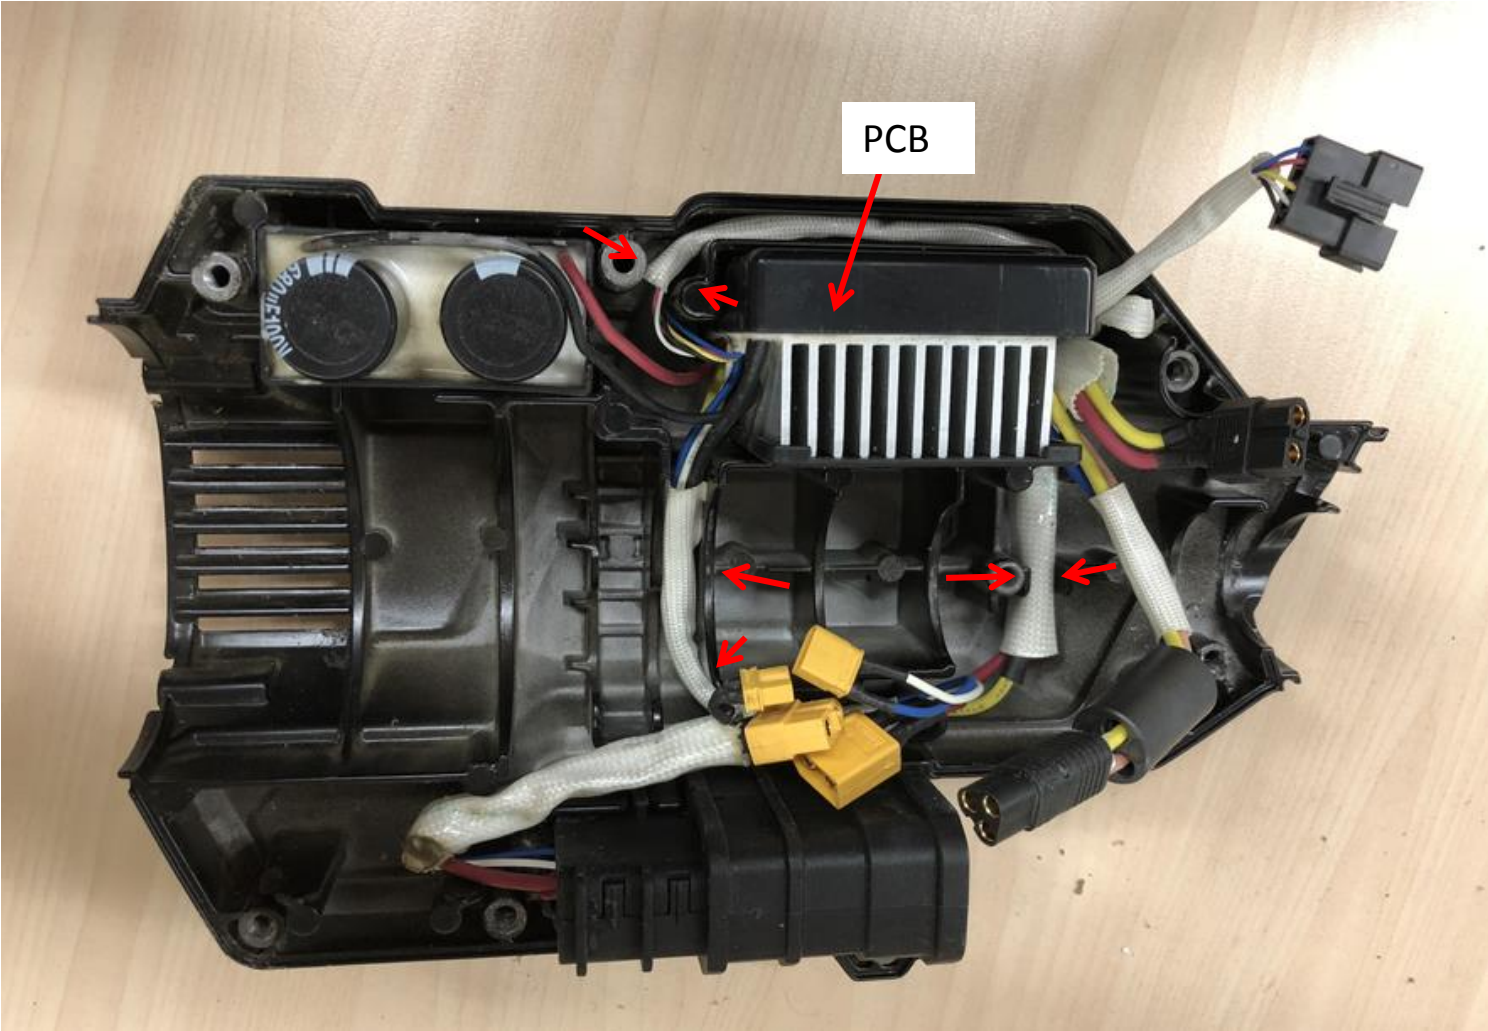
7. Align the wires into its groove and mount the PCBA into the housing.

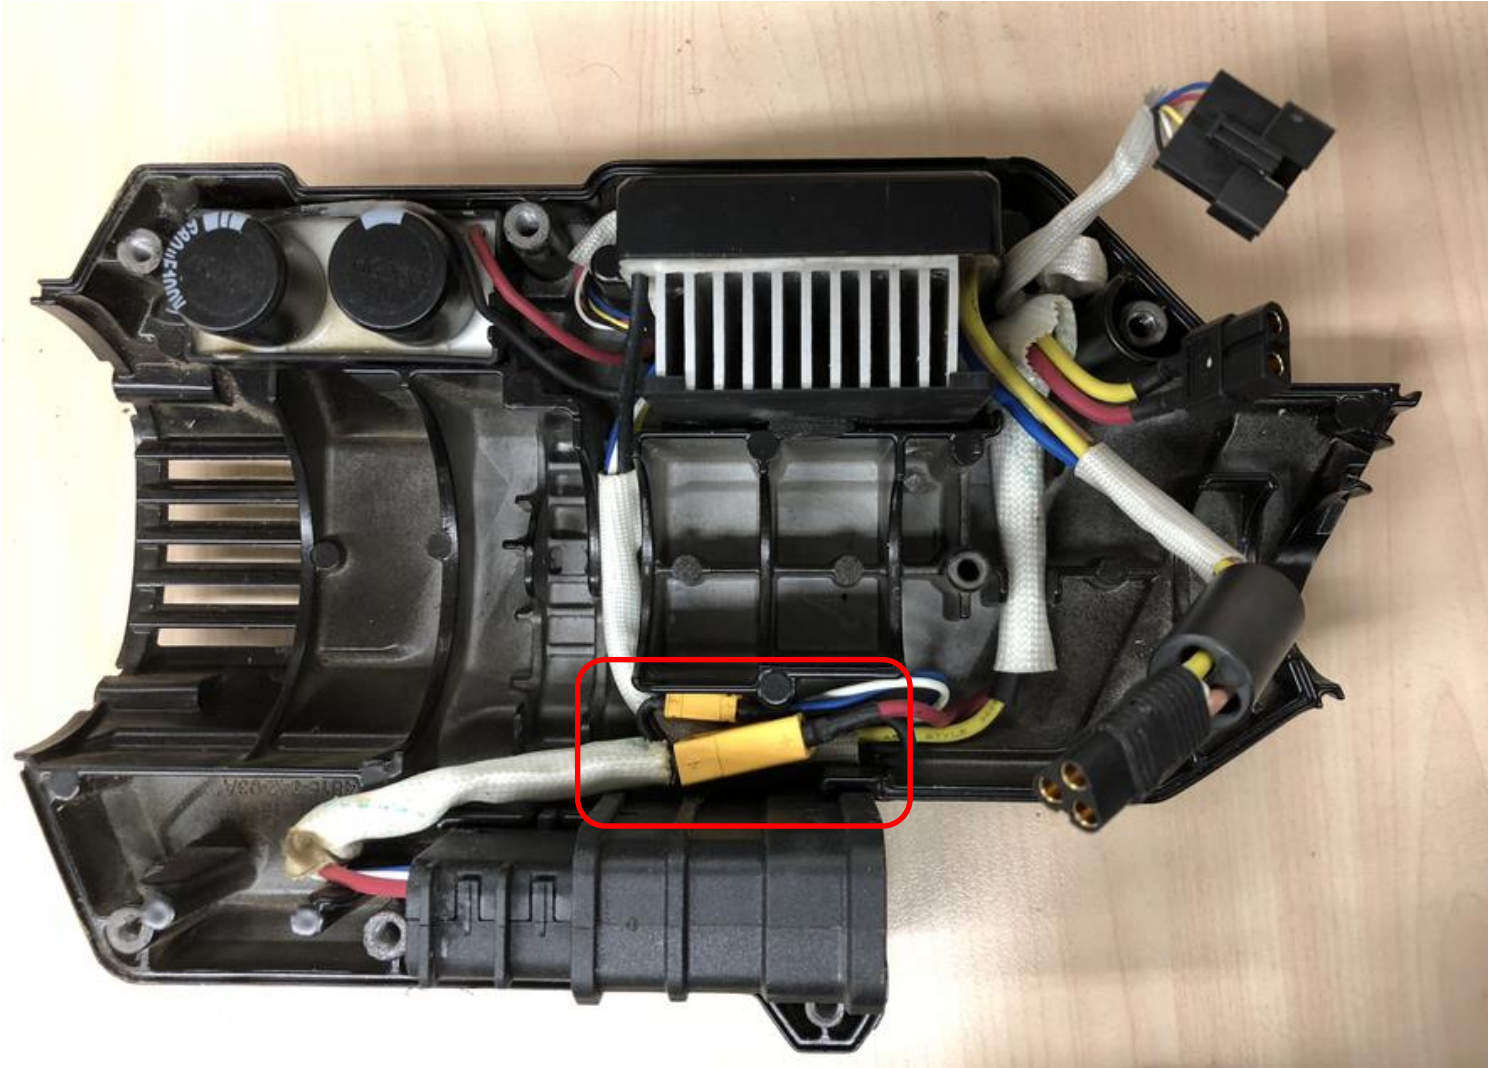
8. Connect the two connectors(yellow in picture). Then align them into groove

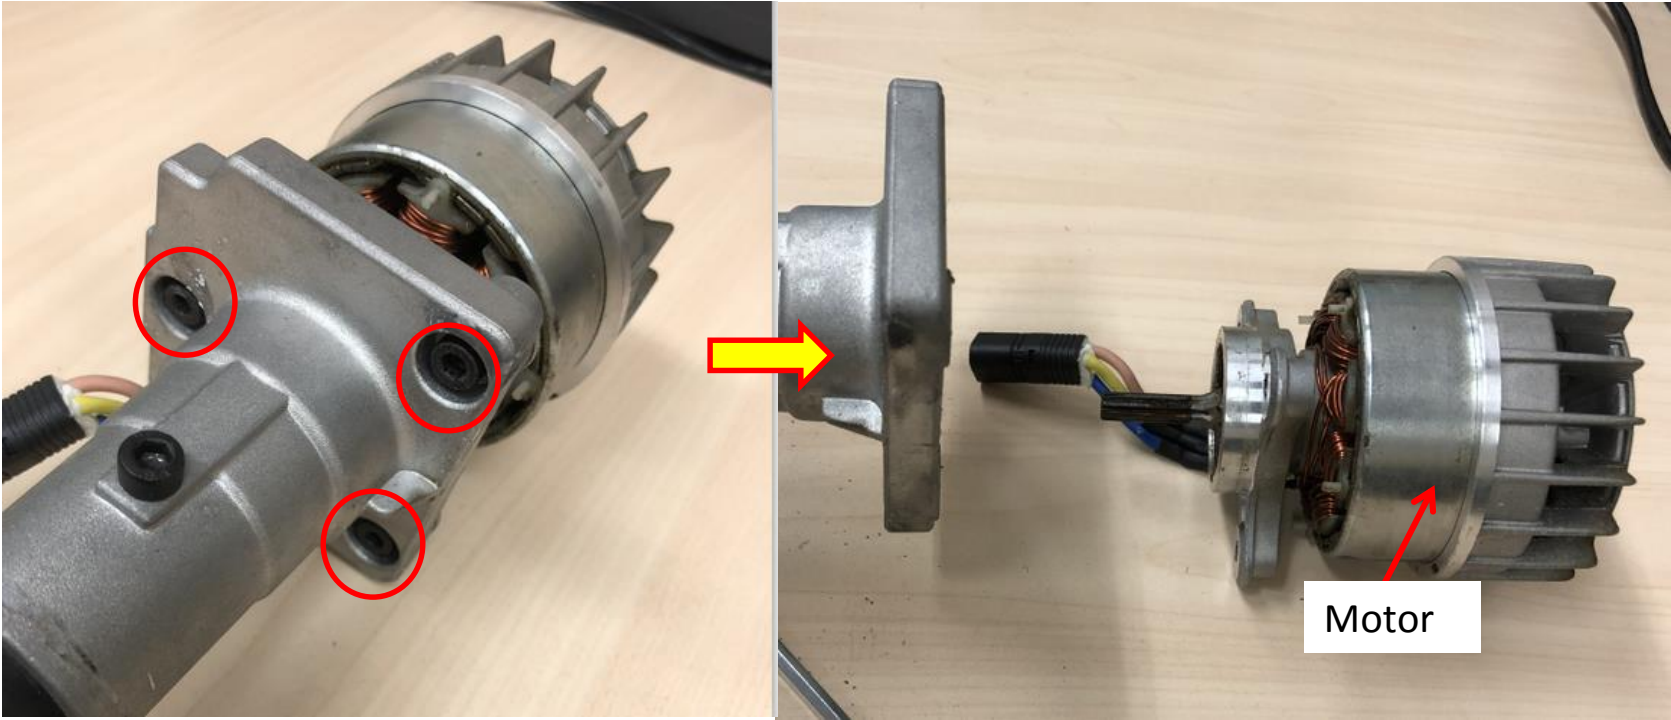
9. Loosen 3 screws to separate the motor from the shaft assembly.

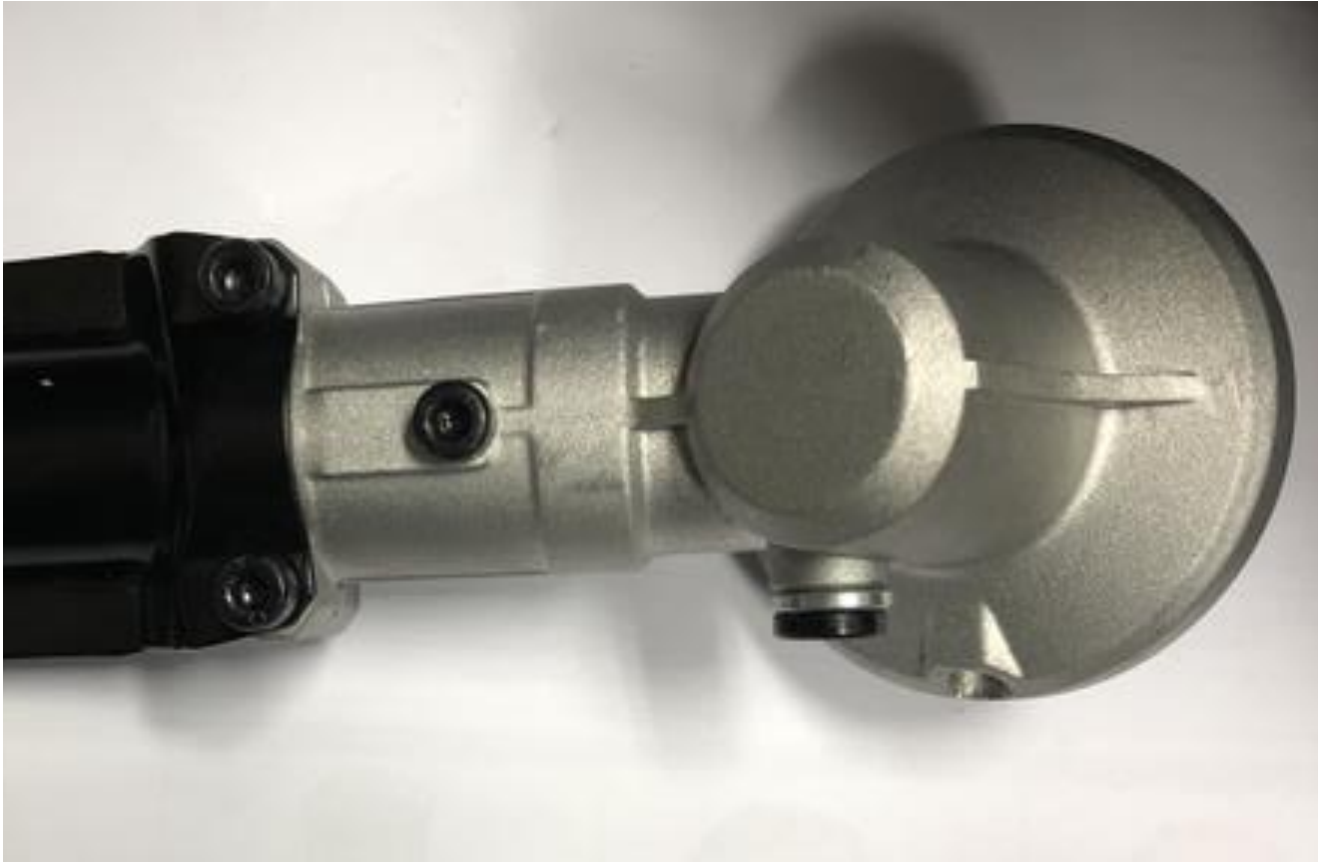
11. Replace the gear case assembly with a new one and assemble the gear case assembly with the shaft assembly with screw.

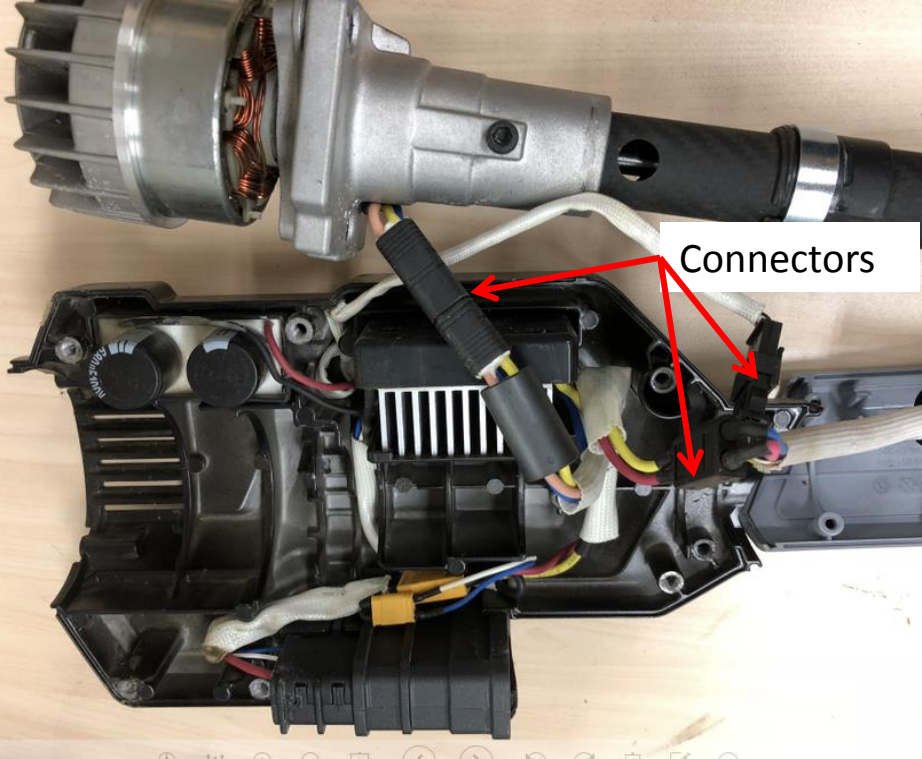
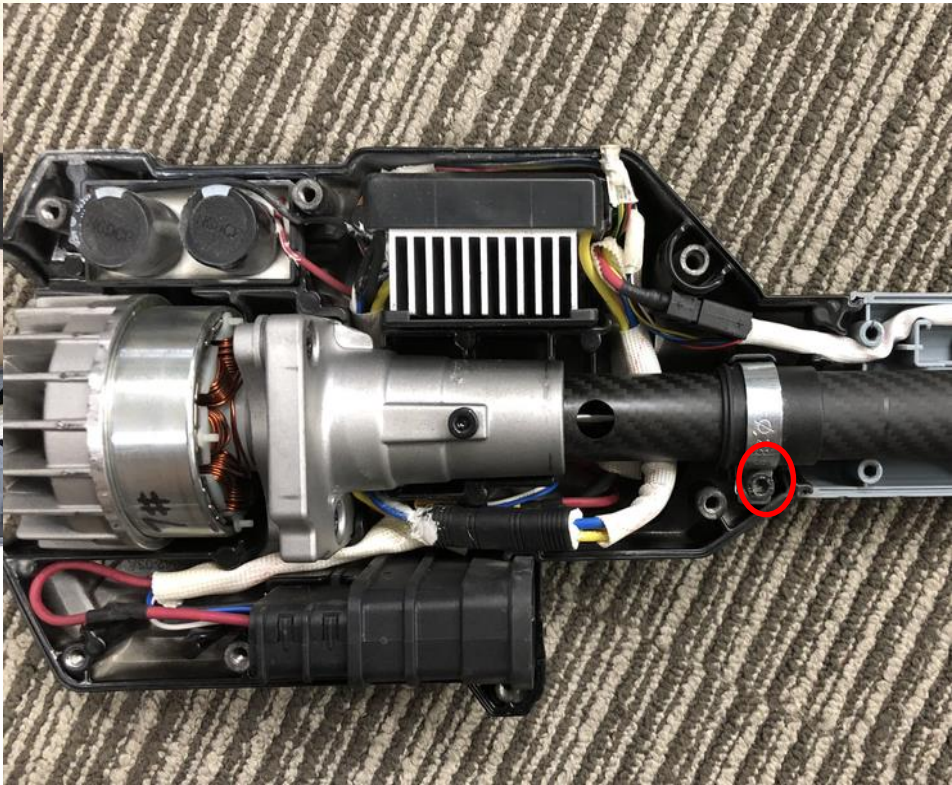
13. Connect the three connector and put the shaft with motor into the housing, then tighten the screw.

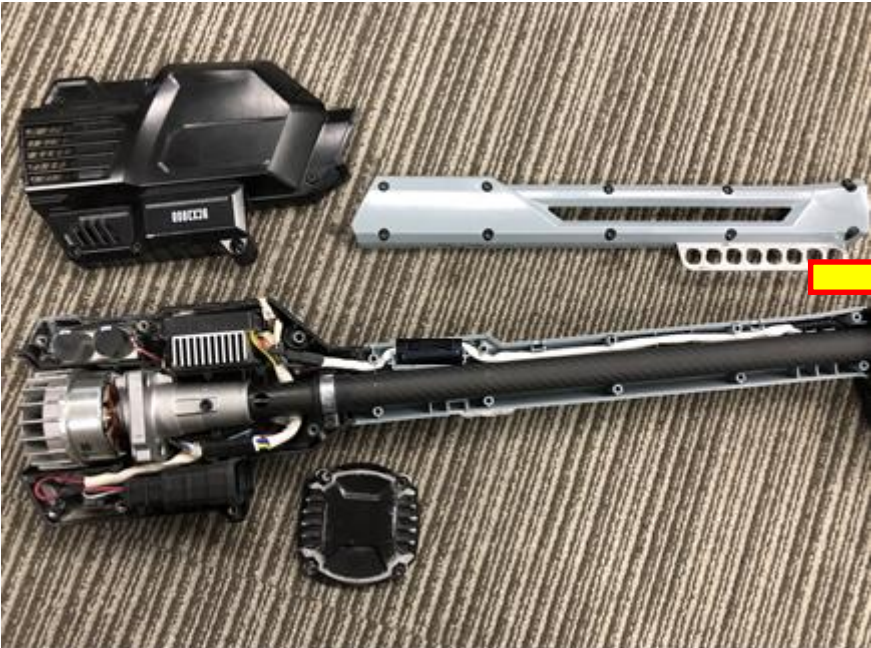
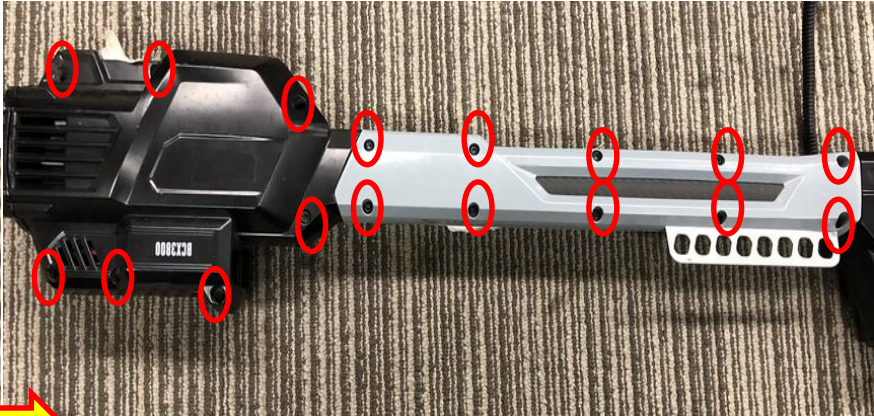
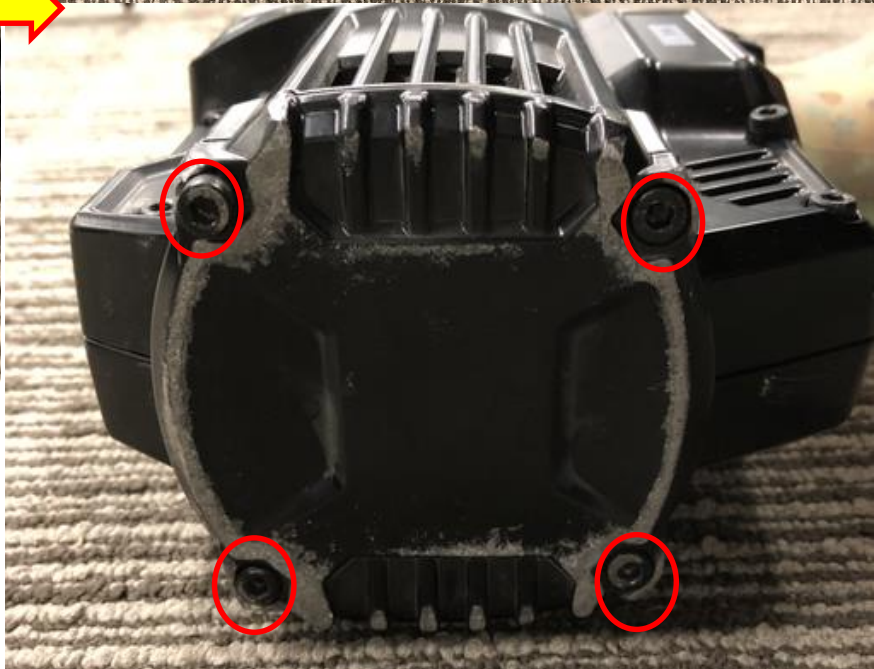
14. Assemble the housing assembly with 17 screws. Then assemble the Rear Cover with 4 screws.

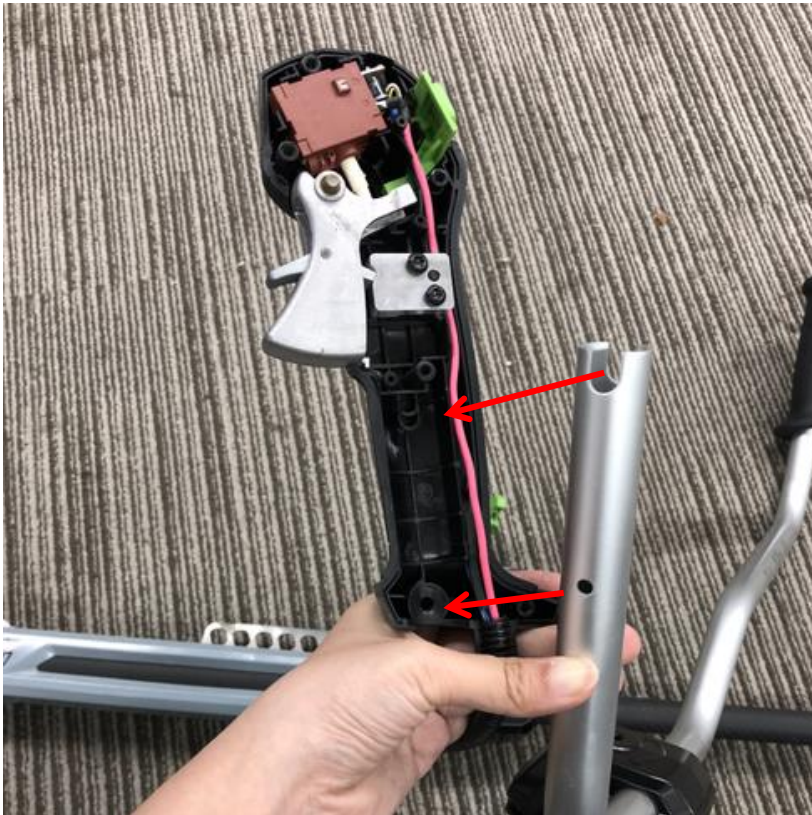
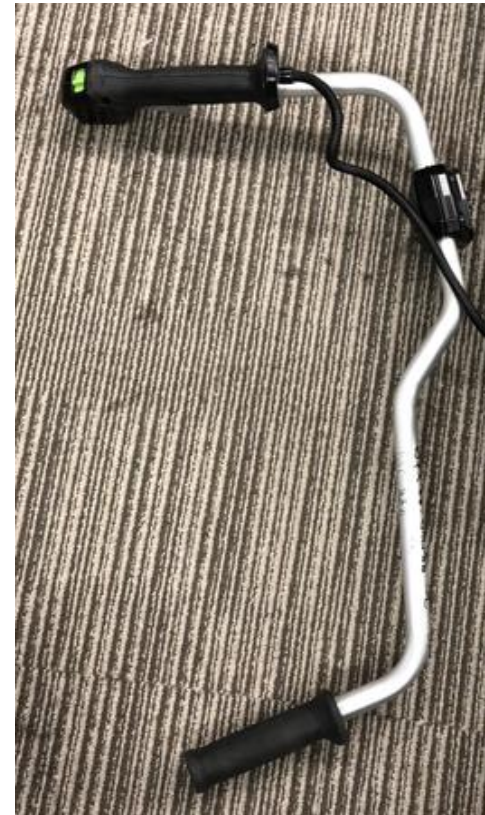
15. Align the slot on the connecting tube with the rib on the housing, as well as aligning the location pole on the housing with the hole on the connecting tube to mount the control handle set onto the connecting tube.
16. Lock the control handle set with 5 screws and 1 bolt with its washer and nut. And assemble the handle cover ASSY

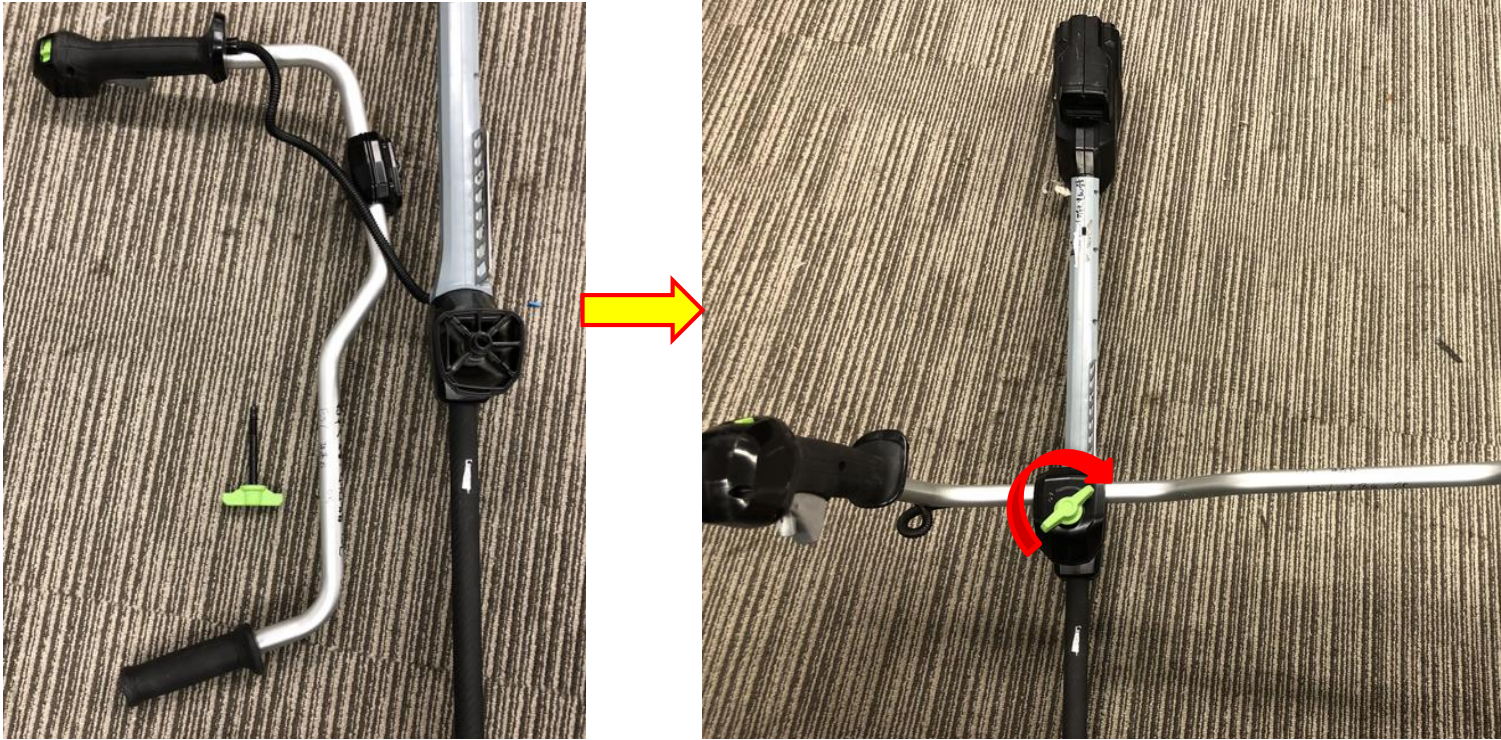
- 7. Rotate the wing bolt to connect the shaft base set with the connecting tube base set if it had been disassembled.

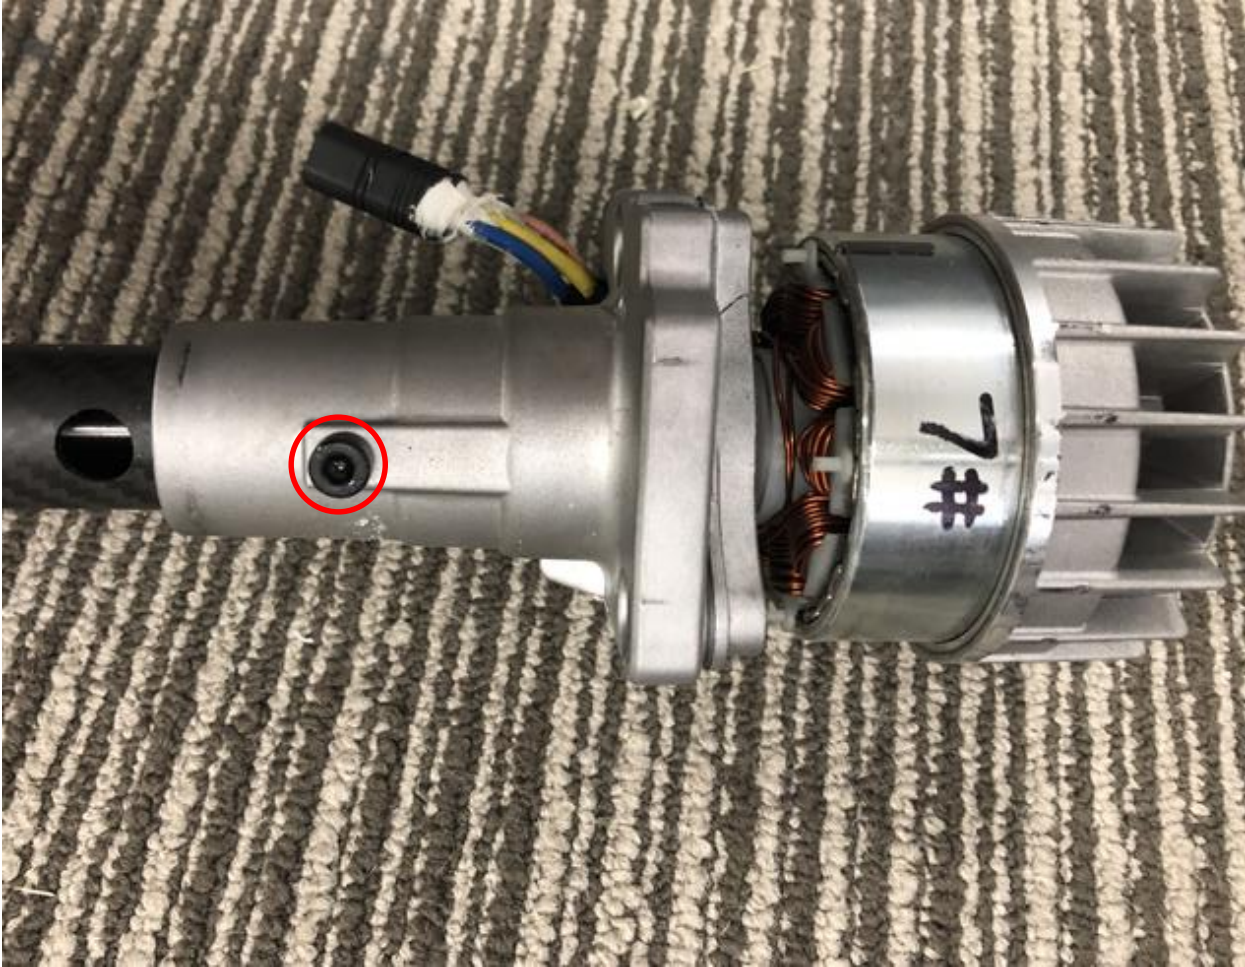
- 1. Loosen the screw to separate the motor & base assembly from the shaft.

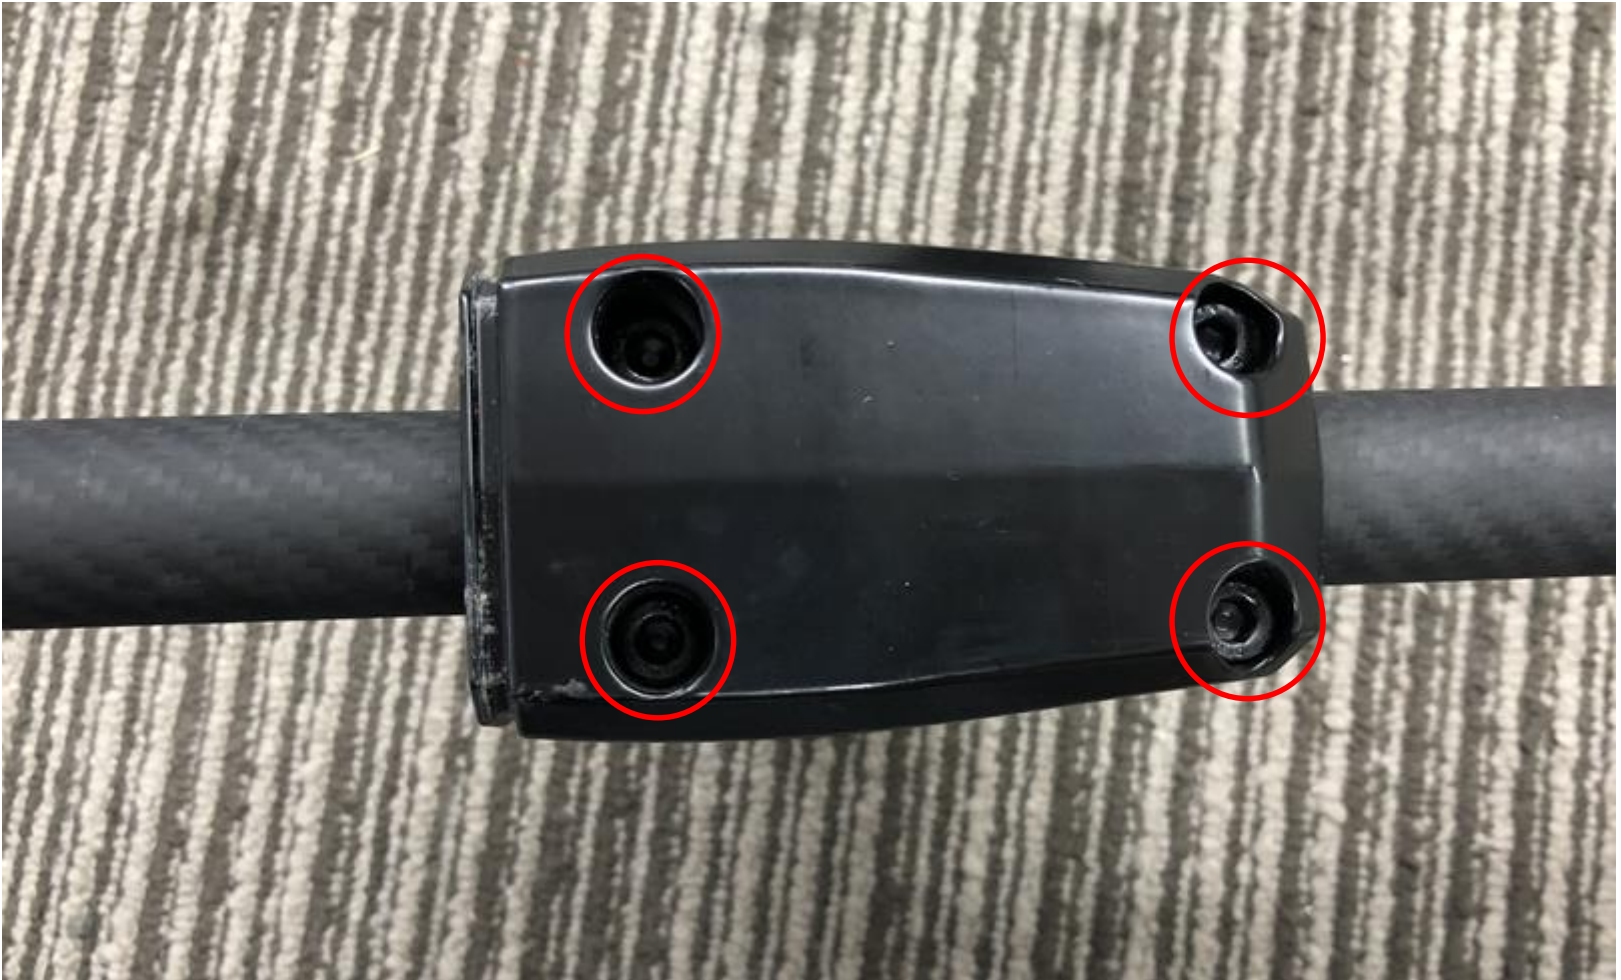
2. Remove the 4 screws and take bottom support & mounting Cover and fixing ring from the shaft .
