# REPAIR GUIDELINE

## Brush Cutter \_BCX3800

*Version: 2*

*Issue Date: 23/05/2019*

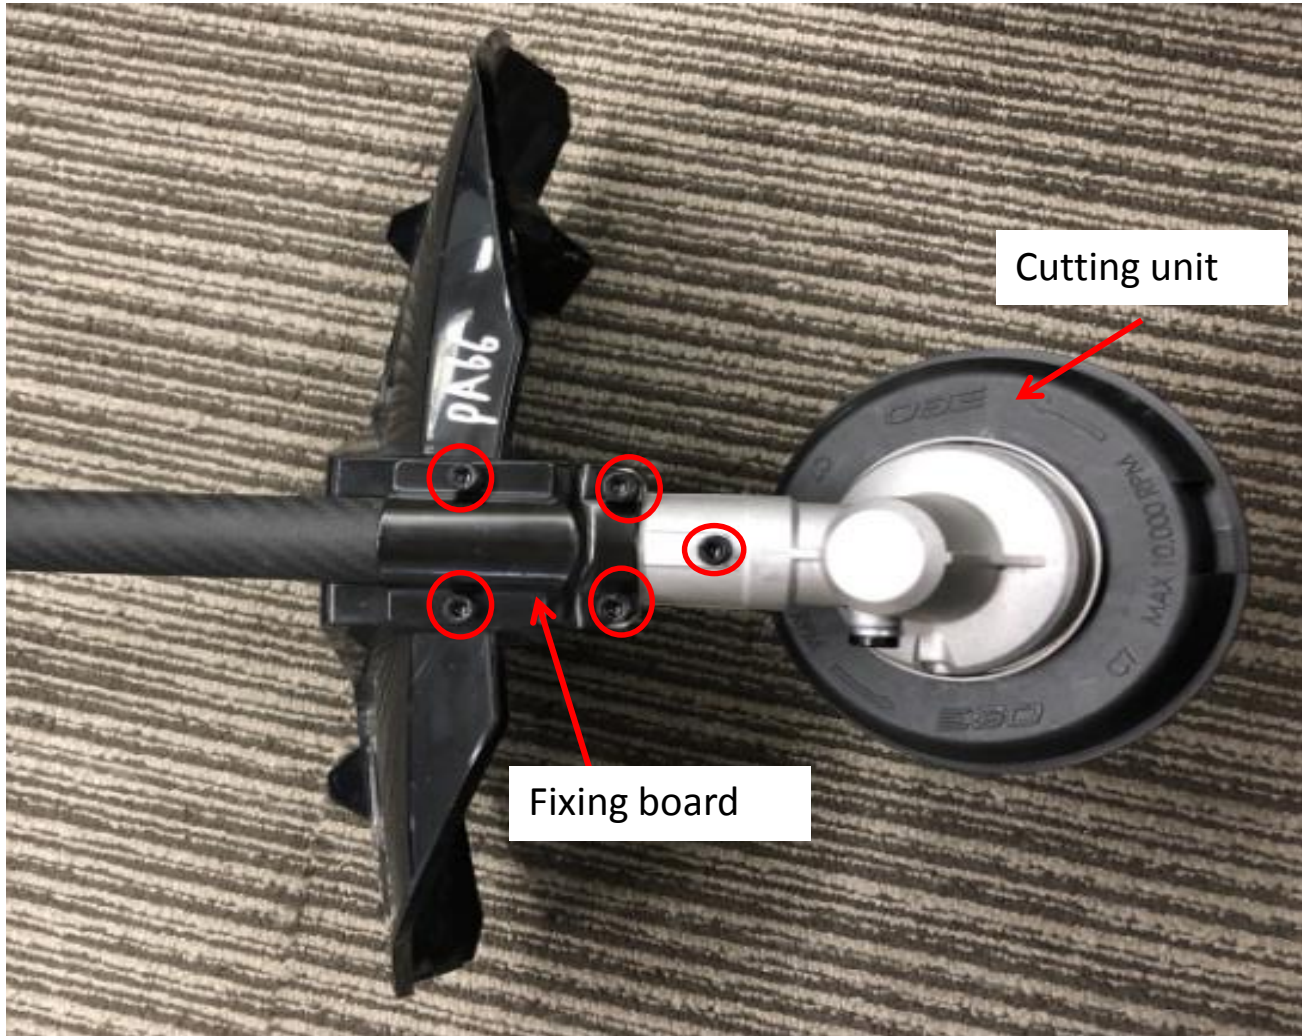
3. Loosen the five screws to separate cutting unit fixing board & guard from the shaft.

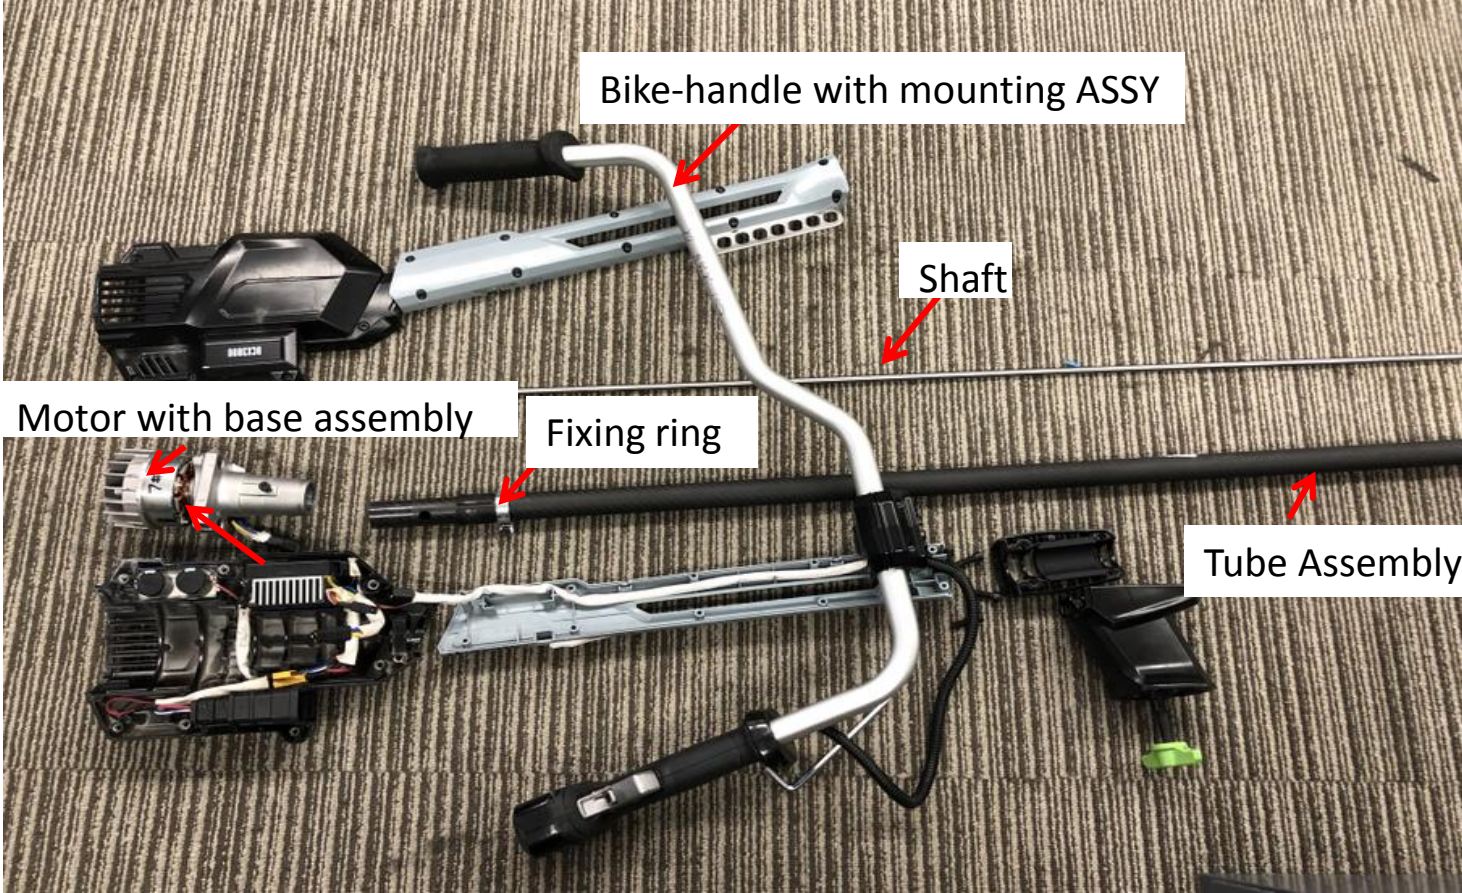
4. Pull out the shaft from the tube ASSY and replace the shaft or the tube ASSY with a new one.
